Freemantle Community Centre

Review Photographs

3rd February 2015

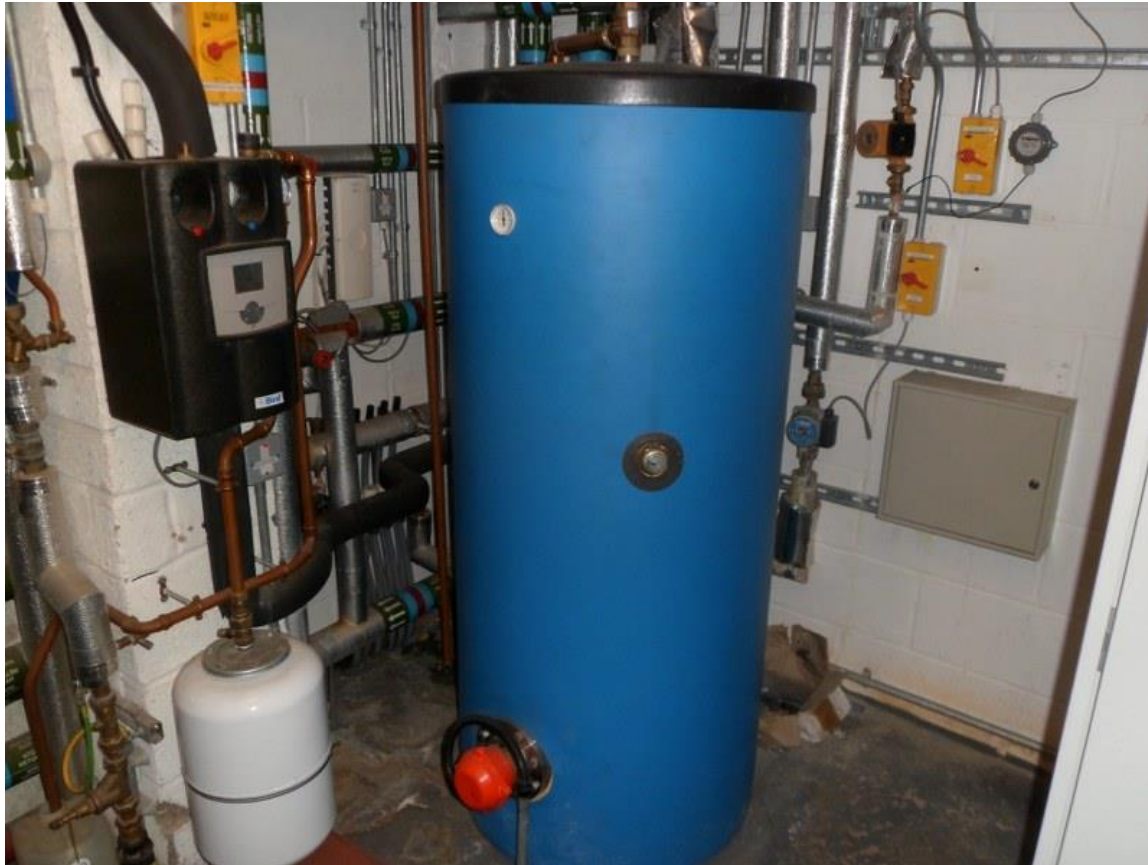
Hot Water Calorifier

Hot water calorifier serving all hot water within the community centre; low storage temperature recorded at the time of this review. Records indicate storage temperature is normally satisfactory at 60.0c or more.

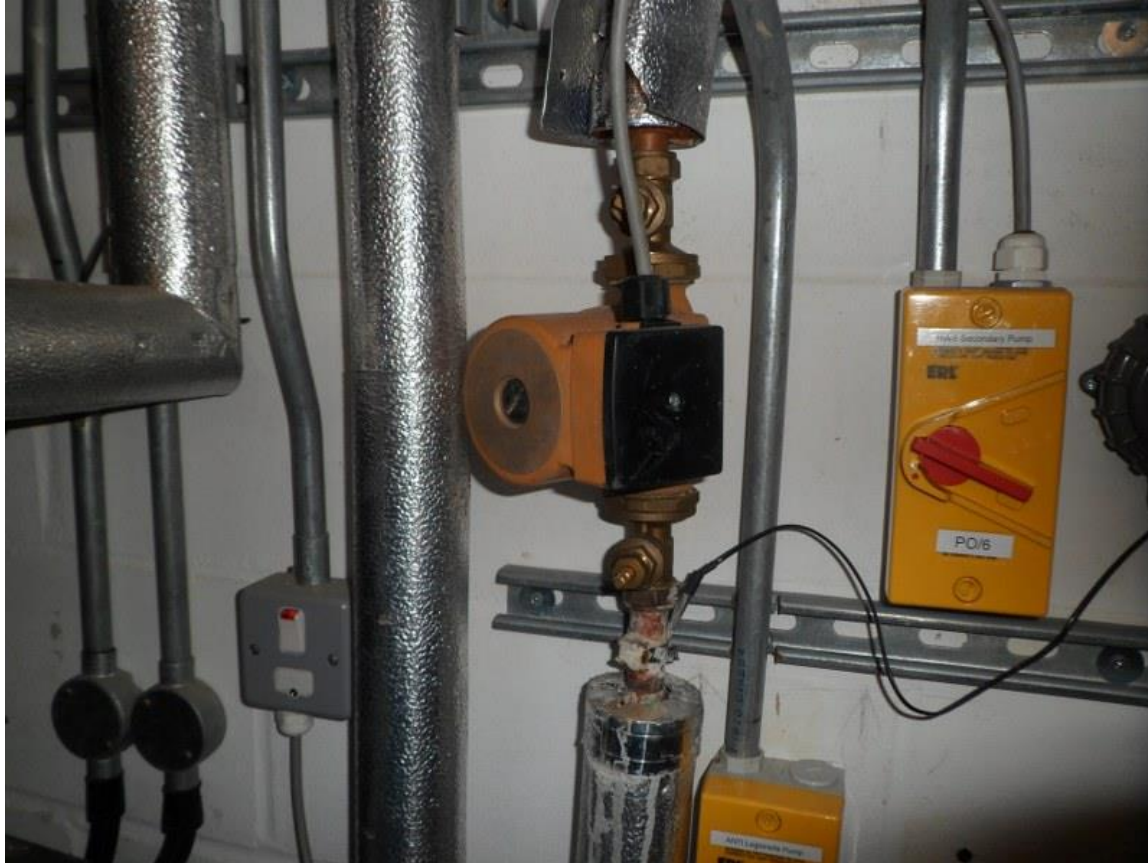
Calorifier Return Pump

Good return temperature recorded at the time of this review; records indicate this is normally satisfactory.

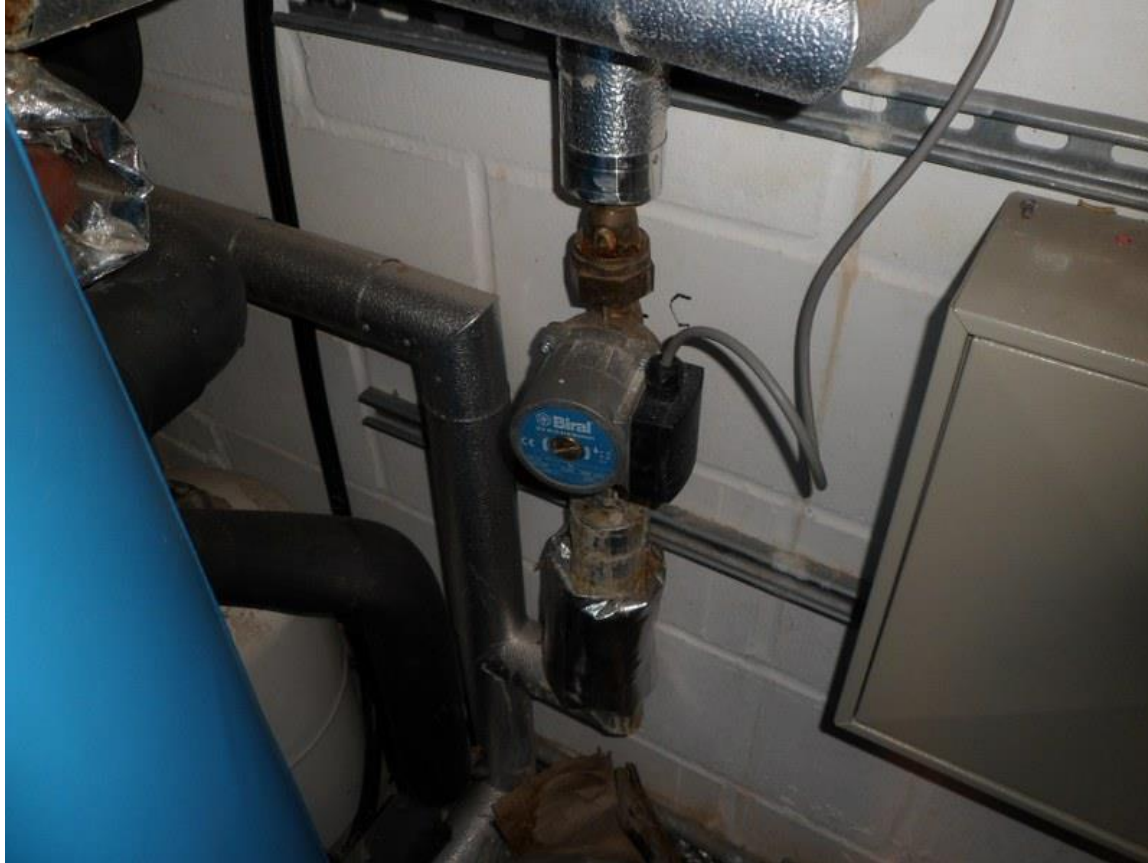
Calorifier De-Stratification Pump

The hot water calorifier is fitted with a de-stratification pump; this appeared to be working satisfactory at the time of this review.

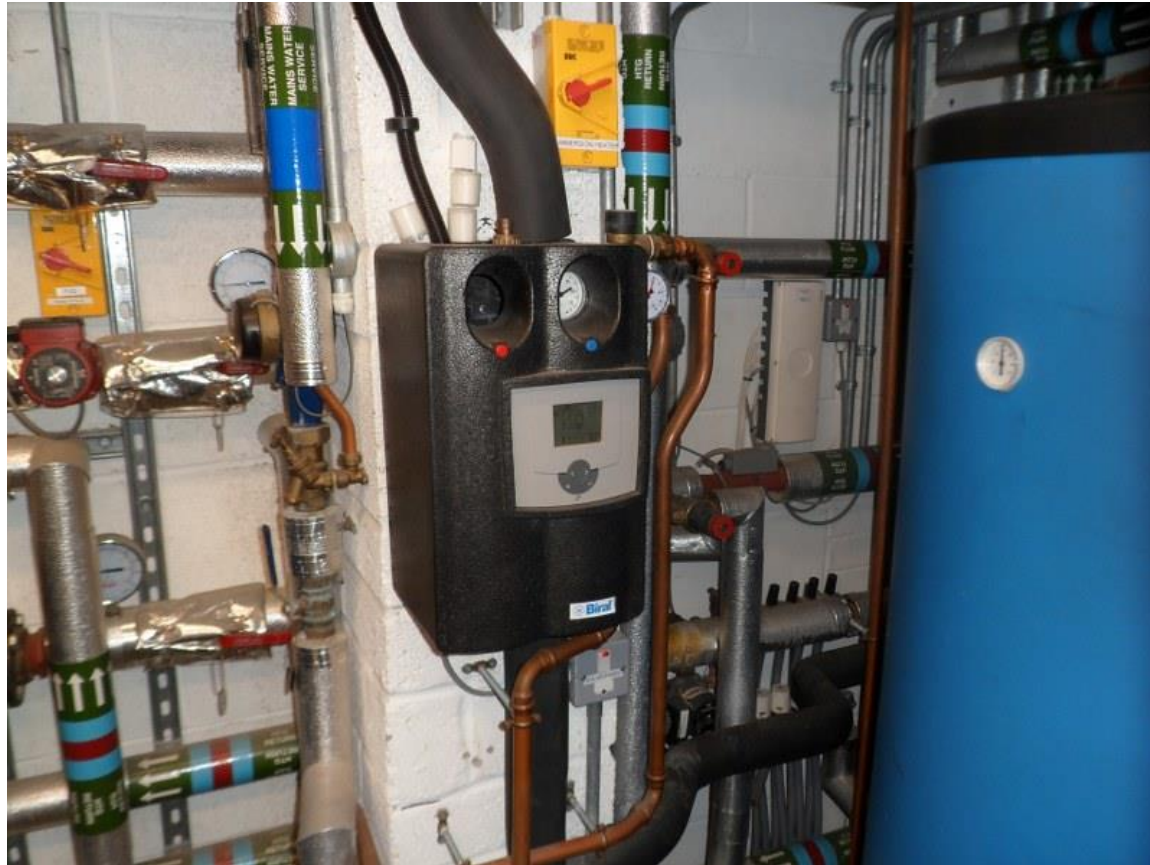
Solar Powered System

The hot water calorifier has a solar powered system fitted to aid with heating.

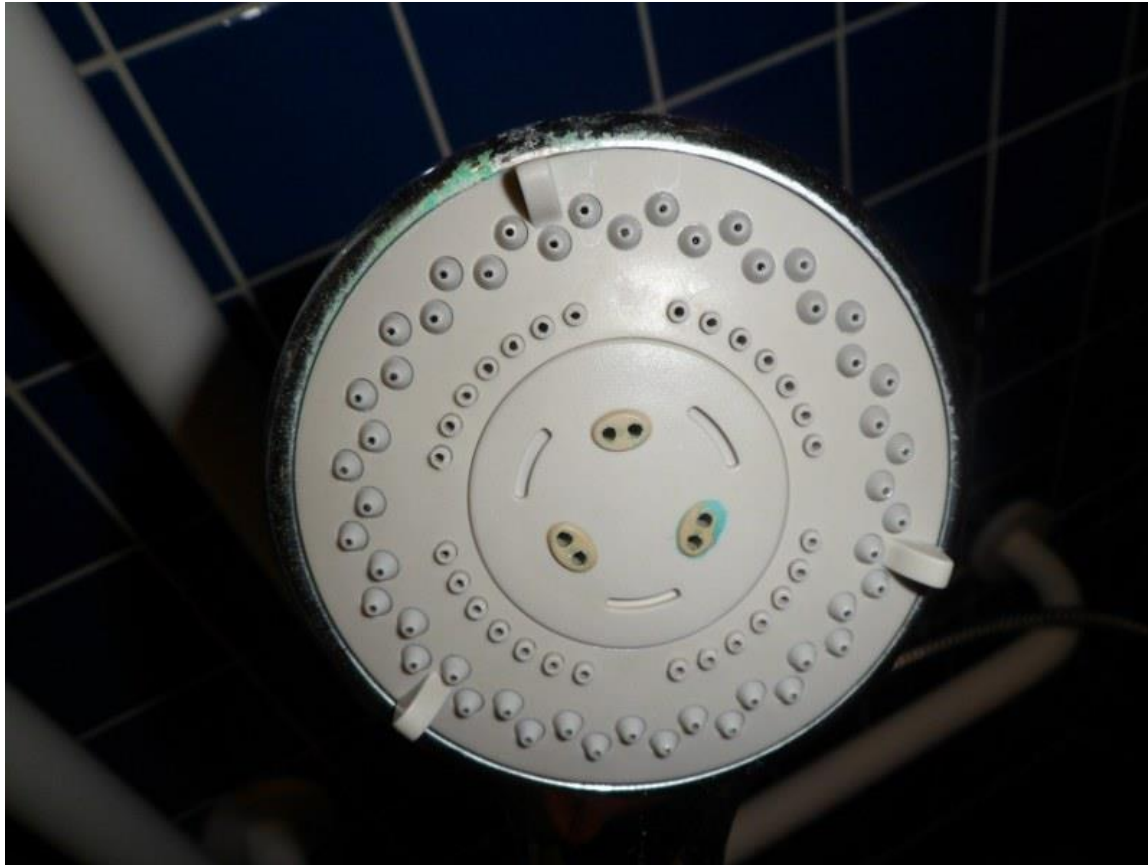
Showerhead

The showerhead fitted in the accessible toilet is being cleaned and disinfected quarterly and recorded; records indicate this was last carried out in January 2015.

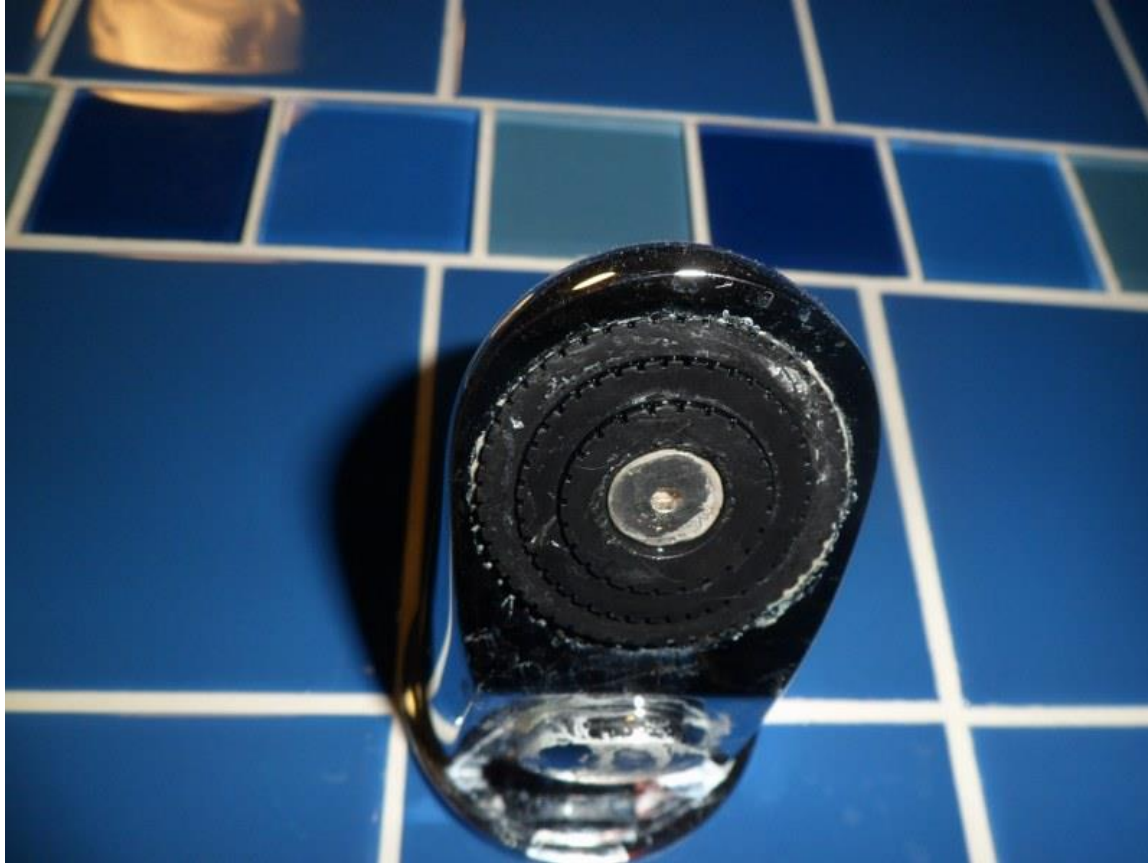
Showerhead

The showerhead fitted in the accessible toilet is being cleaned and disinfected quarterly and recorded; records indicate this was last carried out in January 2015.

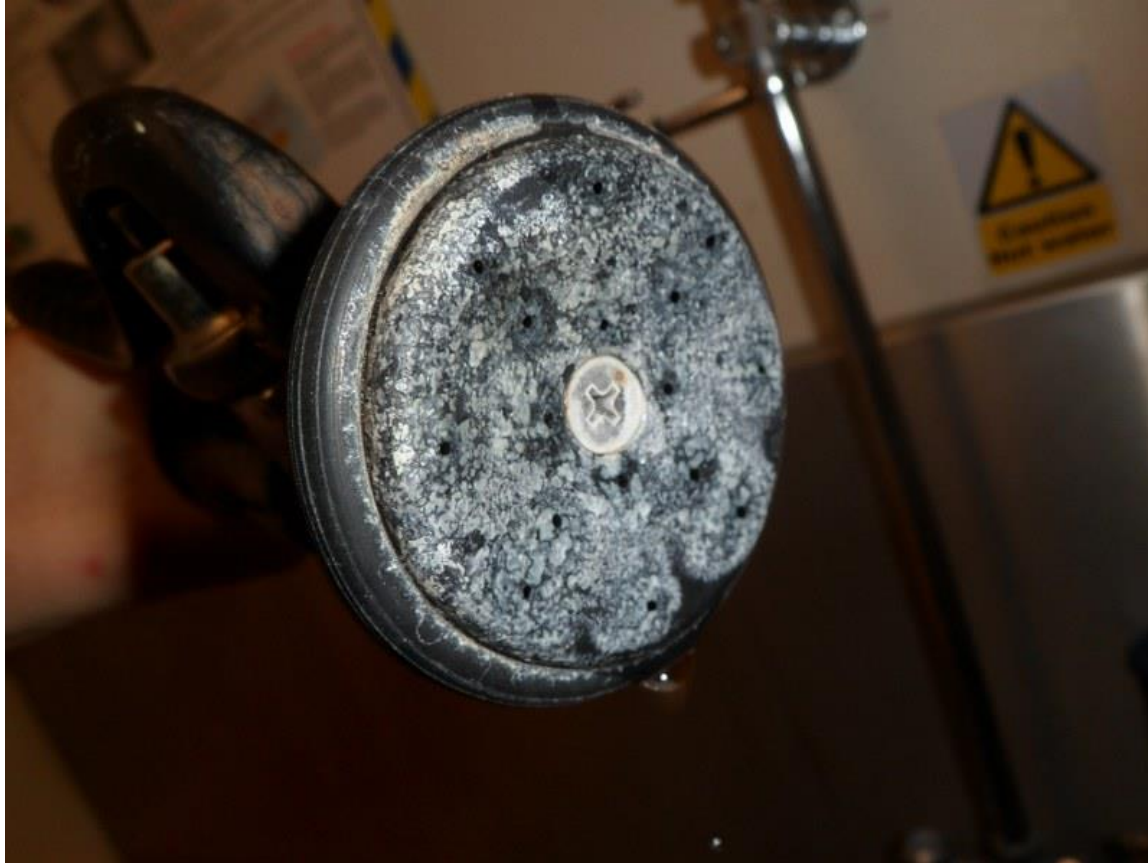
Kitchen Spray head

The kitchen is fitted with a spray head I would recommend this outlet be cleaned and disinfected along with showerheads if required as aerosols are created when in operation.

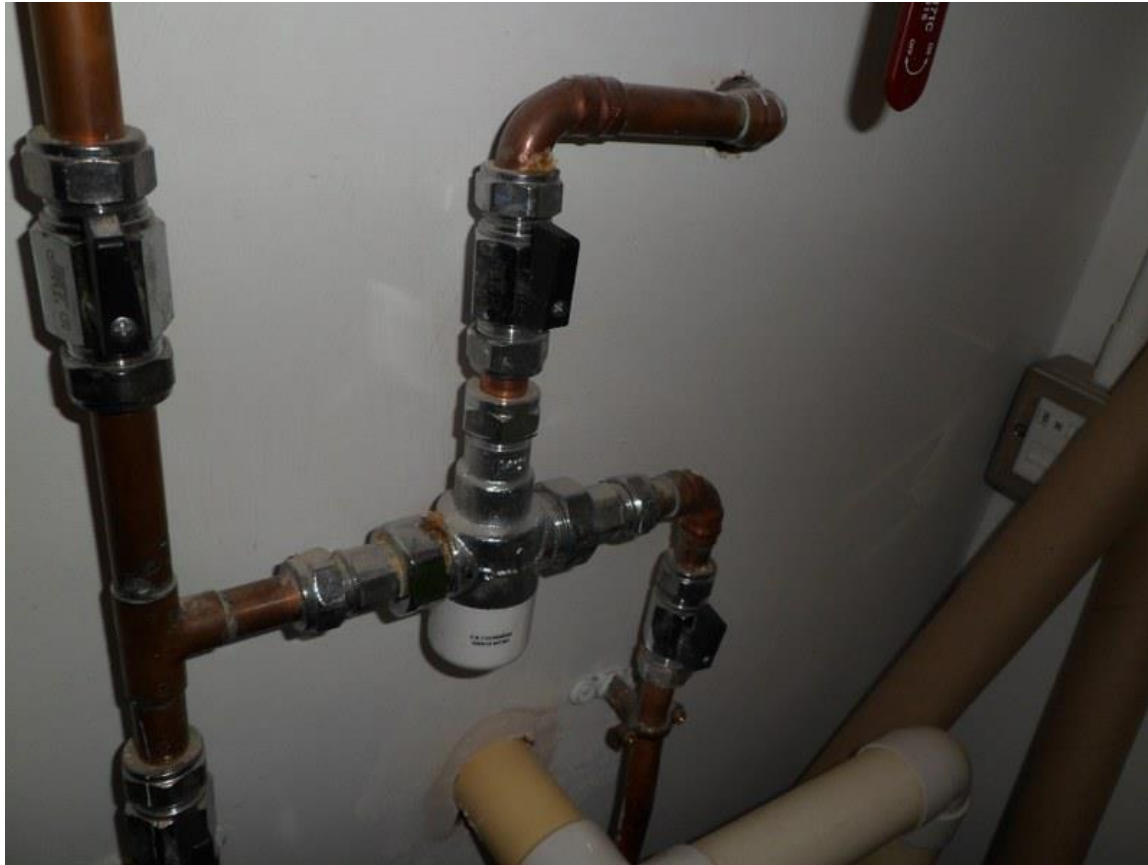
TMVs are fitted within the community centre; records indicate these are being serviced and adjusted; this was last carried out in August 2014.

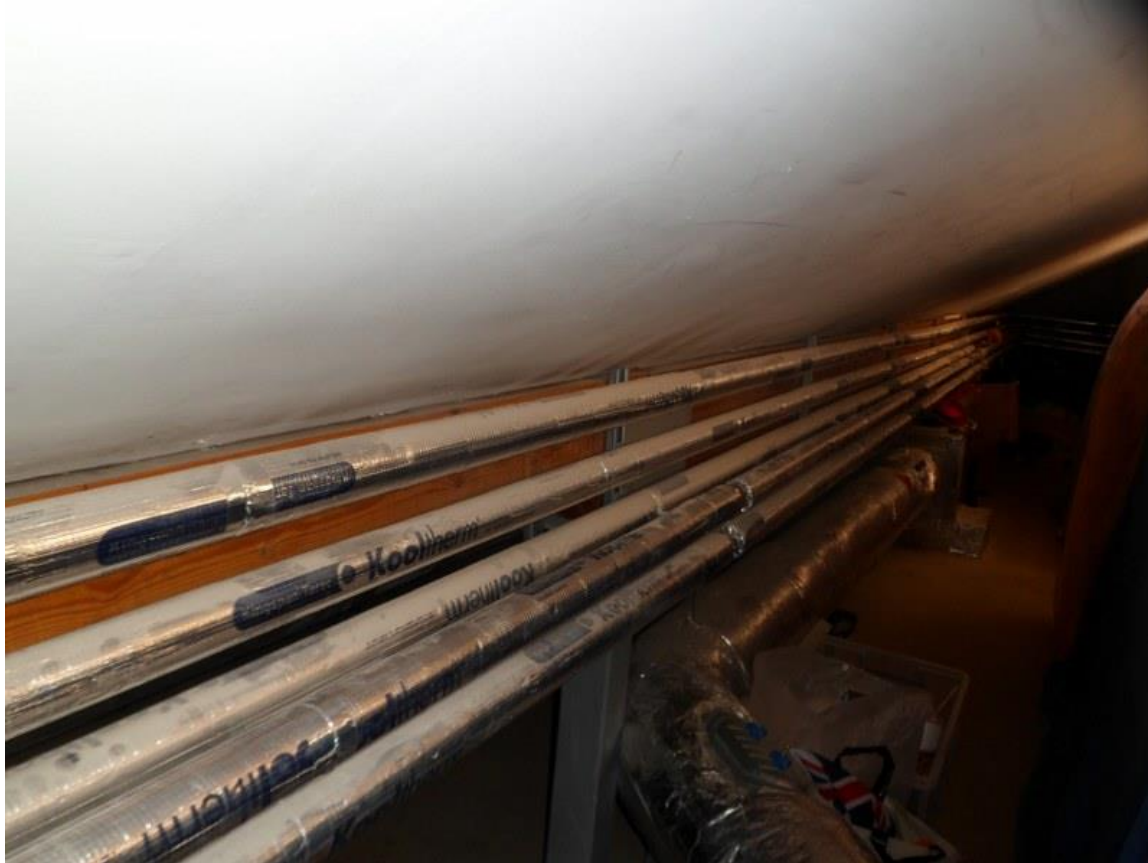
Insulation

The domestic water long pipe runs were seen to be well insulated within the roof void areas.
