Regents Park Community Centre

Review Photographs

22nd January 2015

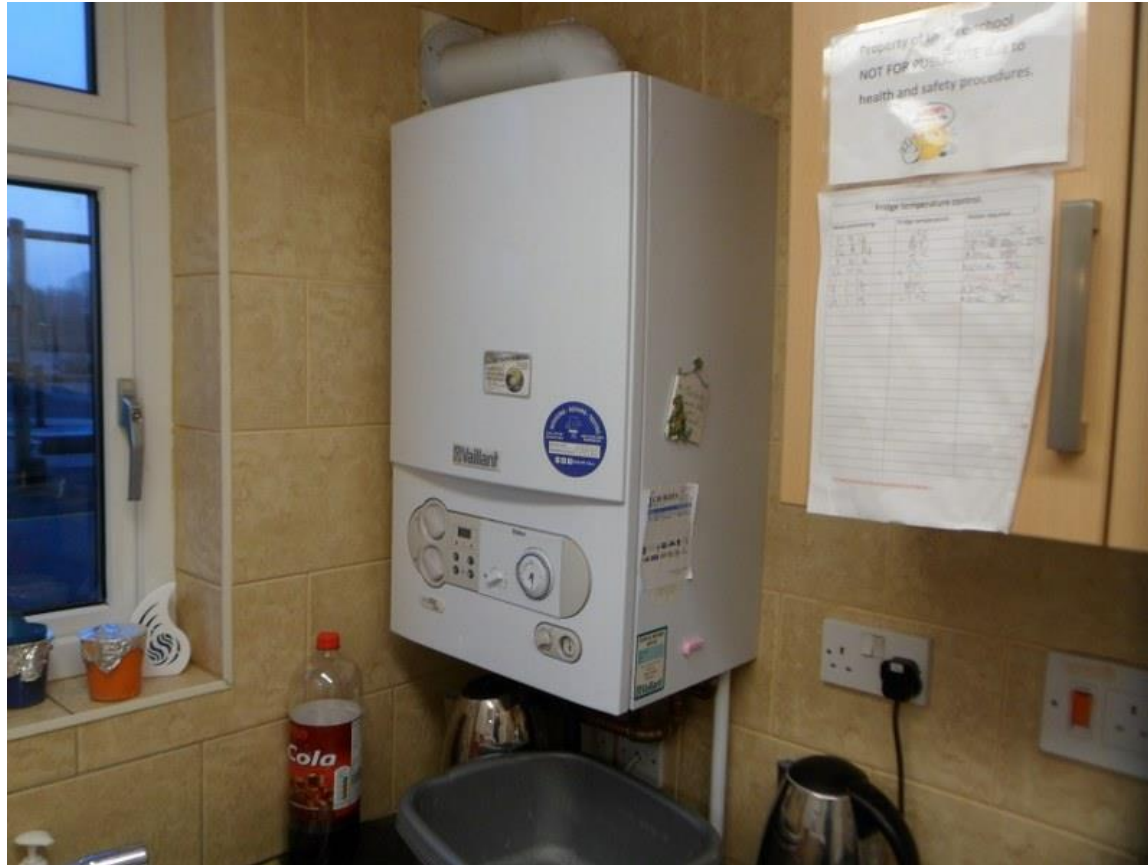
Combination Boiler

The combination boiler serving all hot water within the community centre; good outlet temperature recorded and records indicate normally satisfactory.

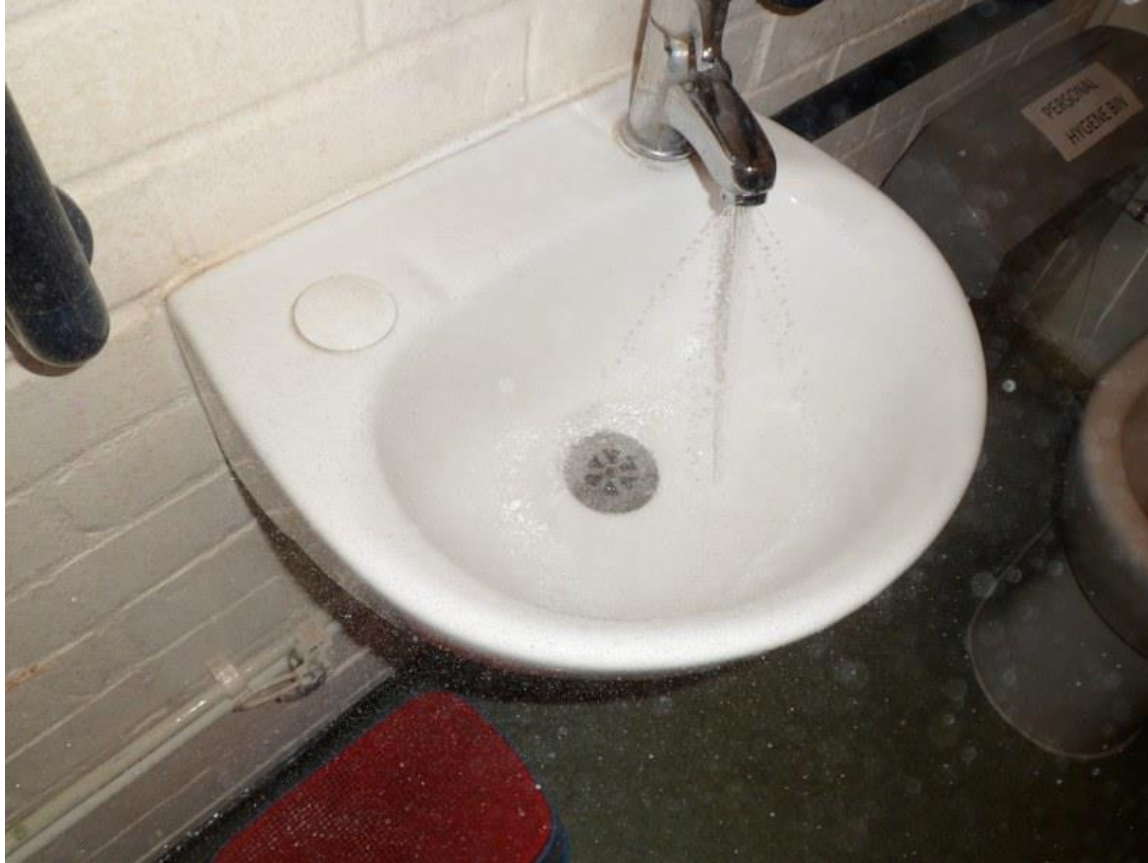
Aerosol Creation

There is a high volume of aerosols created when the disabled toilet tap outlet is operated; I would recommend the spray insert be cleaned or removed to prevent this at the earliest opportunity.

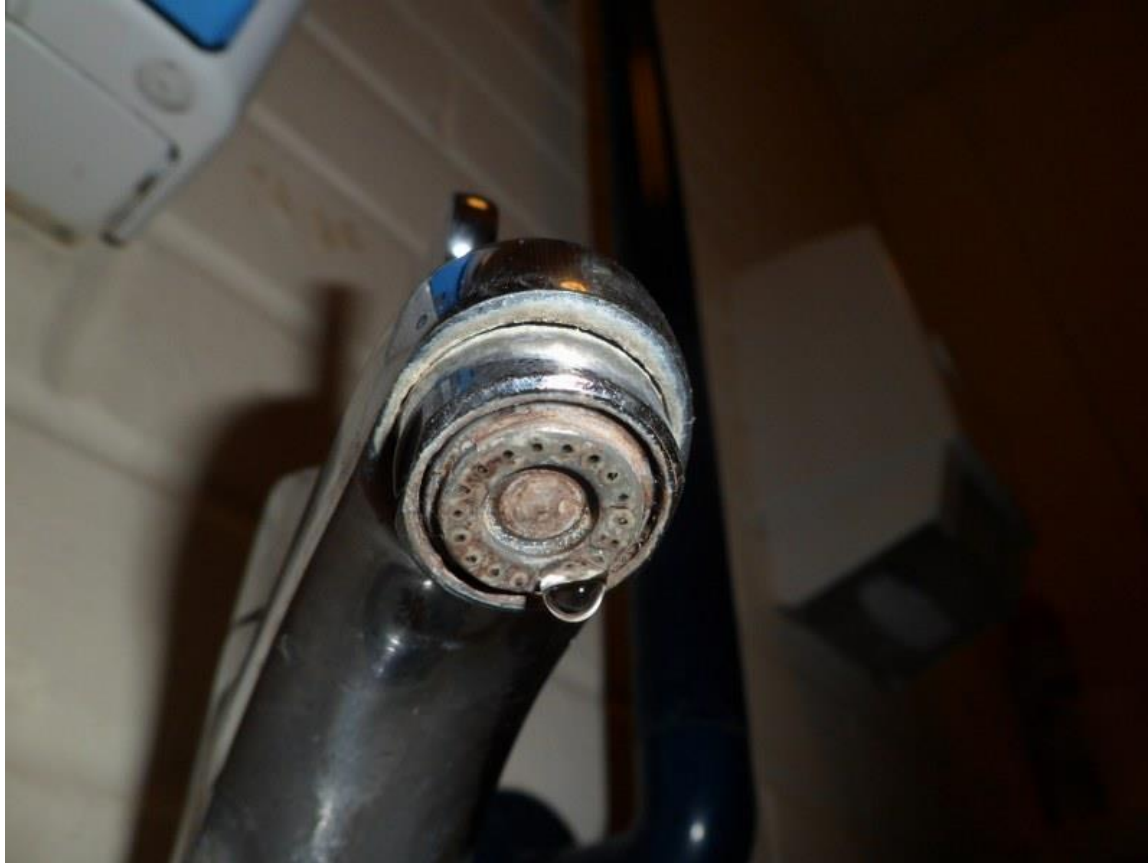
Spray Insert

The disabled toilet spray insert requires removing or at least cleaning to prevent aerosol creation and improve flow through system.

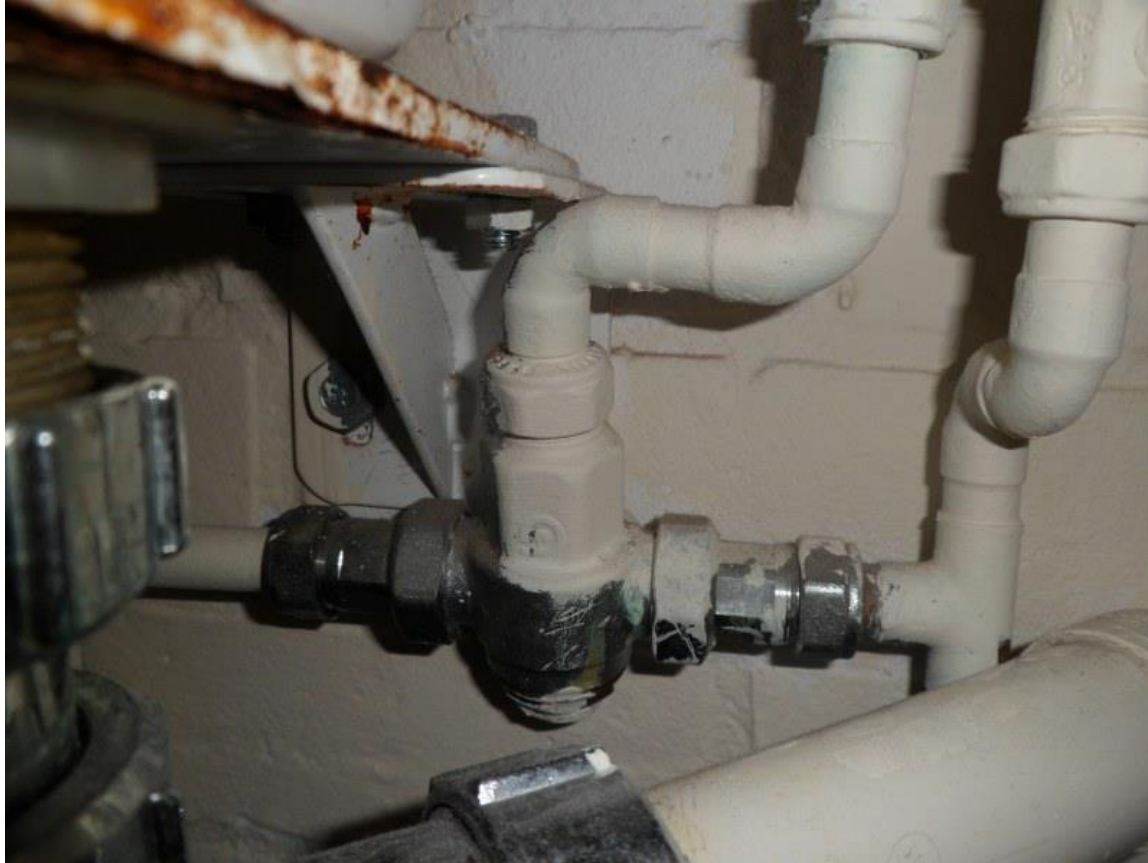
There is a TMV located within the disabled toilet and also assumed located behind paneling in the ladies toilet area. It is believed the hot water to this TMV is already blended and should be investigated.

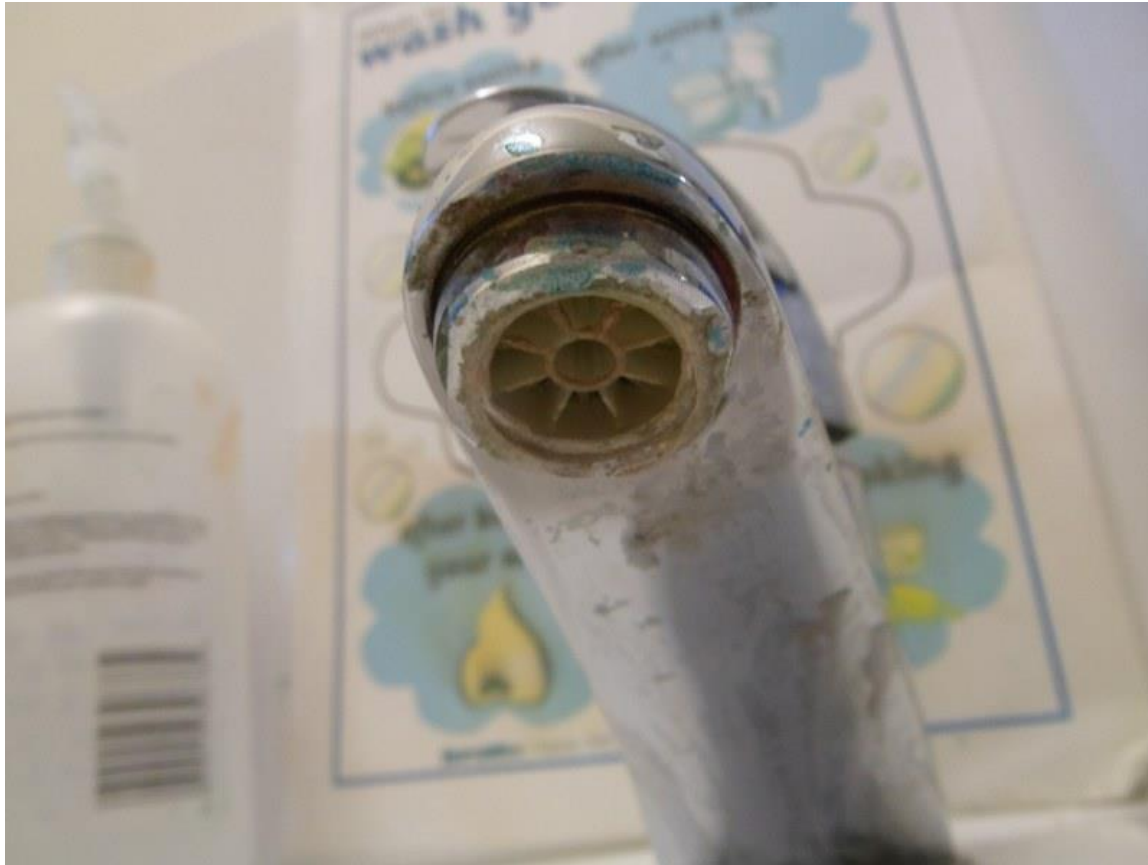
Tap Outlets

All tap outlets should be kept clean and free from scale build up to maintain a good flow of water through the system pipe work.

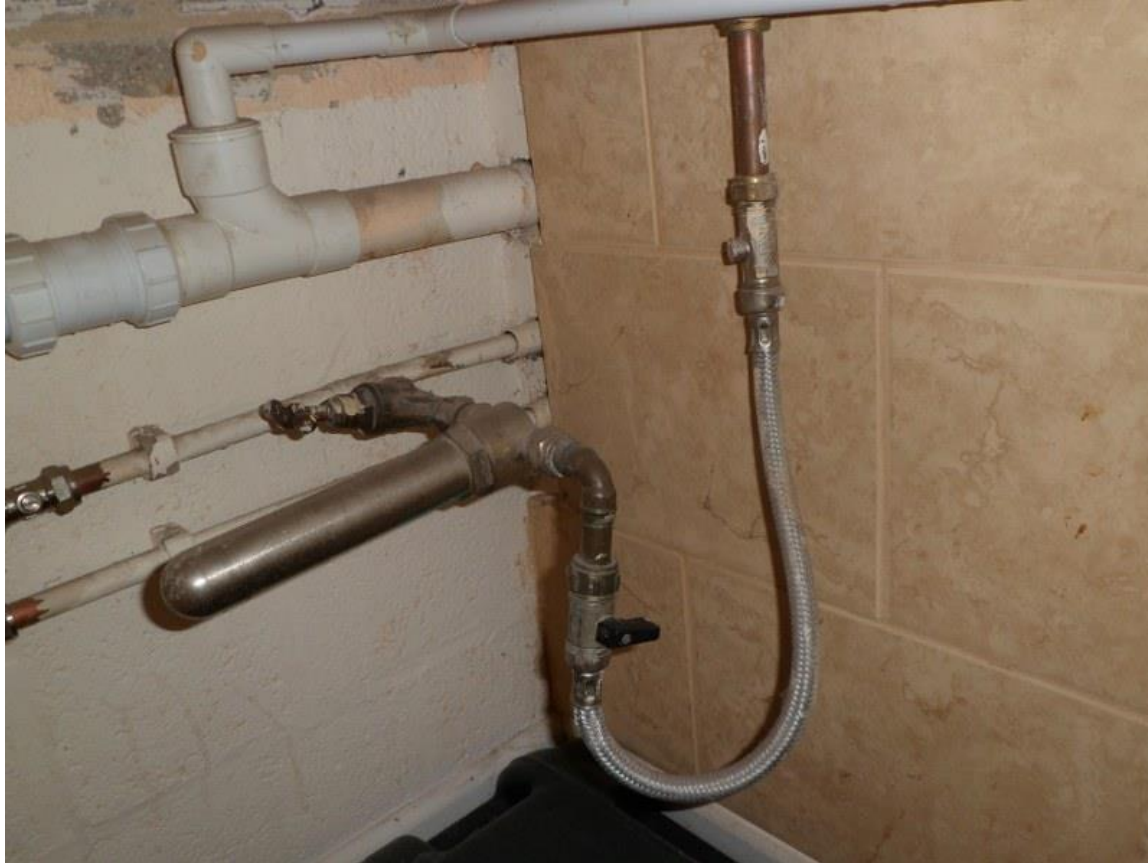
Deadleg

The heating quick fill can act as deadleg pipe work; flush through on a regular basis.

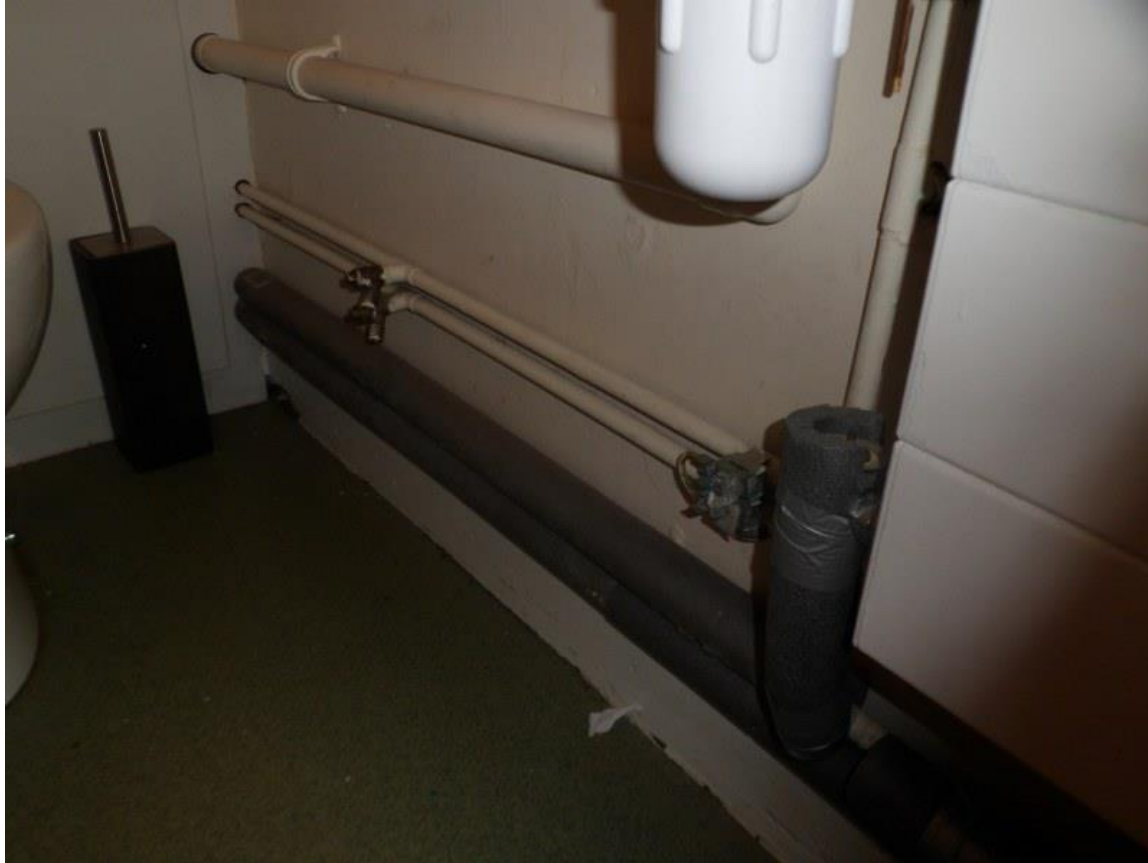
Pipe Work

The domestic water pipe work within the ladies toilet runs above the heating pip work; the heating pipe work has been insulated to help prevent heat transfer.
