**Church View (Old Itech Centre)**

**Review Photographs**

**8<sup>th</sup> August 2017**

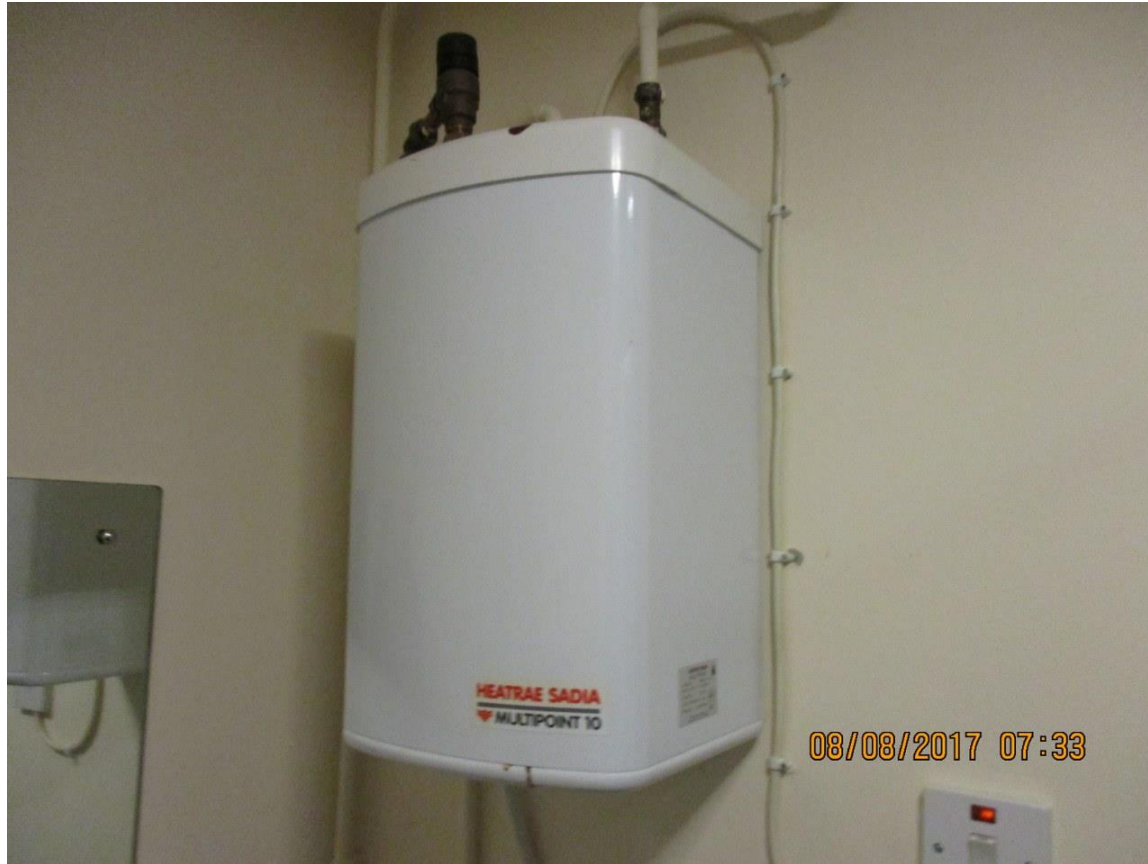
## Water Heater

The water heater within the ladies group room toilet had low storage temperature at the time of this 2017 review; records seen indicate this is normally satisfactory.

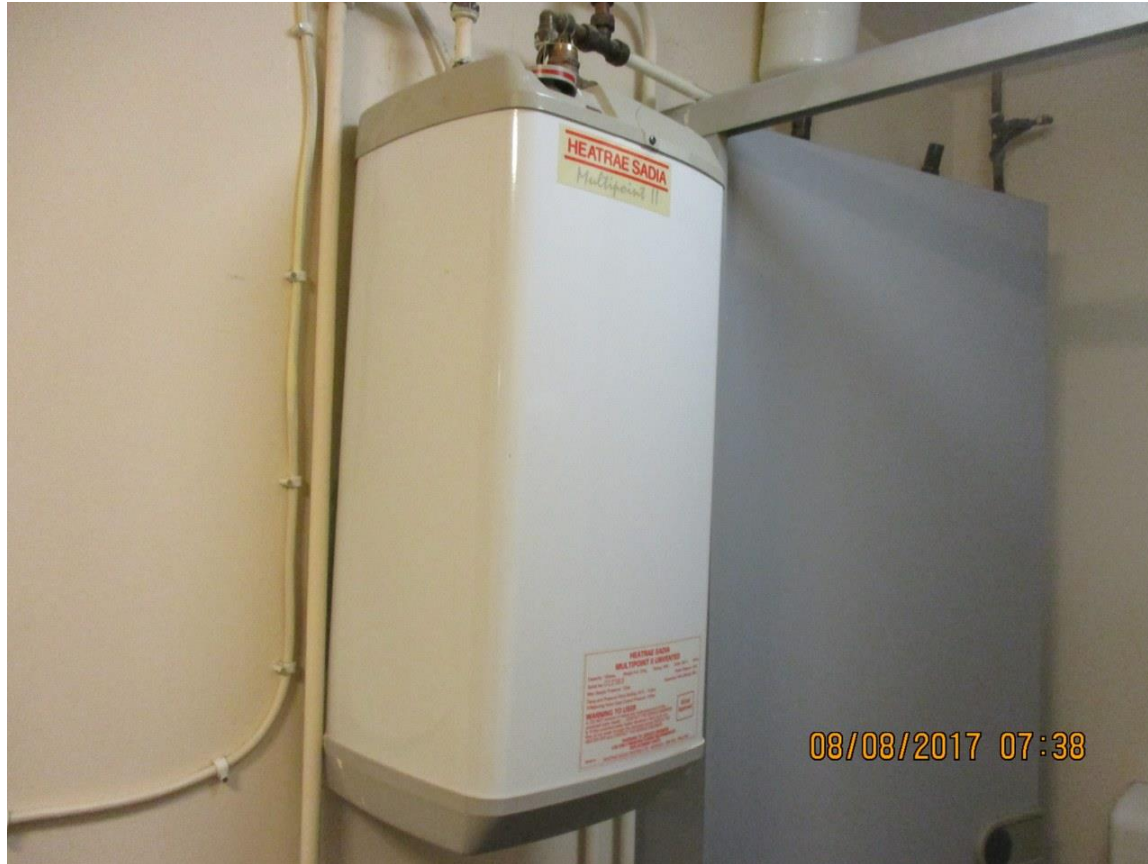
## Water Heater

The water heater within the ladies toilet had a good storage temperature at the time of this 2017 review; records seen indicate this is normally satisfactory.

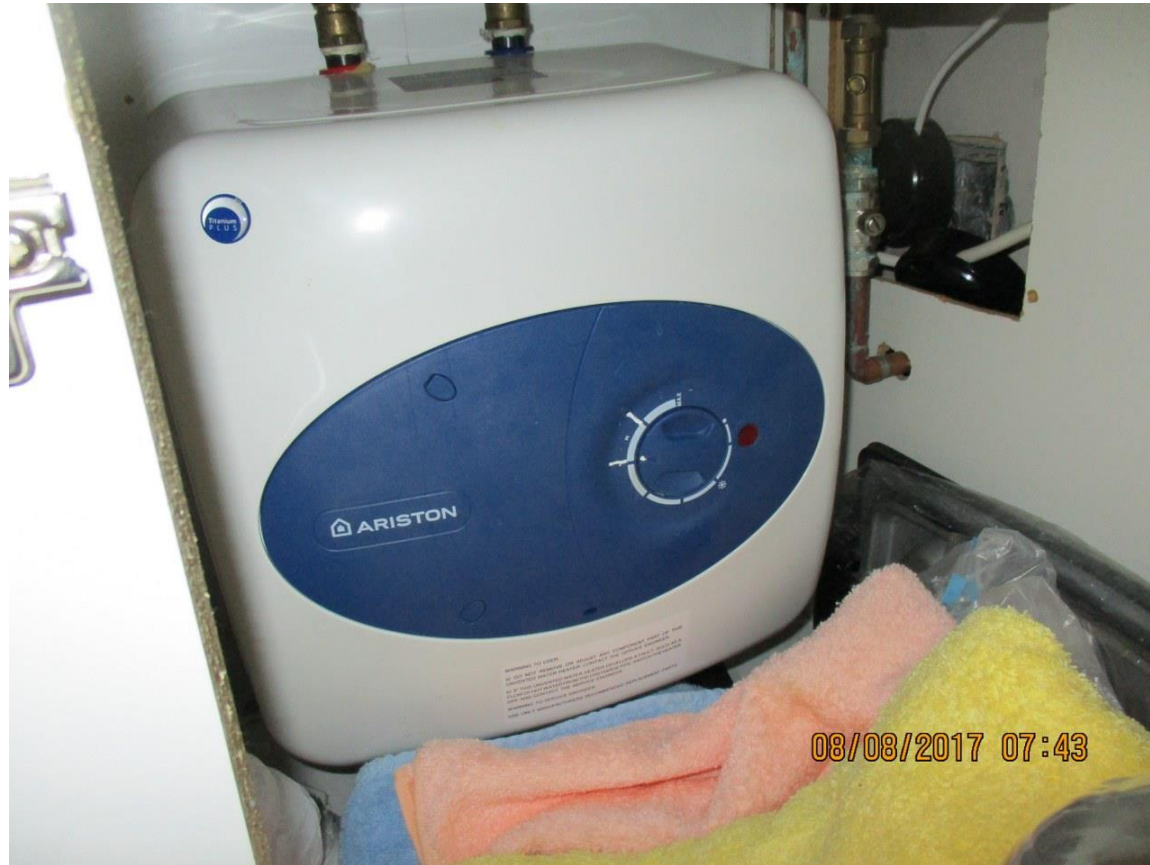
## Water Heater

The water heater within the kitchen area had a good storage temperature at the time of this 2017 review; records seen indicate this is normally satisfactory.

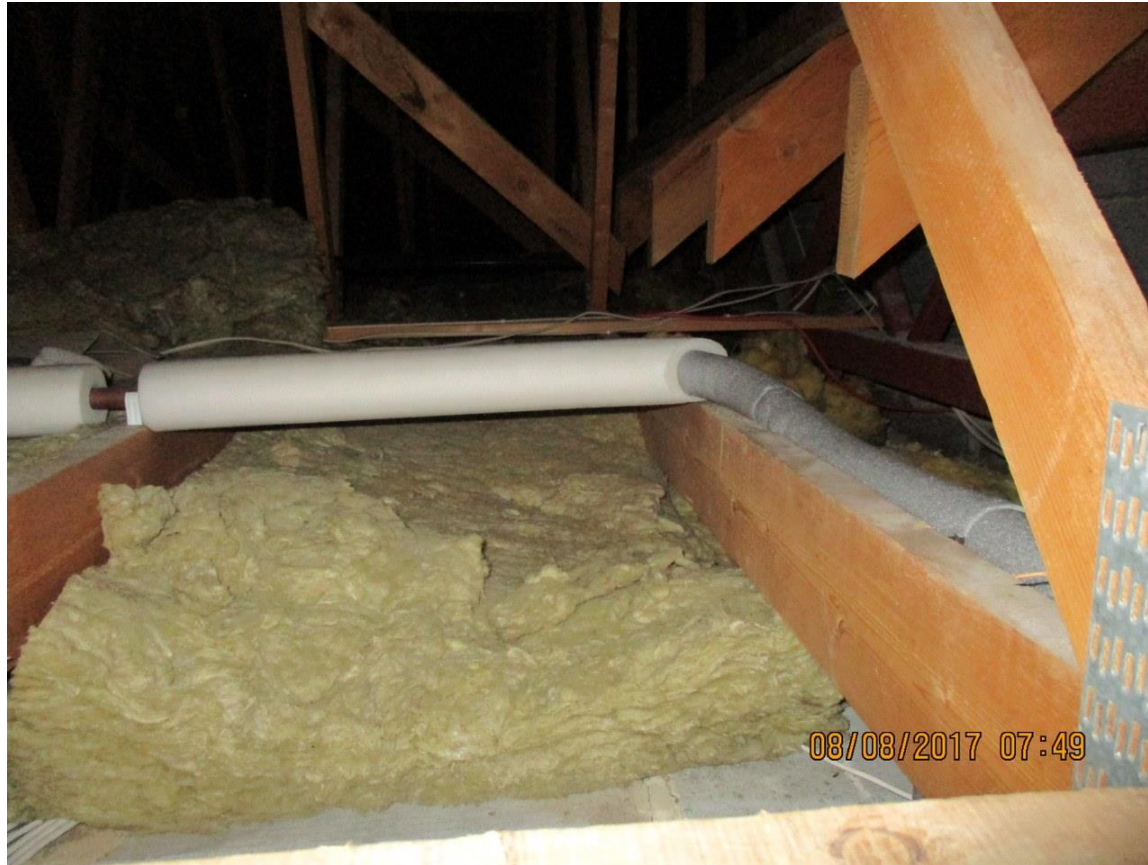
## **Insulated Pipe work**

The domestic water pipe work running in the ceiling voids was seen to be well insulated to help prevent heat gain / loss.

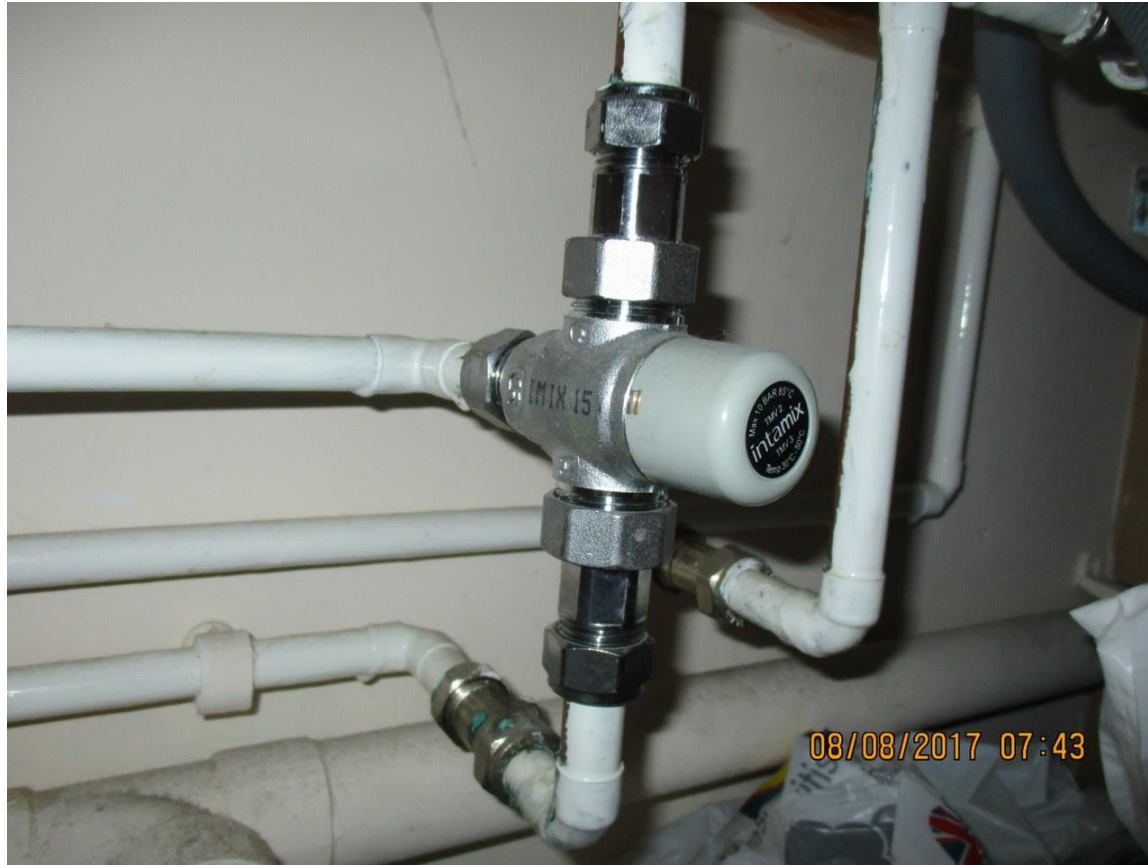
## TMVs

There are two TMVs located within the kitchen area; these were last serviced and adjusted in March 2016 this was seen recorded within the logbook documentation at the time of this 2017 review.
