**Lordswood Community Centre**

**Review Photographs**

**11<sup>th</sup> January 2017**

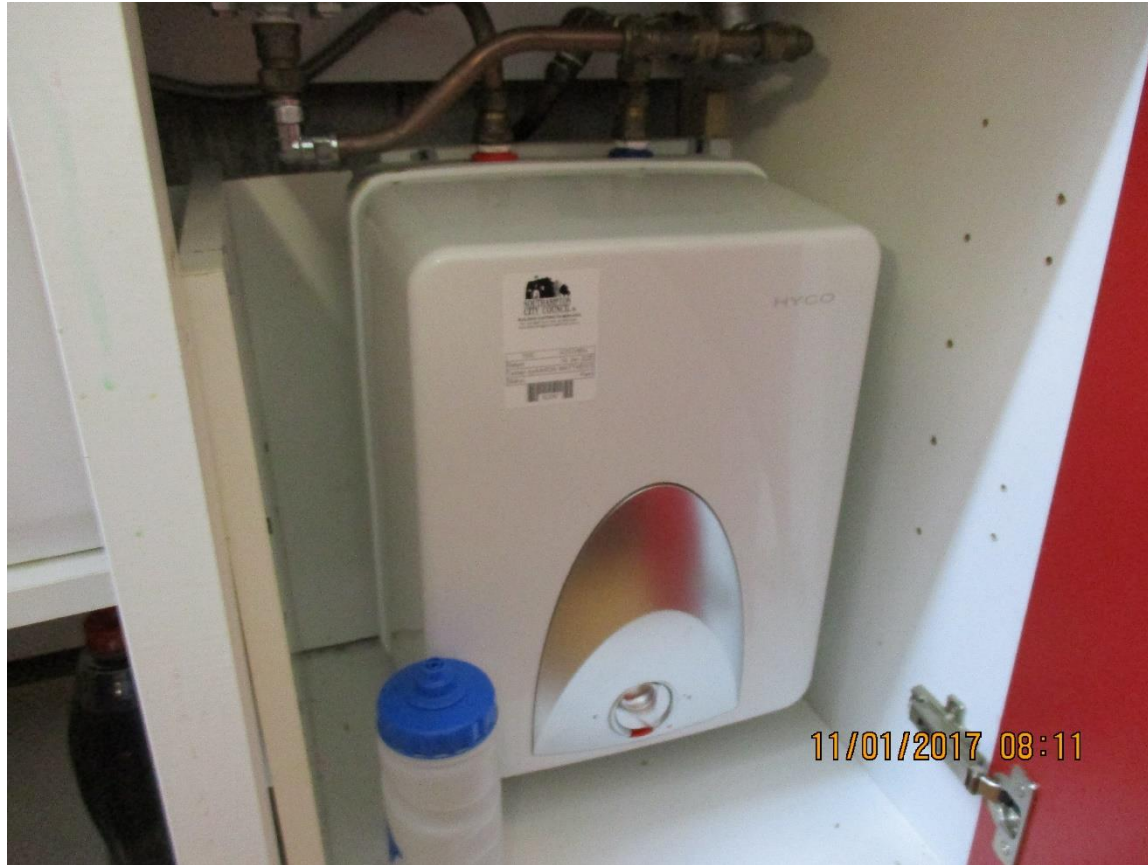
## **Kitchen Water Heater**

The kitchen water heater was found to have a good storage temperature at the time of this 2017 review; records indicate this is normally satisfactory.

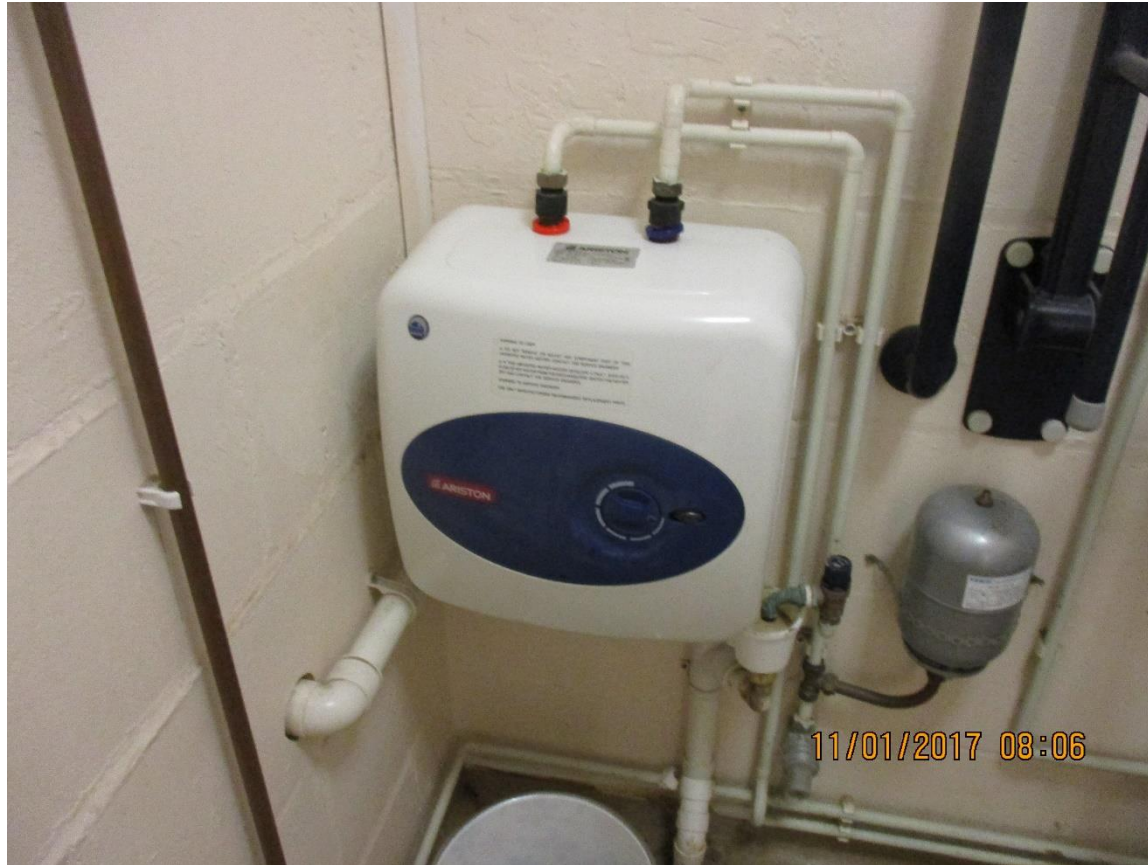
## **Disabled Toilet Water Heater**

The water heater was switched on and was found to be turned to a very low setting creating no hot water. There has been no hot water temperature recorded for many months; recommend this heater is adjusted to store hot water at 50.0 – 60.0C.

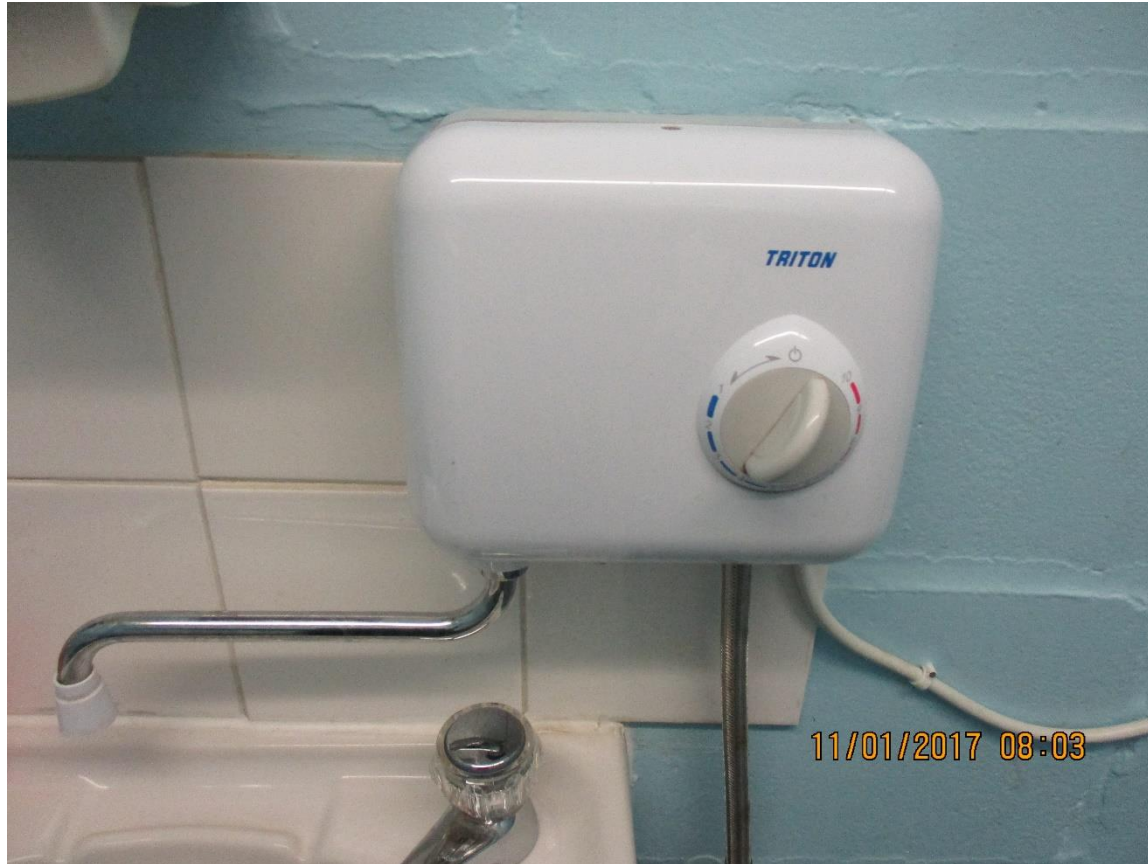
## Water Heater

Instantaneous water heaters are fitted in the ladies and gents toilets; the gents toilet water heater appears to be faulty as switched on and no hot water available; recommend investigated.

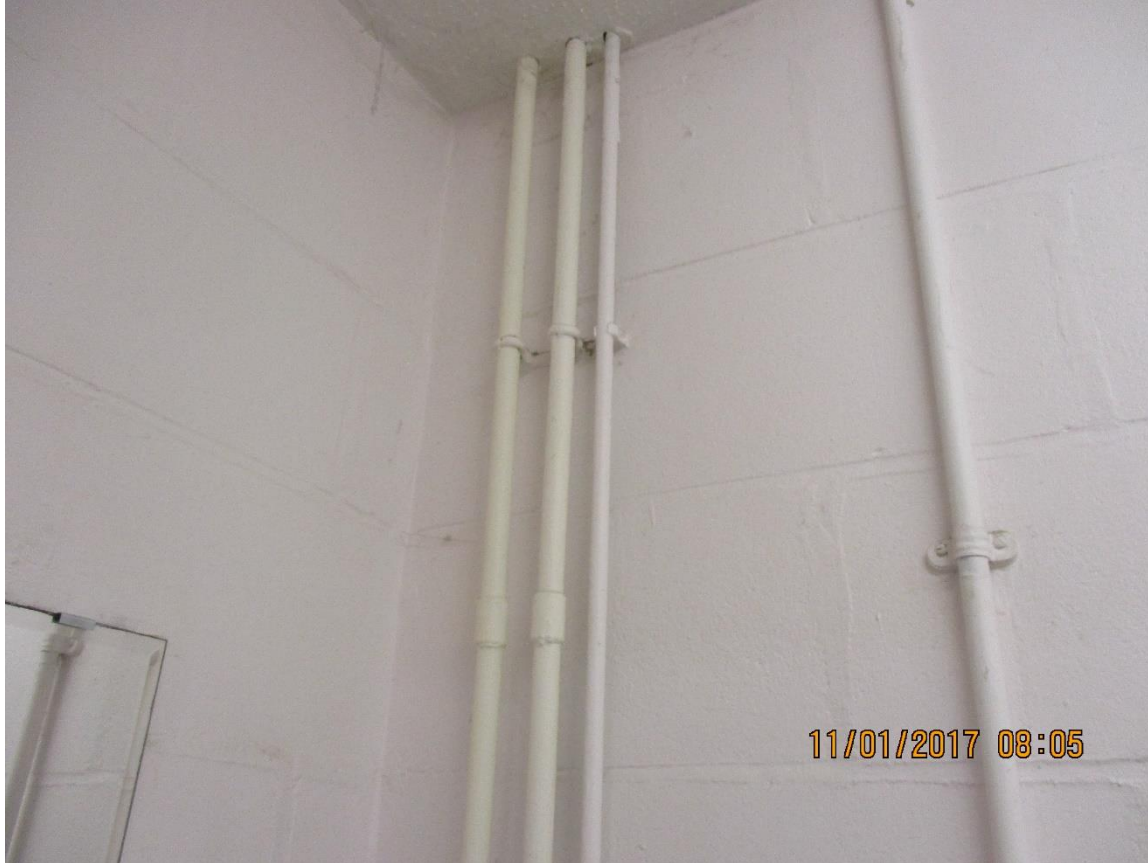
## **No Insulation**

The mains water pipe work is running with heating pipe work in the ladies toilet area; again I would recommend this be insulated to prevent heat gain.
