**Moorlands Community Centre**

**Review Photographs**

**8<sup>th</sup> February 2017**

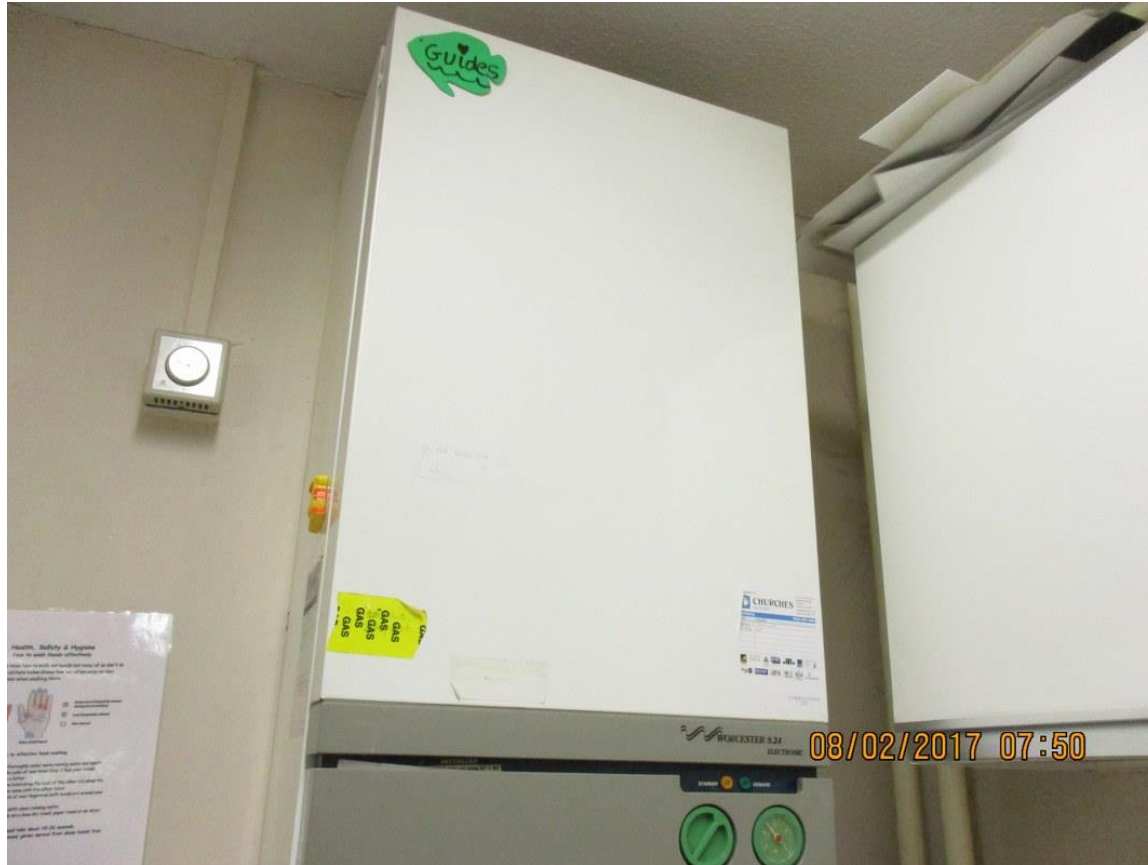
## Combination Boiler

The combination boiler serving the kitchen and disabled toilet only achieved 46.0C at the time of this 2017 review; records seen indicate this is normally above 50.0C; ensure set to maintain 50.0C or more.

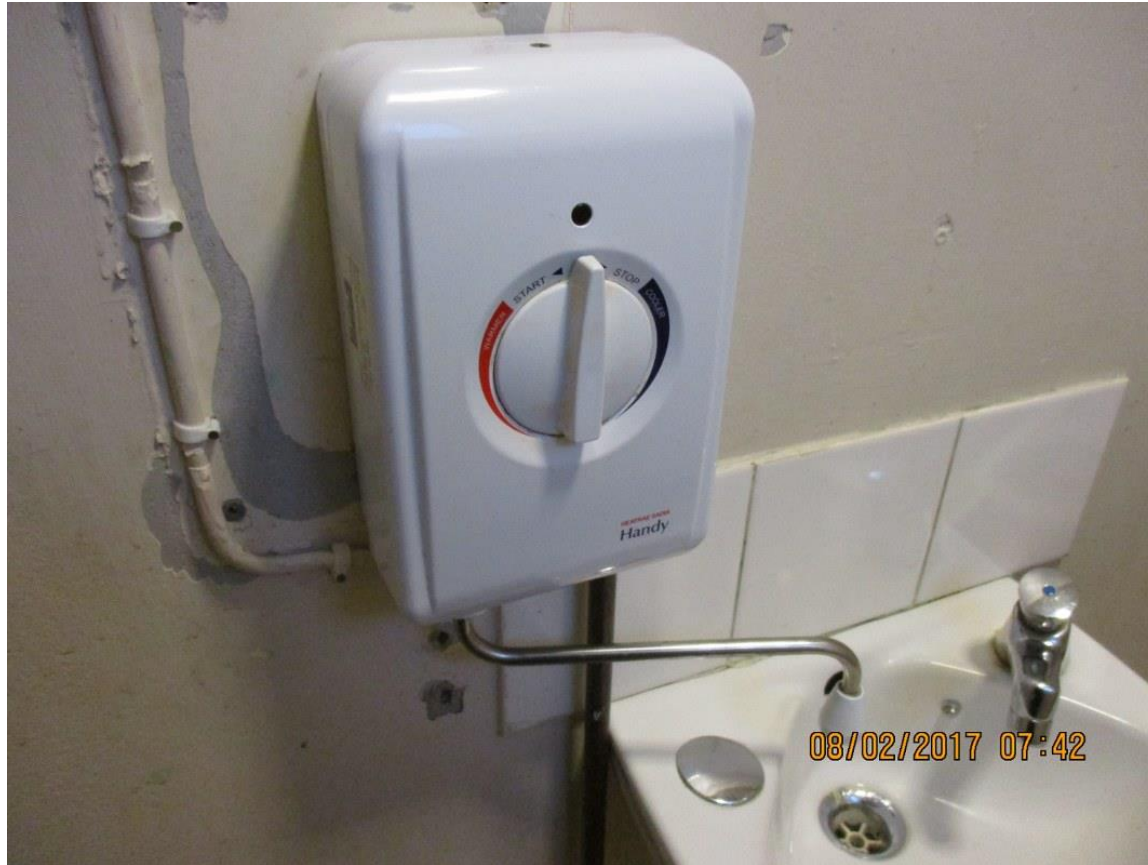
## Water Heater

New water heaters have been installed in the ladies and gents toilet areas since the last review; both water heaters achieved more than 50.0C at the time of this 2017 review which is satisfactory.

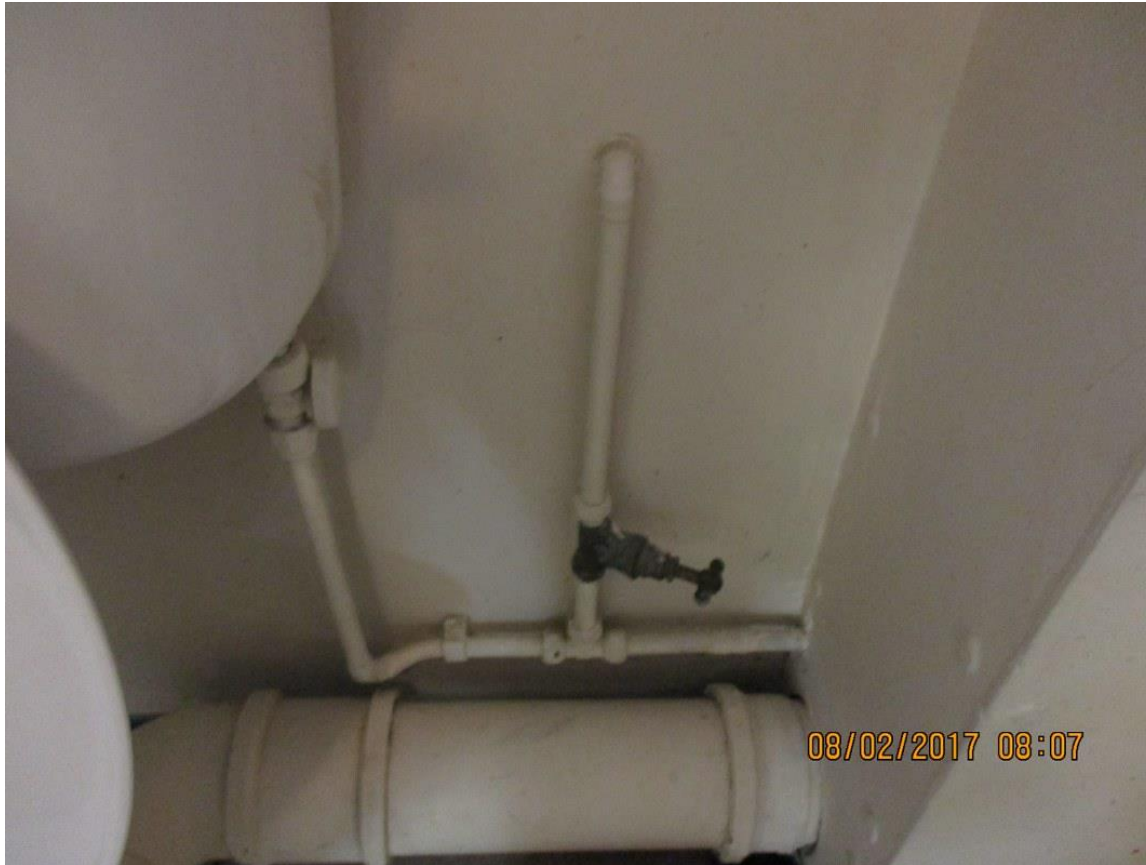
## **Deadleg**

The outside tap has now been removed but the supply pipe work was still seen in place creating a deadleg; I would recommend this pipe work be removed.

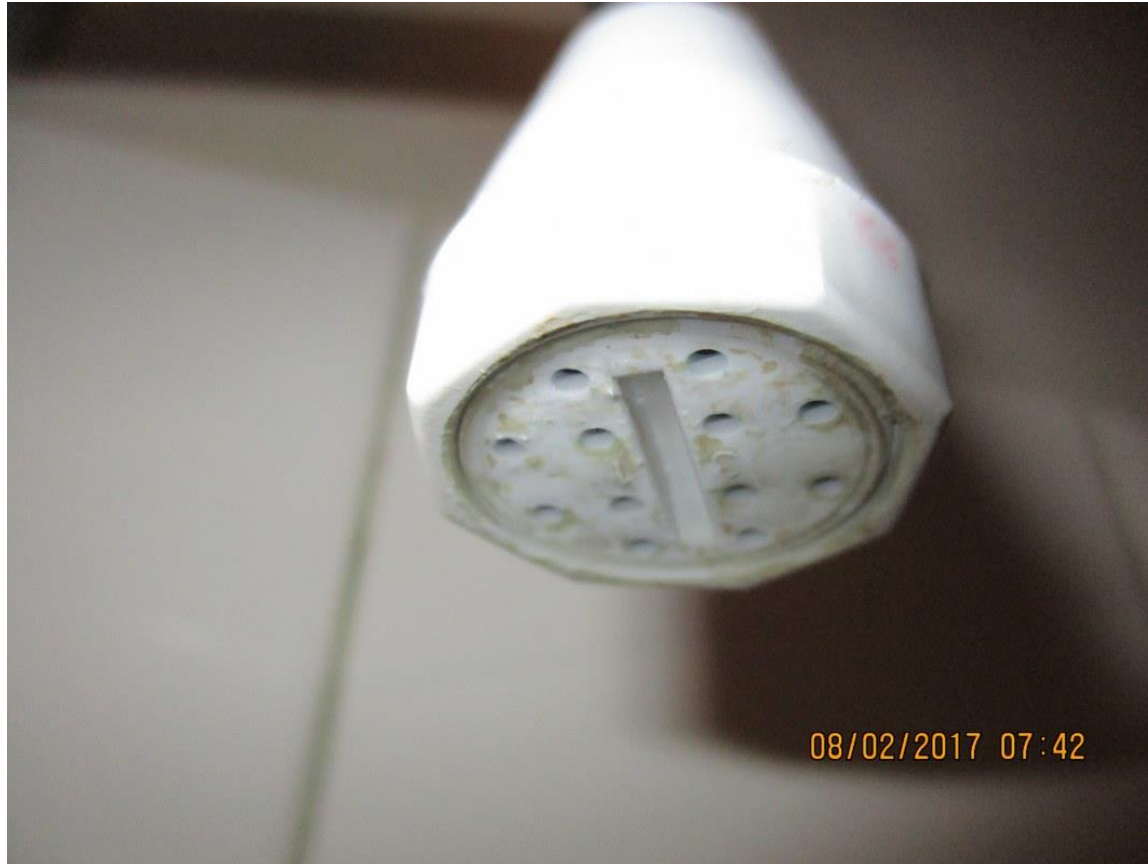
## **Water Heater Spray Nozzles**

Ensure the water heater spray nozzle outlets remain free from scale build up to maintain a good flow of water and prevent aerosol creation.

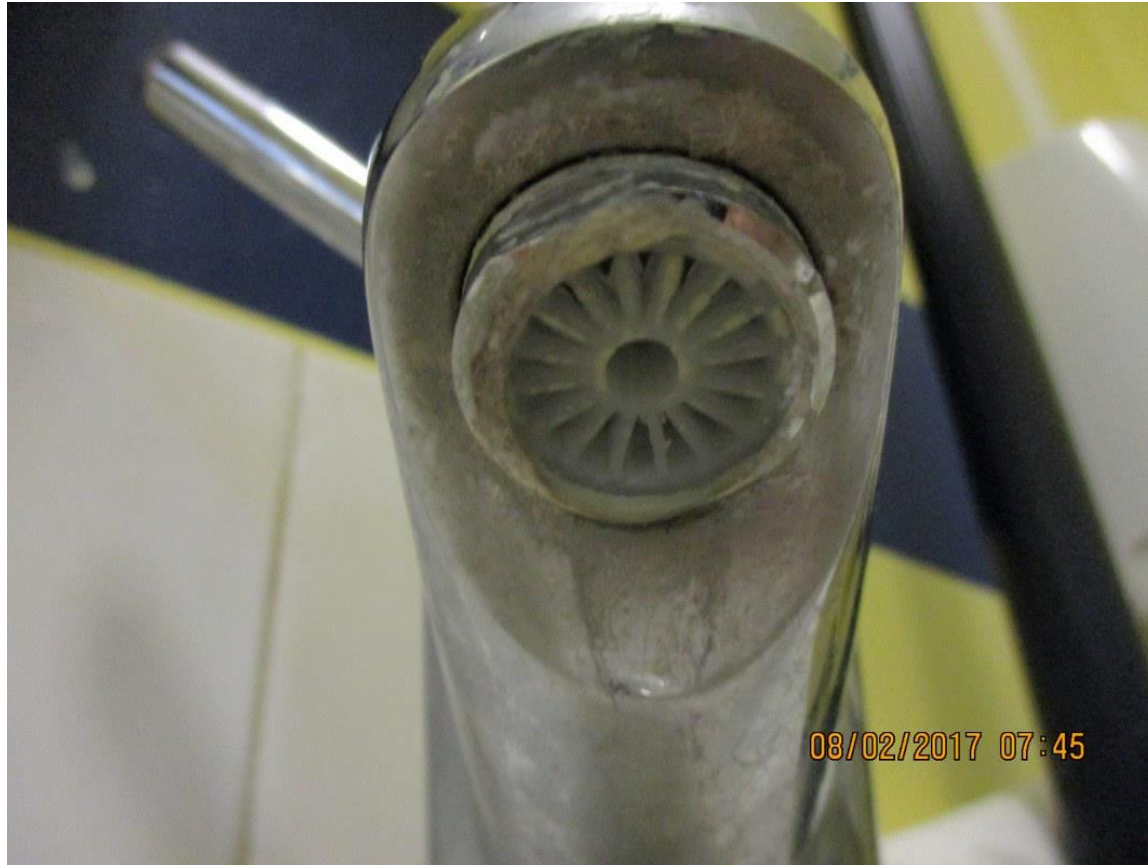
## Tap Outlets

Ensure all tap outlets remain free from scale build up to maintain a good flow of water and prevent aerosol creation.

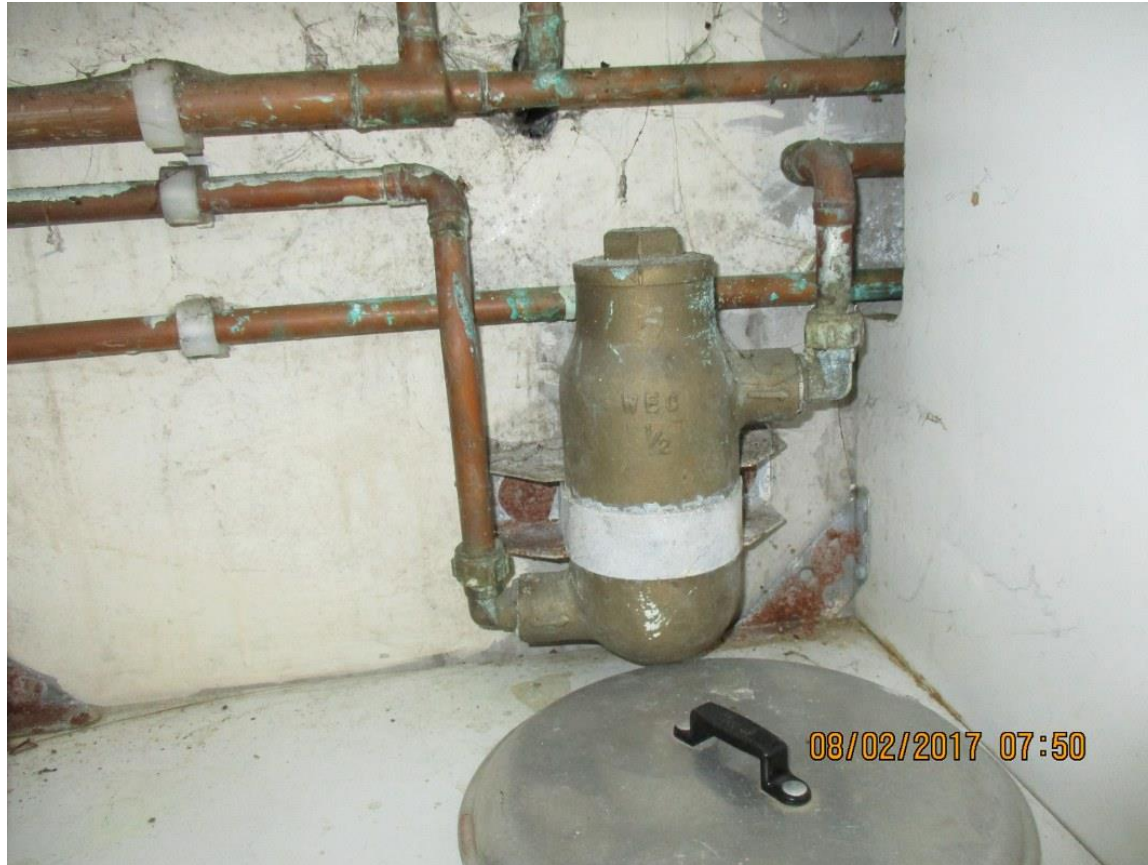
## Water Conditioner

The water conditioner is still in place on the cold feed to the combination boiler; not known if this is still being used and maintained.

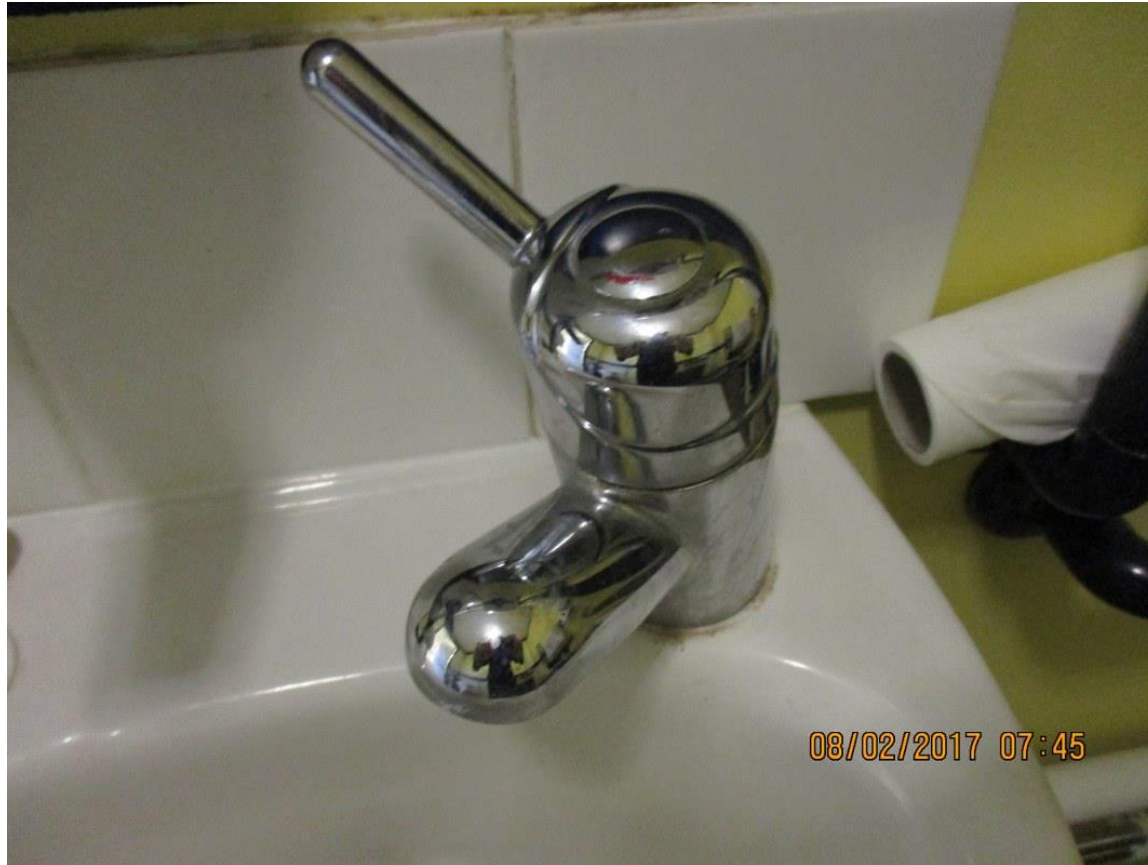
## **TMV Tap**

The TMV tap outlet in the disabled toilet should be serviced and maintained as recommended by the manufacturers; no records were seen for this at the time of this 2017 review.
