**Shirley Warren Primary School**

**Review Photographs**

**4<sup>th</sup> January 2017**

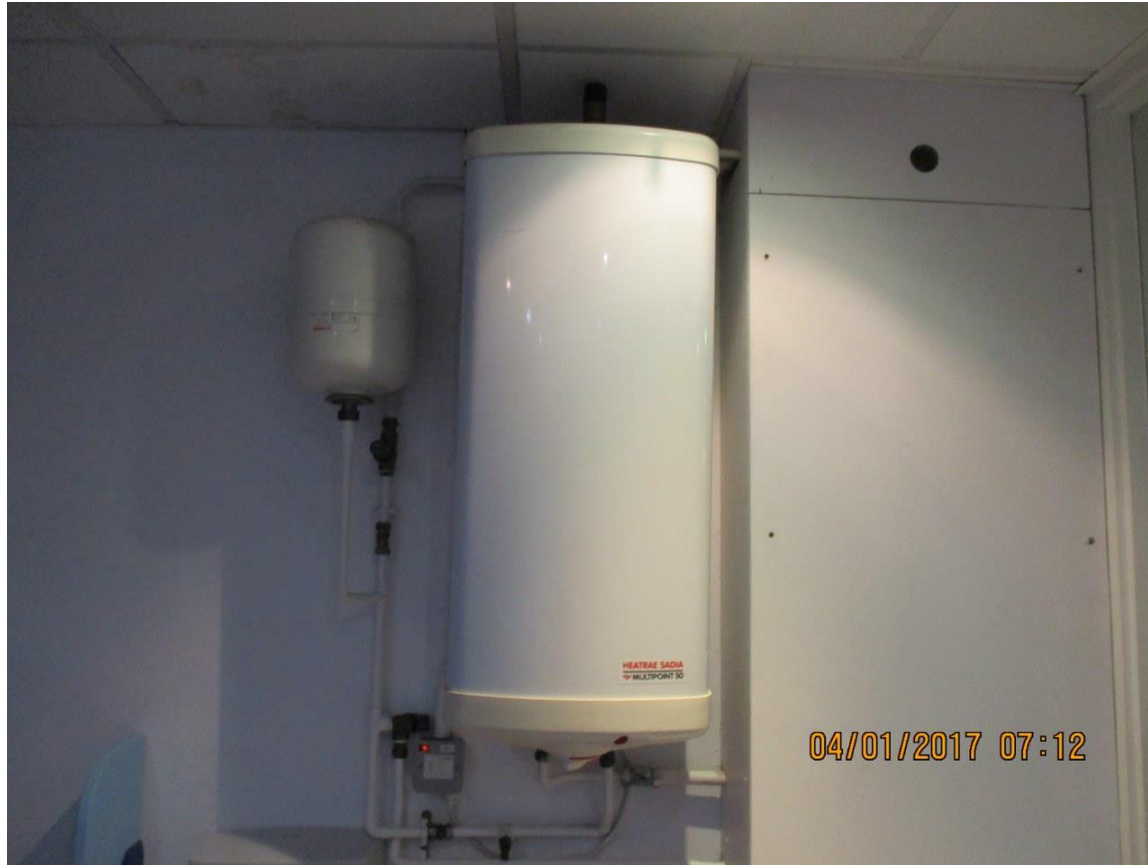
## **Nursery Toilet Water Heater**

Local water heater serving the nursery area had a good storage temperature recorded at the time of this 2017 review.

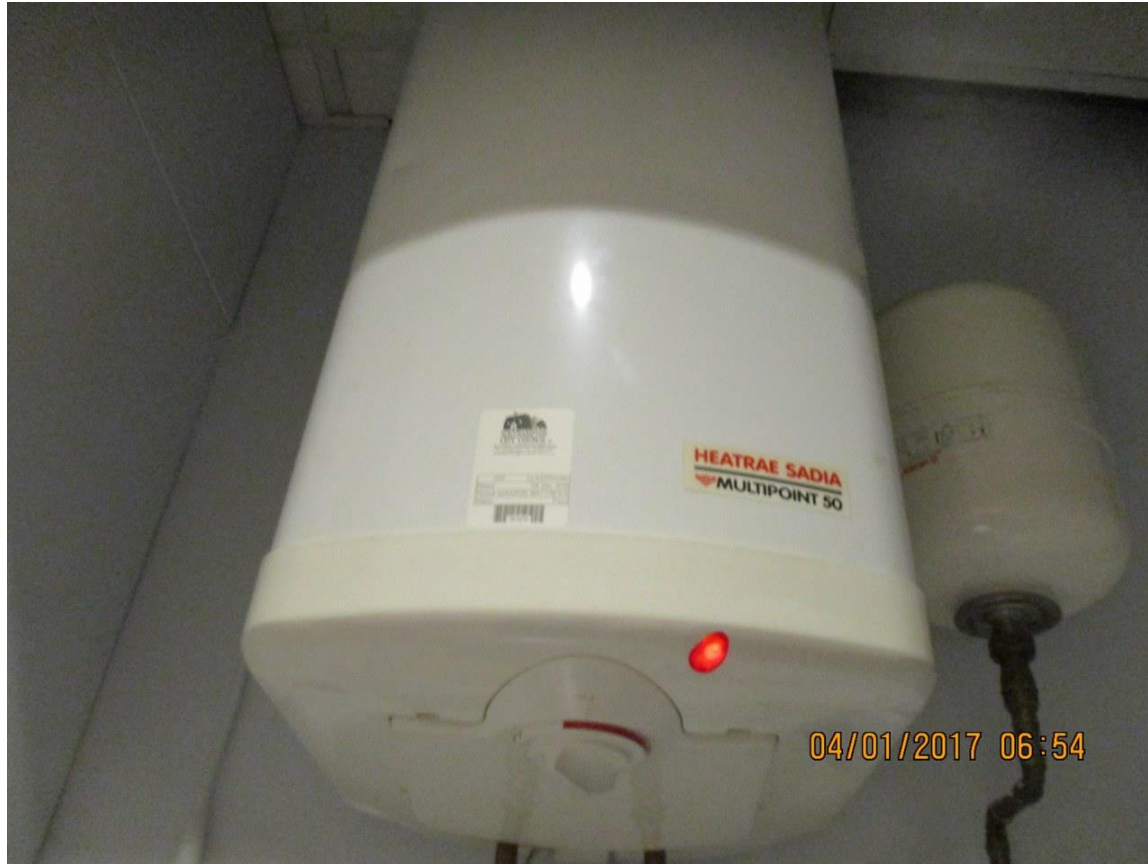
## **Chestnut Wing Toilet & Shower Water Heater**

This local water heater serving the toilet and shower in Chestnut wing was found to have very low storage temperature; recommend the thermostat is checked for correct operation at earliest opportunity.

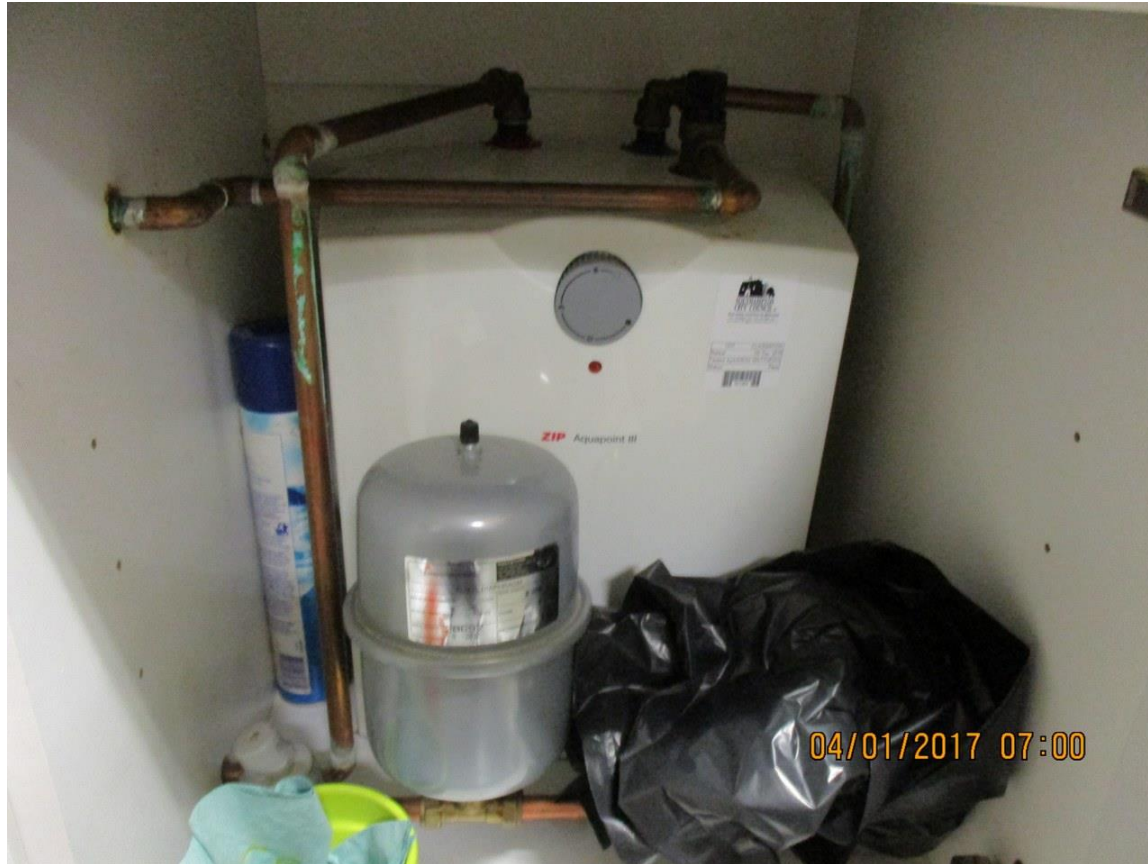
## Typical Local Water Heater

Typical local water heater located within classroom areas; random water heaters checked at the time of this 2017 review were found to have good storage temperatures.

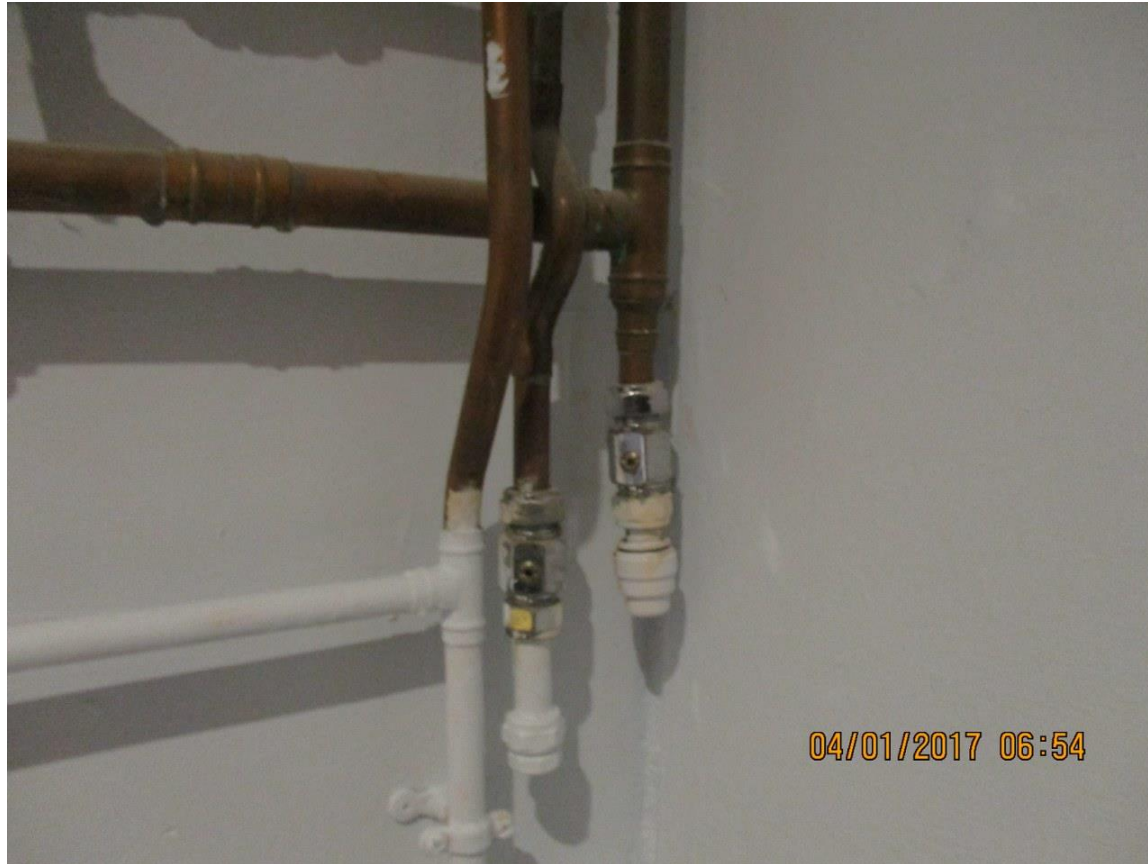
## **Deadleg Pipe Work**

The deadleg pipe work was still seen to be in place on Chestnut toilet water heater pipe work; I would again recommend removal.

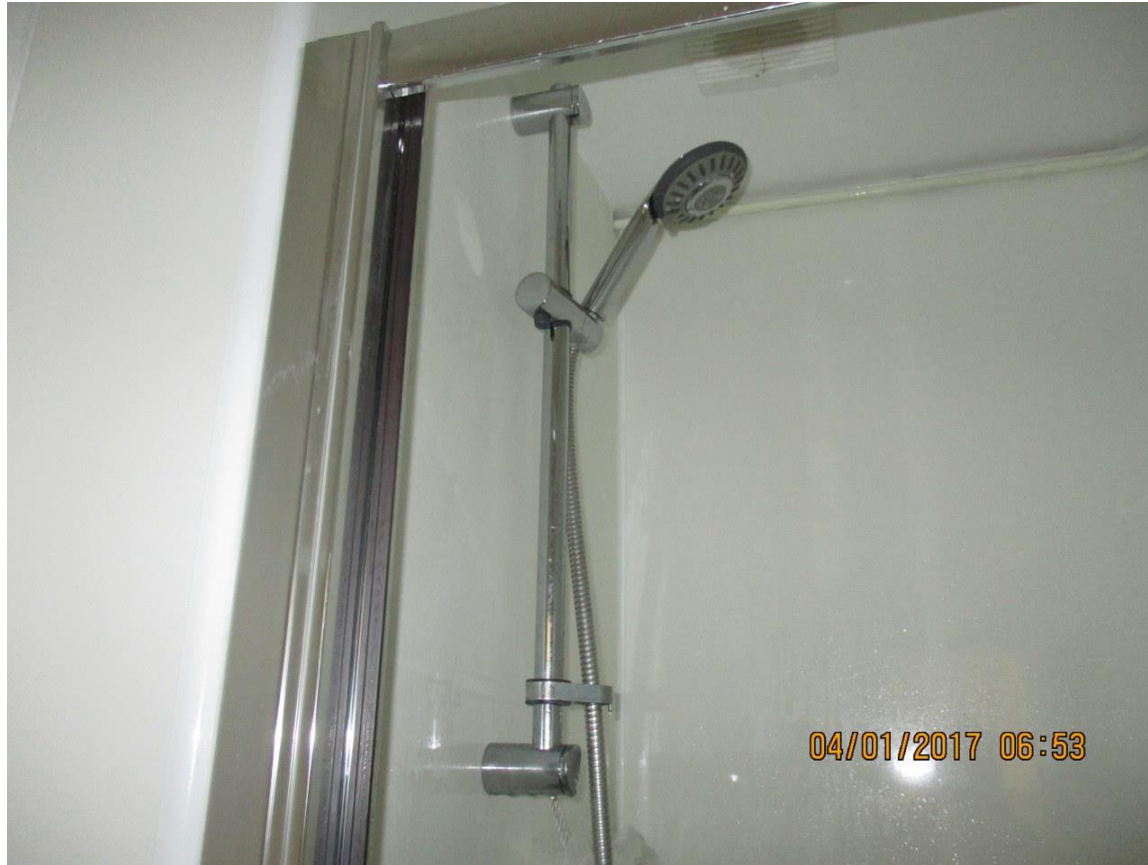
## **Shower**

Ensure the shower located in the ground floor toilet in Chestnut wing is used on a regular basis or flushed at least on a weekly basis.

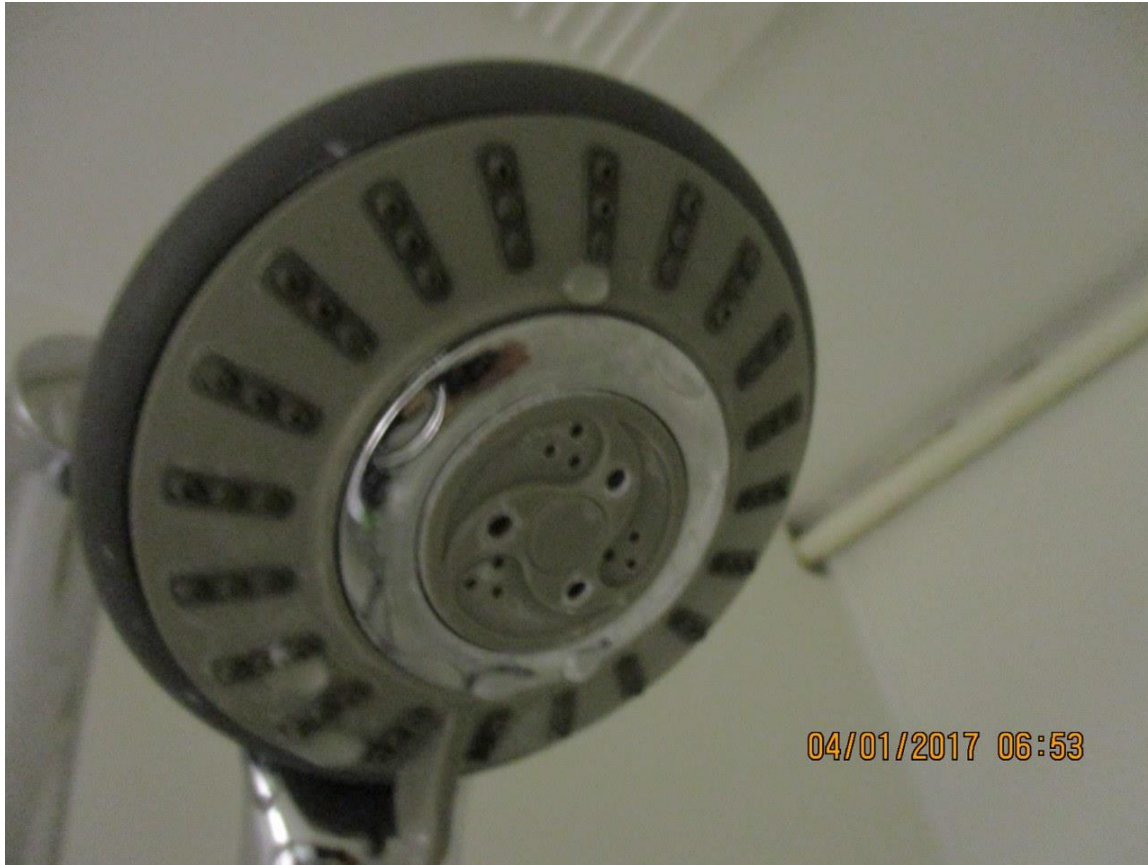
## **Showerhead**

Ensure the showerhead is continued to be cleaned and descaled at least on a quarterly basis; records indicate this was last carried out in October 2016.

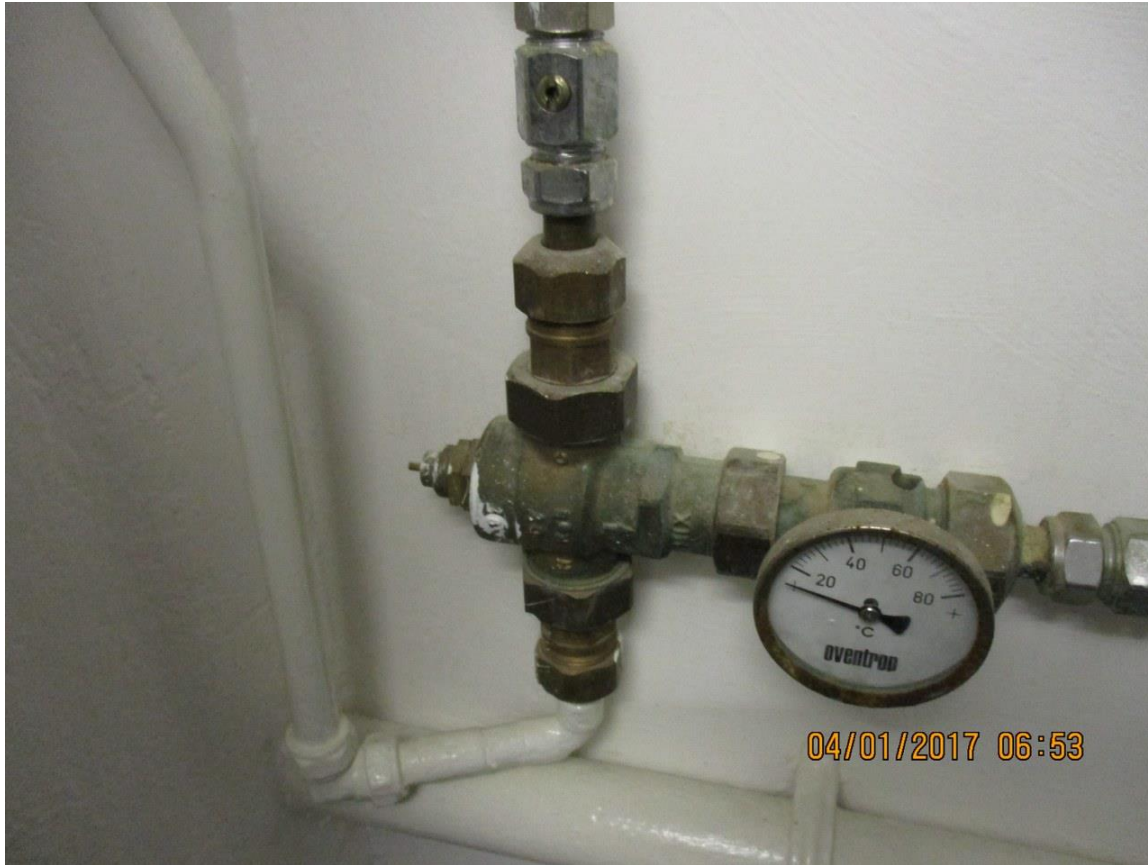
## TMVs

Ensure all TMVs are serviced and maintained as recommended by the manufacturers; no records for this were seen at the time of this 2017 review.
