**Westgate Hall**  
**Review Photographs**  
**6<sup>th</sup> March 2017**

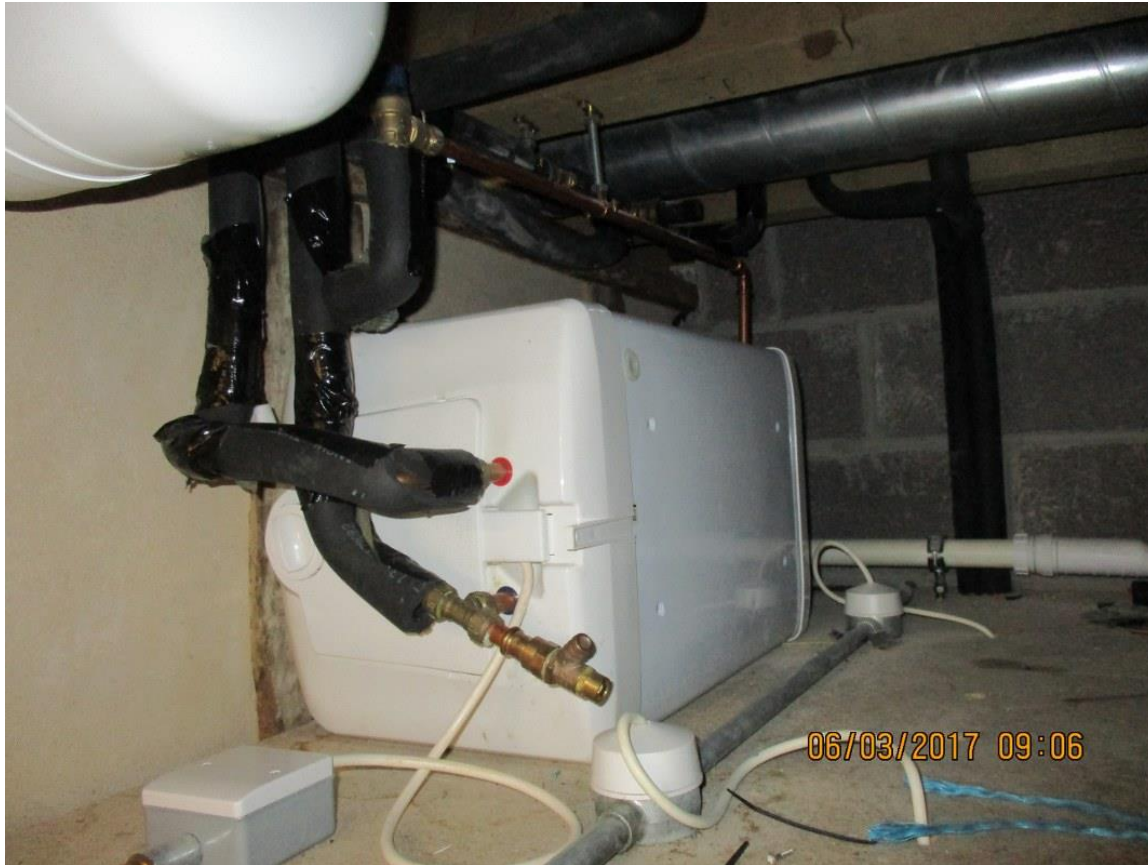
## Local Water Heater

Local water heater serving all hot water outlets within Westgate Hall; good temperatures recorded at the time of this 2017 review.

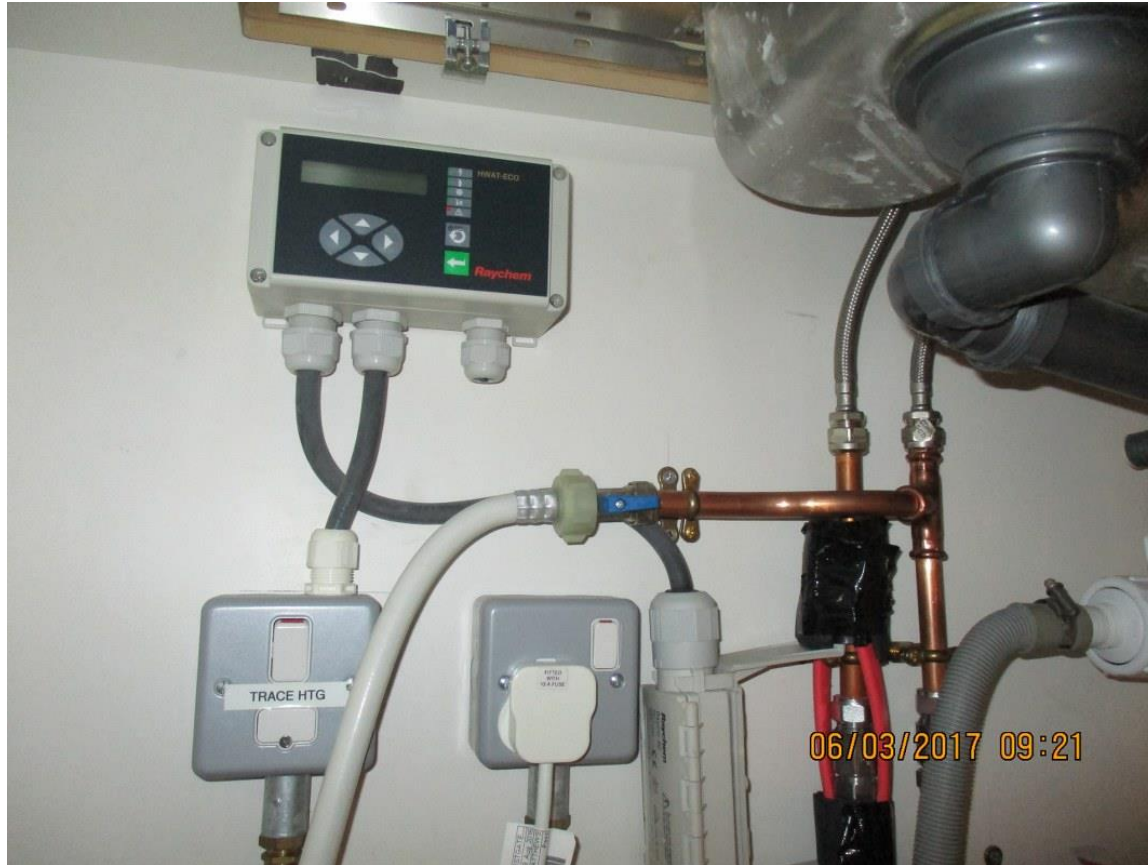
## Trace Heating

Trace heating is fitted to the hot water distribution pipe work within the building; even though this was switched on the trace heating wires were cold; recommend this is investigated for correct operation. Ensure trace heating maintains 50.0C or more at all times.

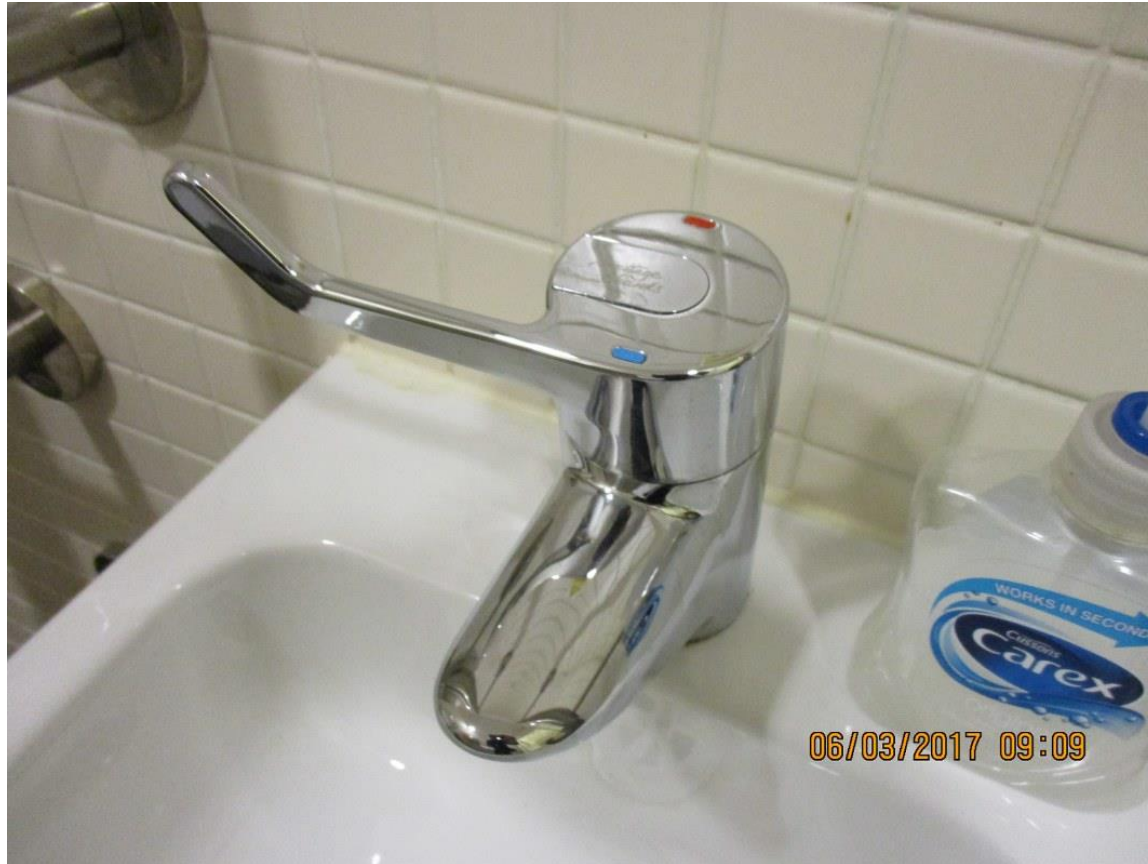
## **TMV**

The TMV tap fitted in the accessible toilet should be serviced and maintained as recommended by the manufacturers; no records seen for this being carried out at the time of this 2017 review.

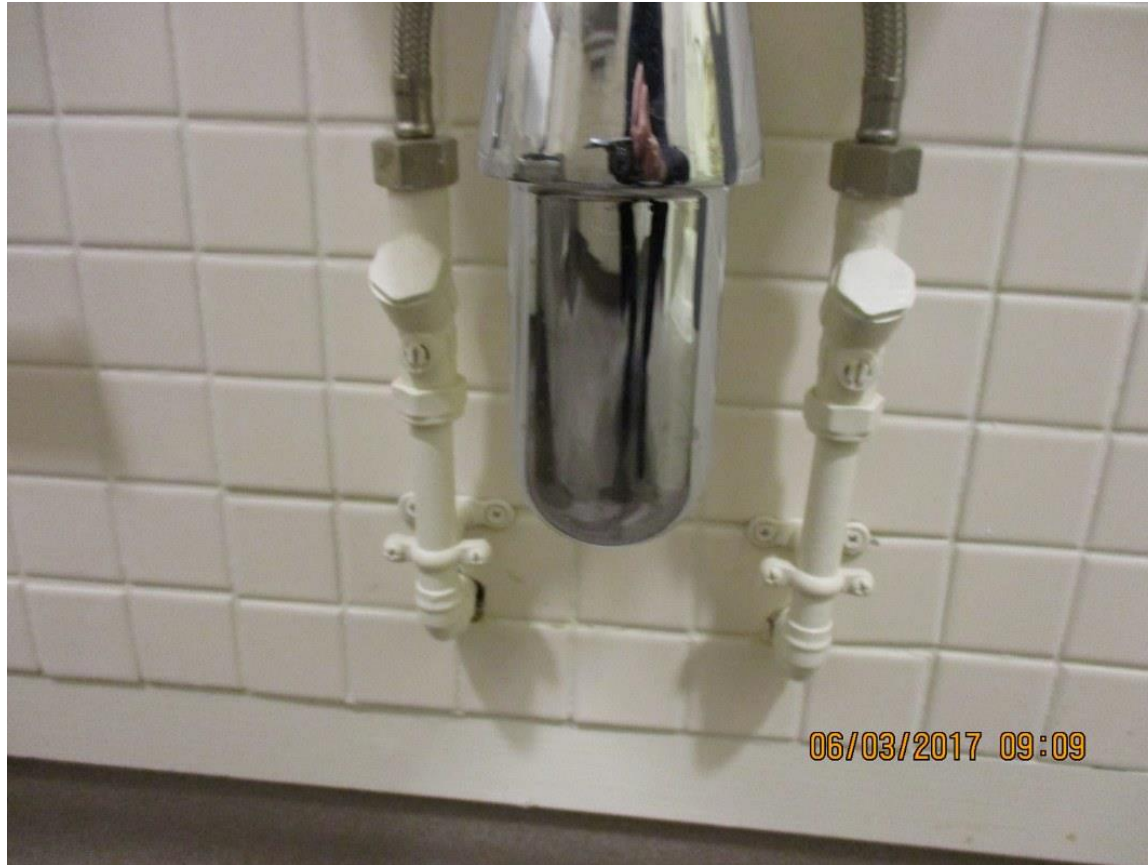
## **Inline Strainers**

Inline strainers fitted prior to the TMV tap should be cleaned on a regular basis; no records were seen for this being carried out at the time of this 2017 review.

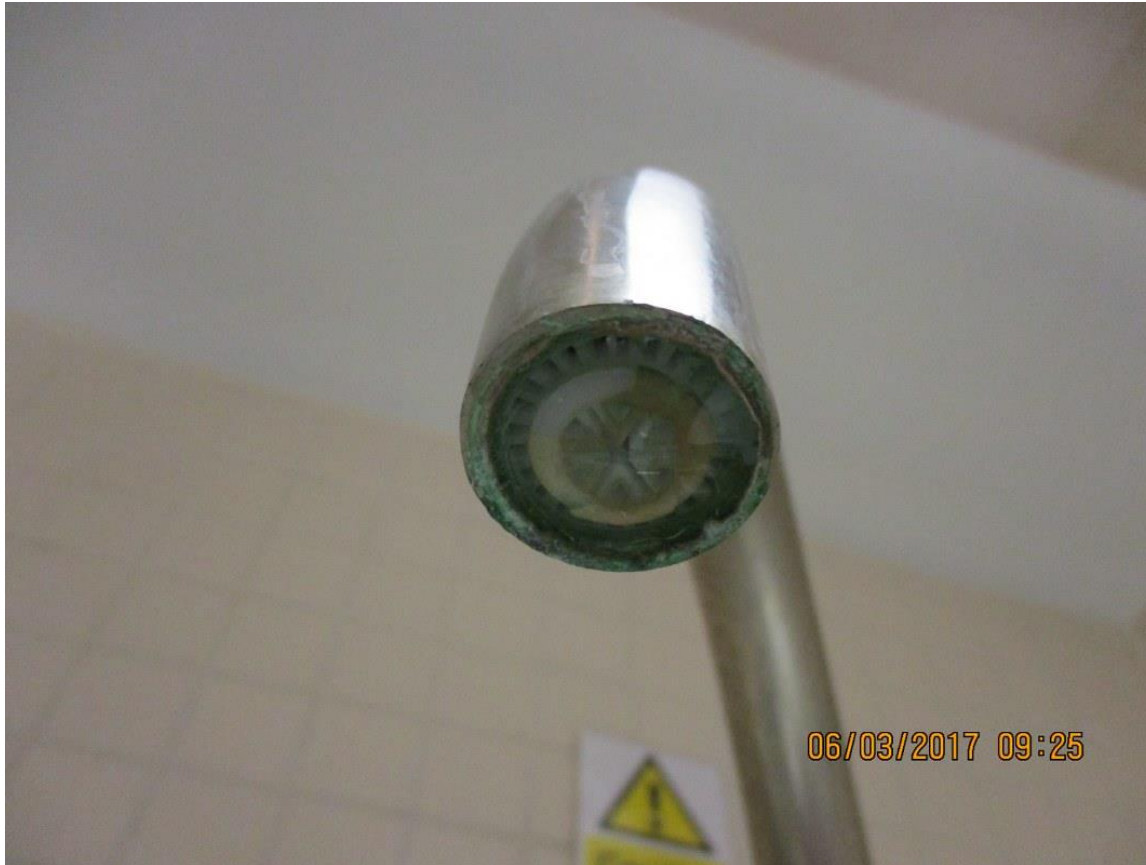
## **Scale Build Up**

The first floor sink outlet had scale build up creating poor flow from outlet; recommend taps are maintained in a good clean and free from scale build up condition.
