**Collection Management Centre
Units 29-31 City Industrial Park**

Review Photographs

25th September 2018

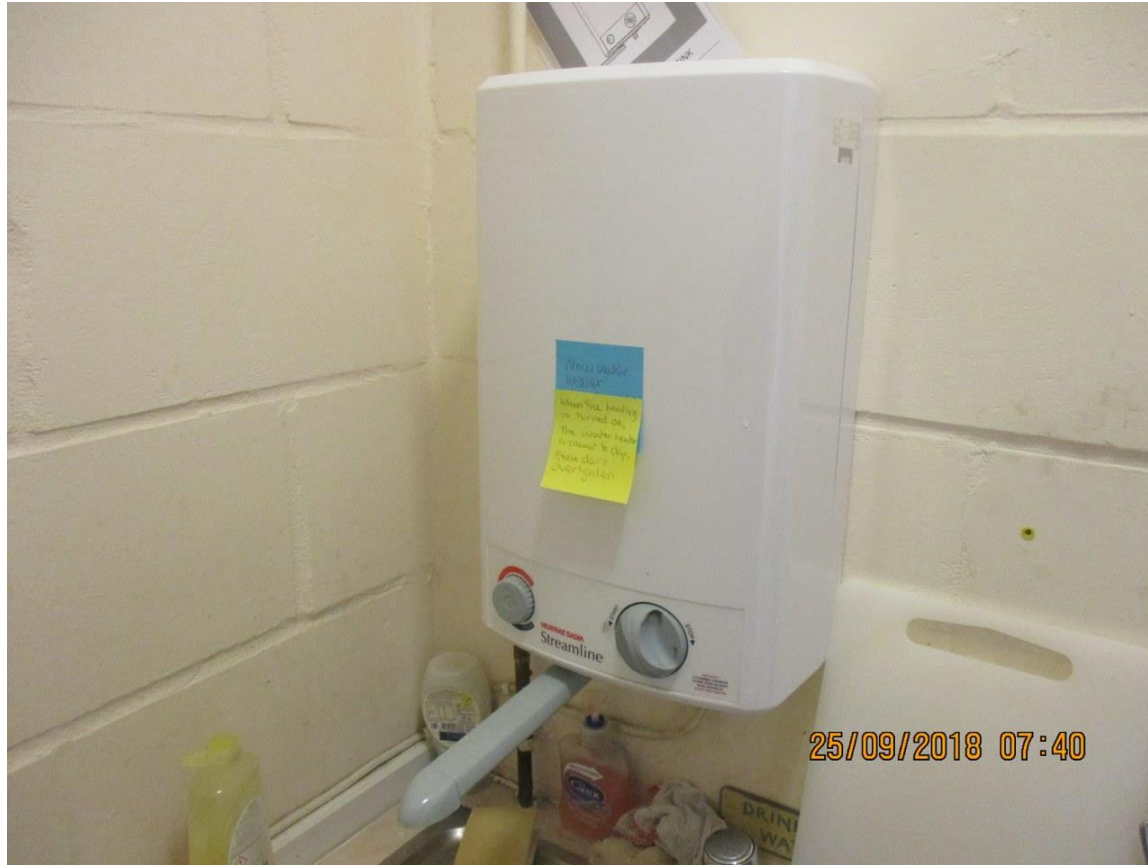
Typical Water Heater

A typical water heater located in unit 29 and 31 kitchen areas; these are the only water heaters in use within both units and both had good storage temperatures at the time of this 2018 review.

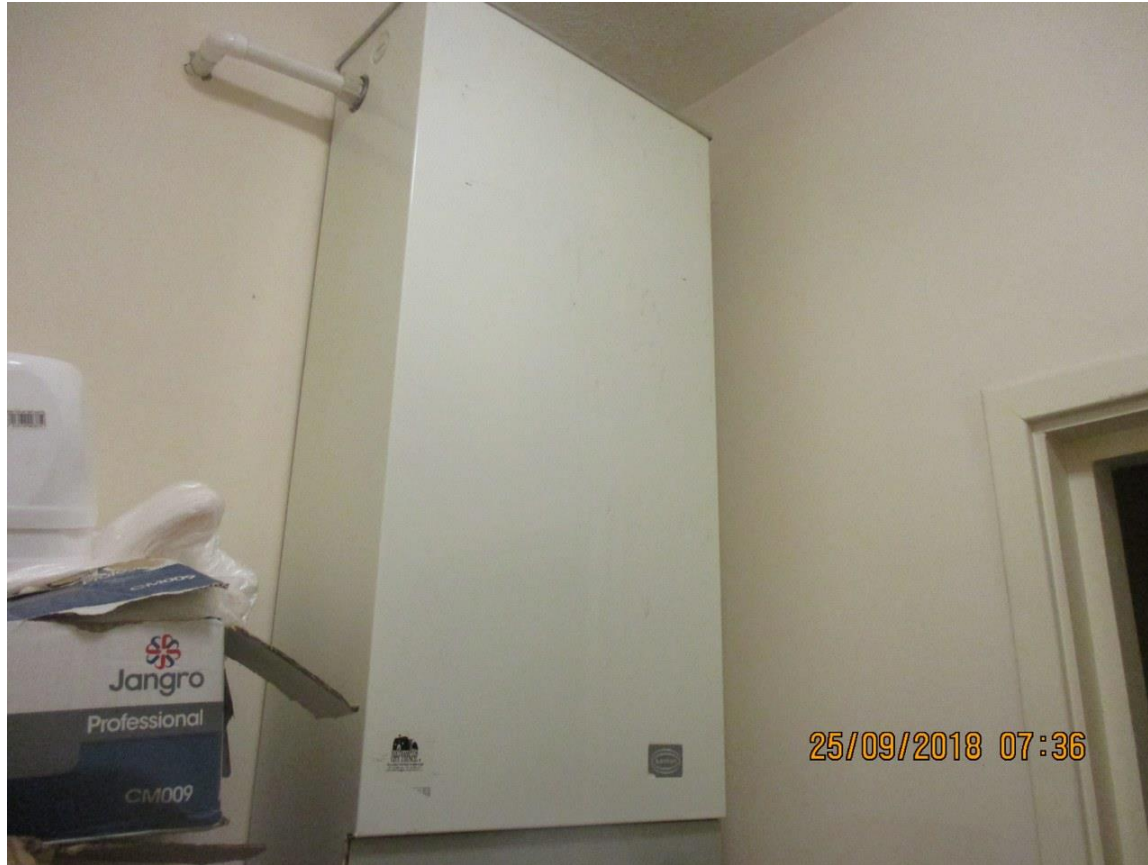
Isolated Drained Water Heater Deadleg

The drained water heater in unit 31 ladies toilet has been isolated on the mains water supply pipe work creating deadleg pipe work; the water heater should be replaced and the deadleg pipe work removed.

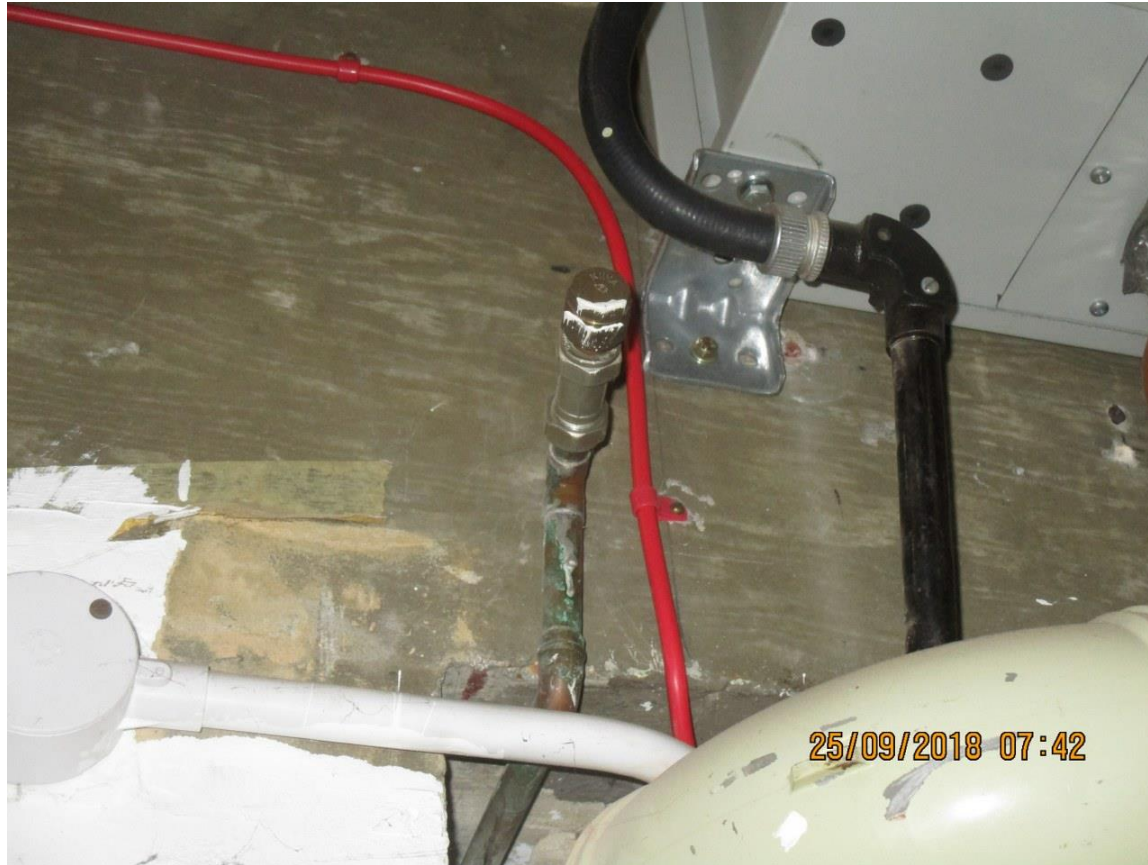
Deadleg Capped Off Pipe Work

The capped off deadleg pipe work in the storage area in unit 31 is still in place; I would recommend removal.

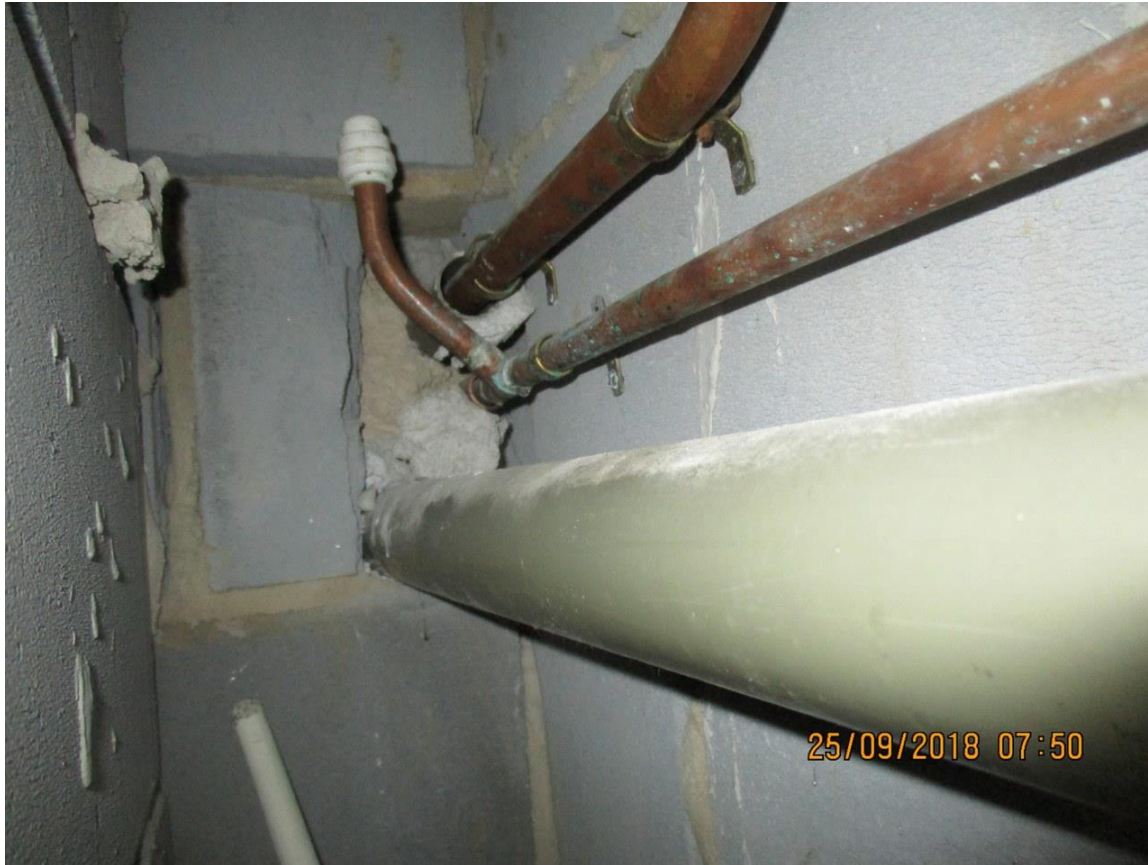
Deadleg Pipe Work

The old supply to a removed water heater is still in place in Unit 29 ladies toilet cavity area; recommend removal.

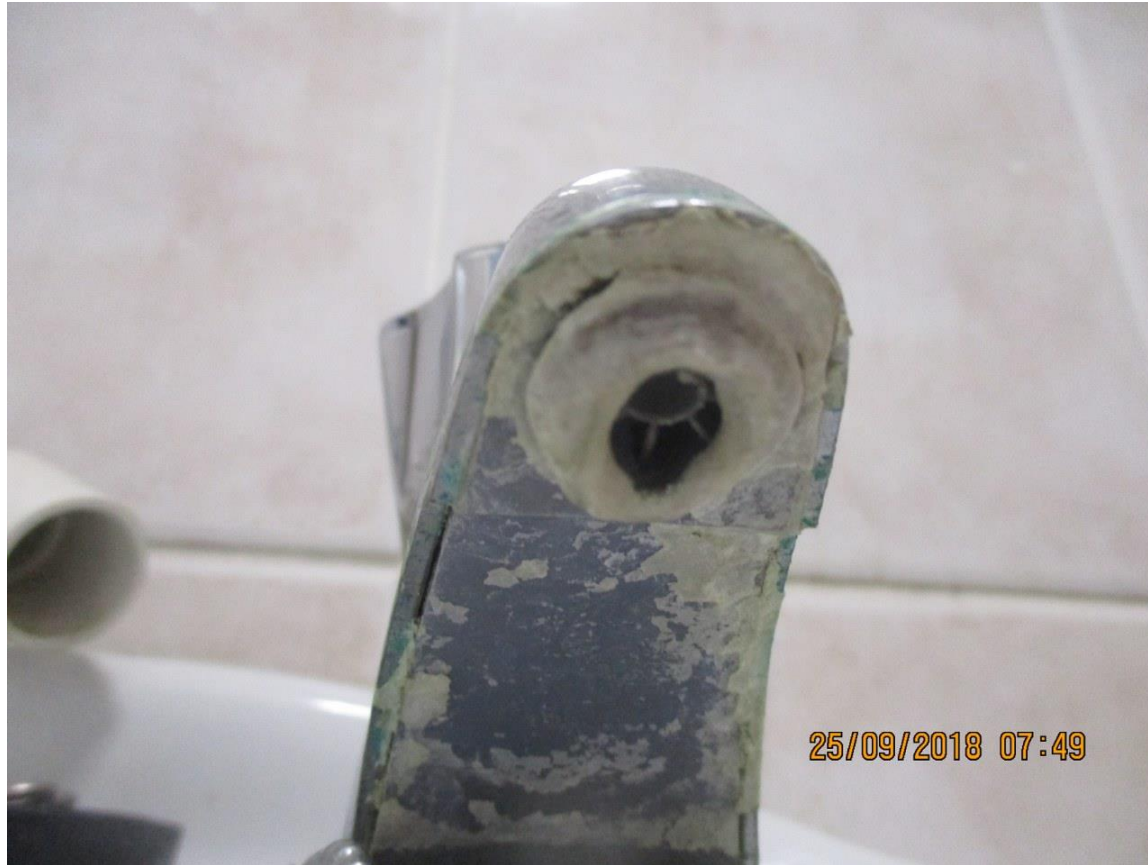
Outlet Scale Build Up

Some tap outlets within units 29 & 31 were seen to have scale build up; this could act as a nutrient for bacteria proliferation and should be cleaned and descaled on a regular basis.

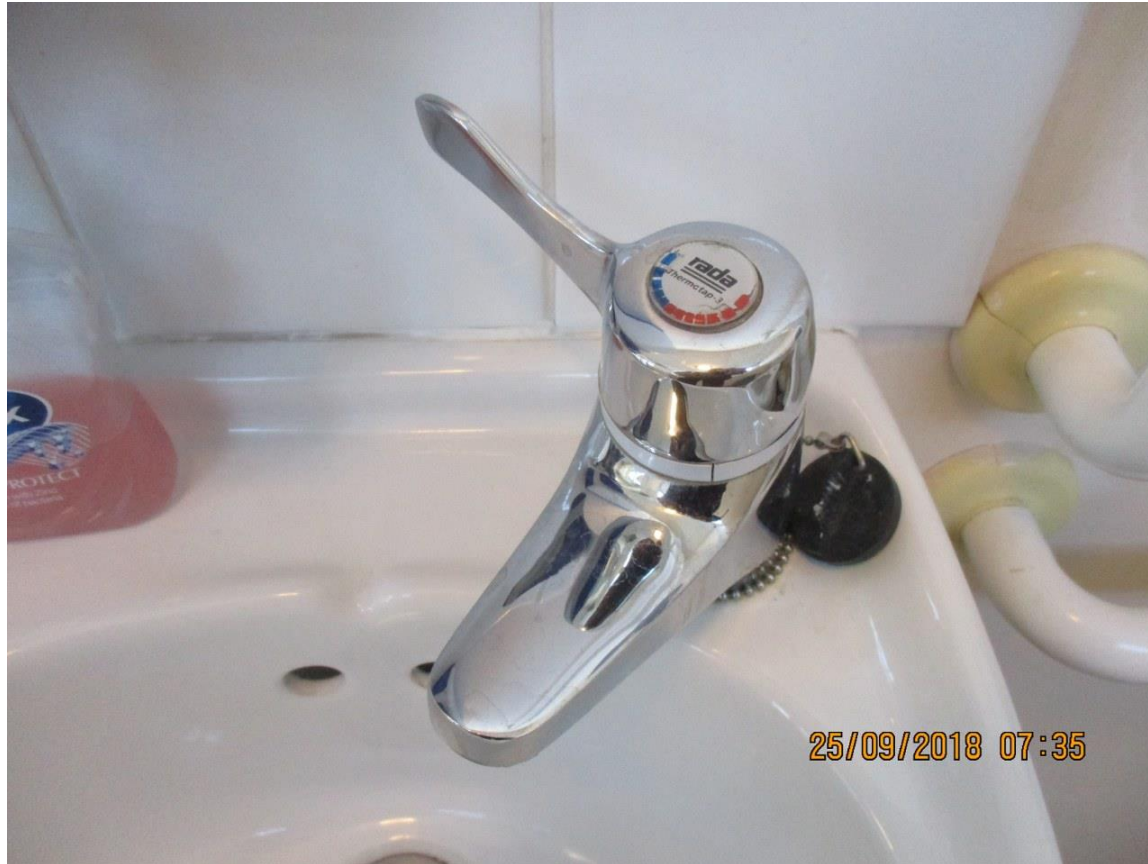
TMV Tap

A TMV tap is located in unit 31 accessible toilet area; this should be serviced and maintained as recommended by the manufacturer.

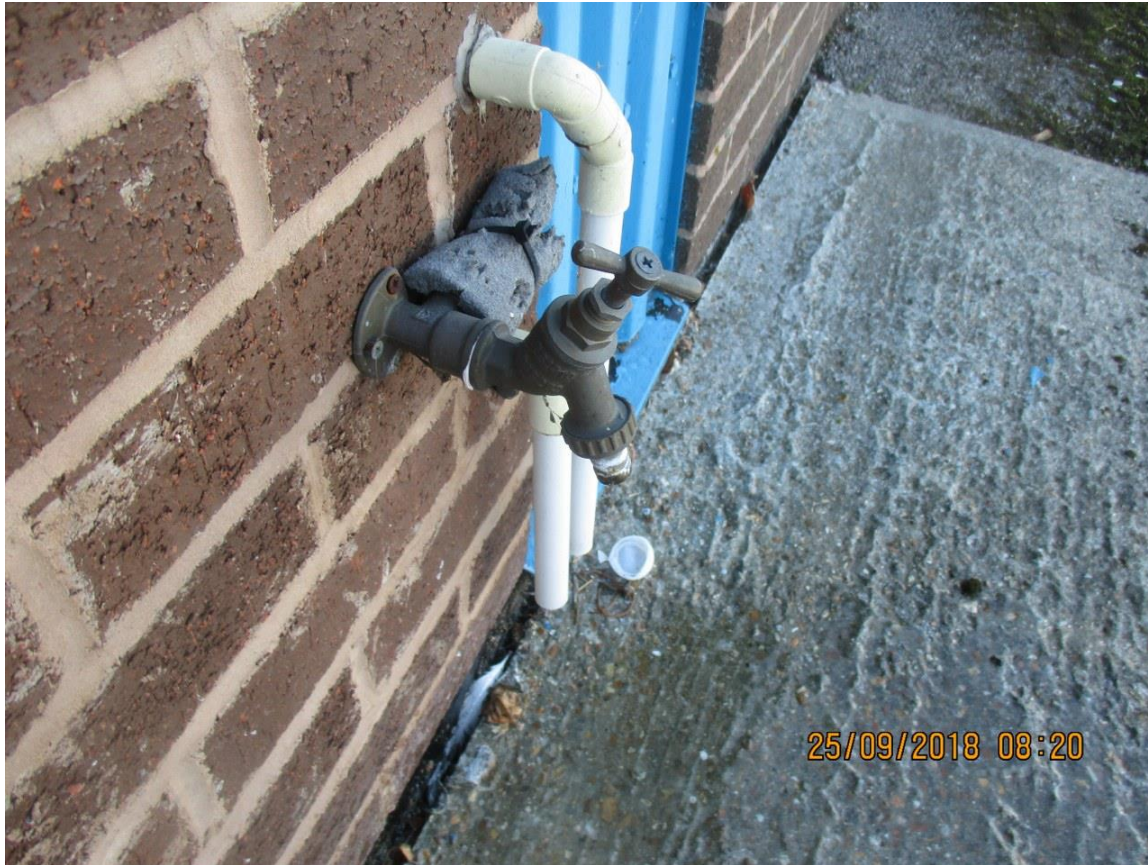
Infrequently Used Outside Tap

The outside tap located on unit 31 should be flushed on a weekly basis if not being used.
