Holly Lodge Common Yard

Review Photographs

5th March 2018

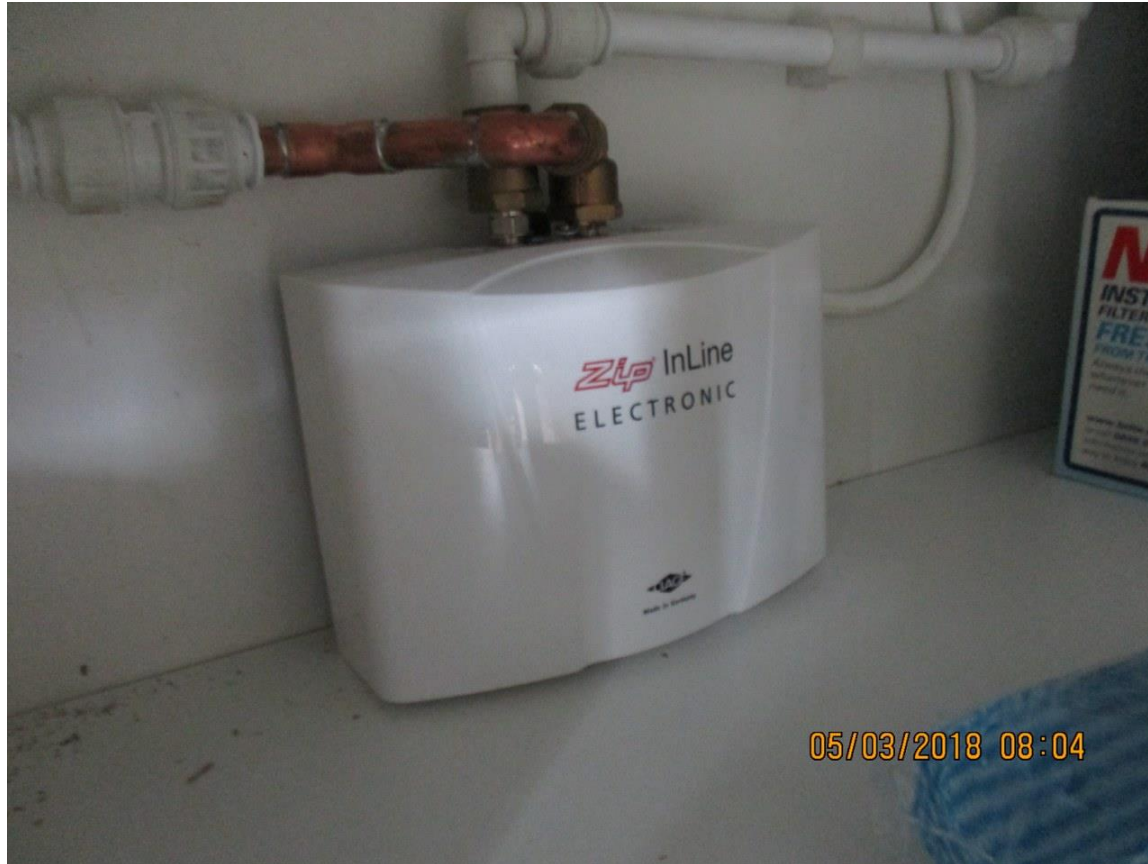
Water Heater

A new instantaneous water heater has been fitted beneath the work top in the rest room area; although this heater does not achieve 50.0C at the outlet it is mains water supplied and does not store hot water and with regular use therefore reduces risk.

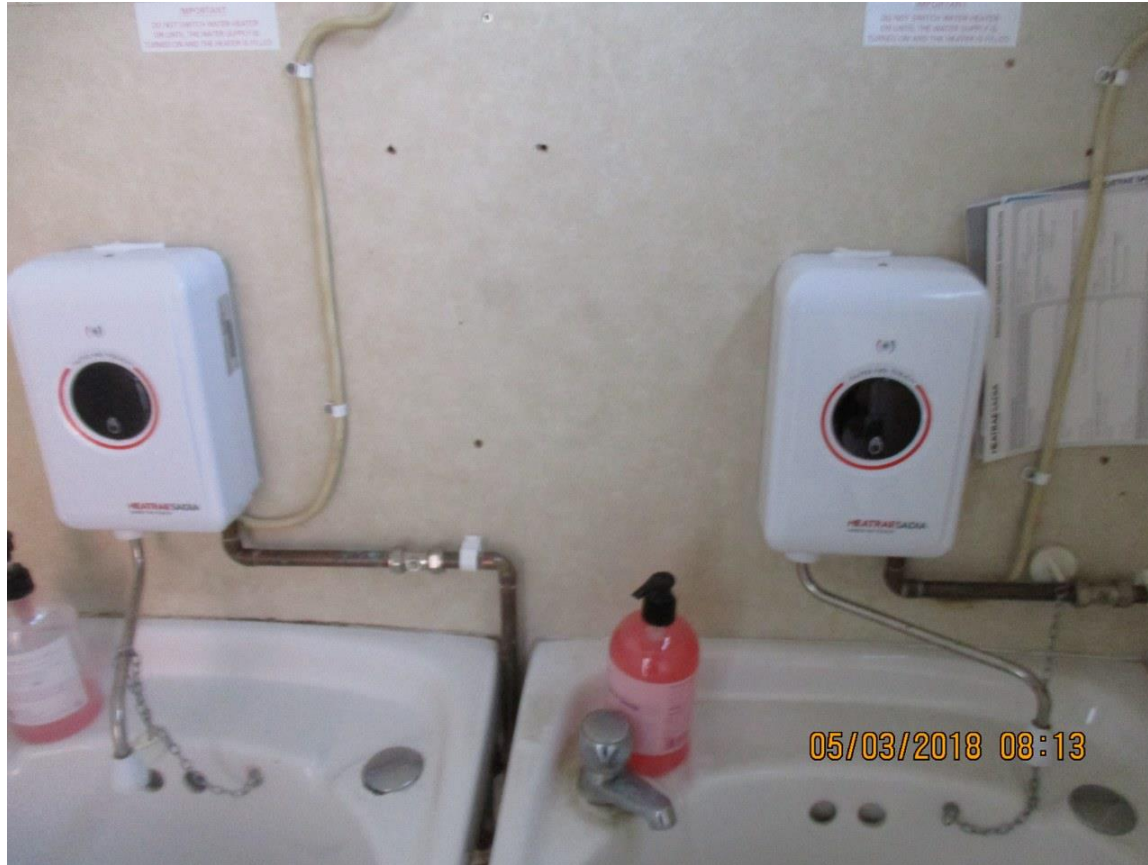
Hand Sensor Water Heaters

New instantaneous hand sensor type water heaters have been fitted office and toilet areas; although these heaters do not achieve 50.0C at the outlets they are mains water supplied and do not store any hot water and with regular use therefore reduces any risk.

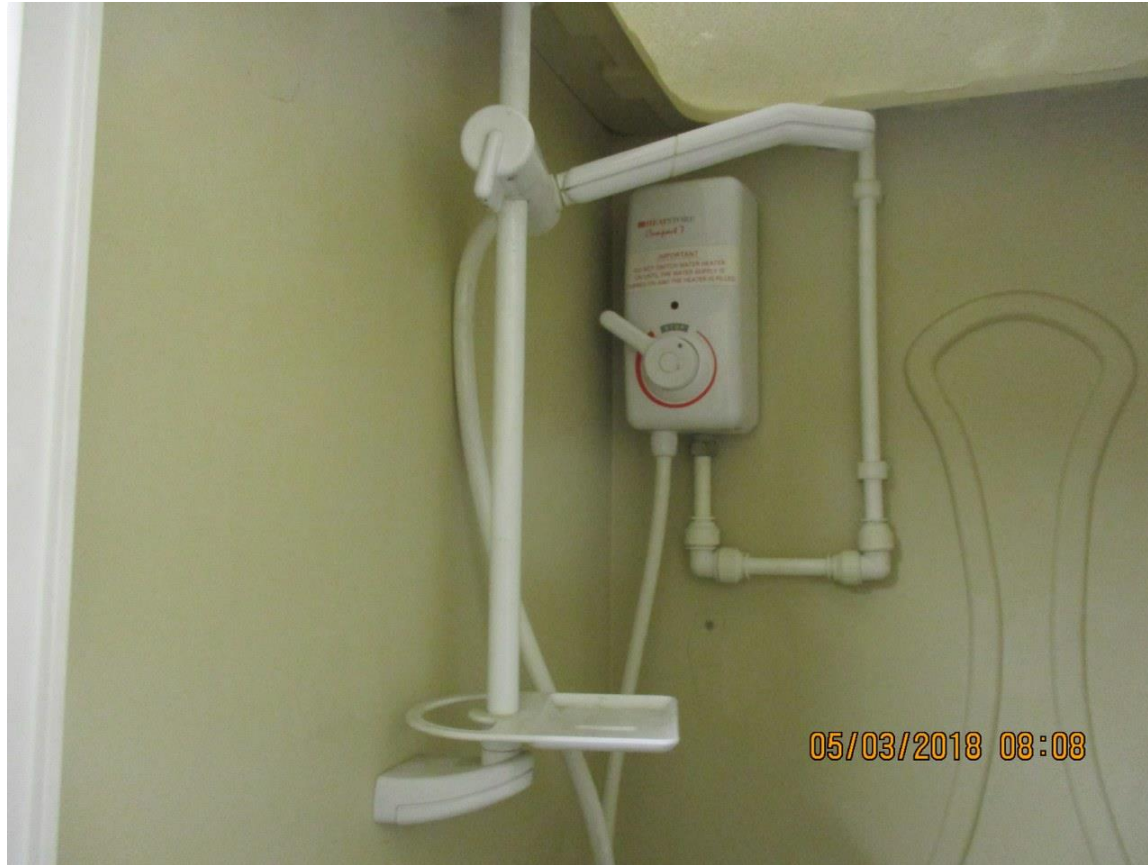
Electric Shower

The shower has now had the deadleg pipe work removed; the shower is infrequently used in the winter months and should therefore be flushed through weekly. Check for correct operation as a fault sheet 6188 was submitted in January 2018 for being too hot at the outlet.

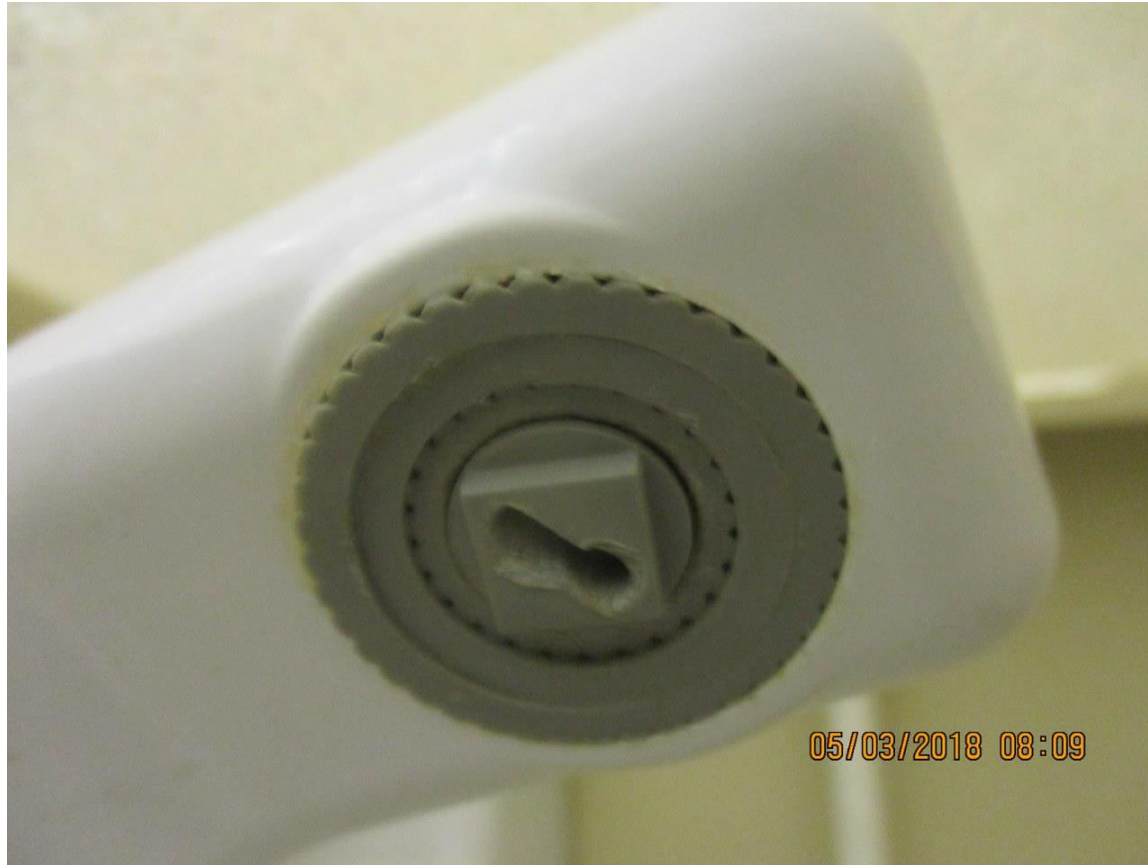
Showerhead

The showerhead is being cleaned and descaled on a quarterly basis; this was last carried out in January 2018 and was seen recorded in the logbook documentation.

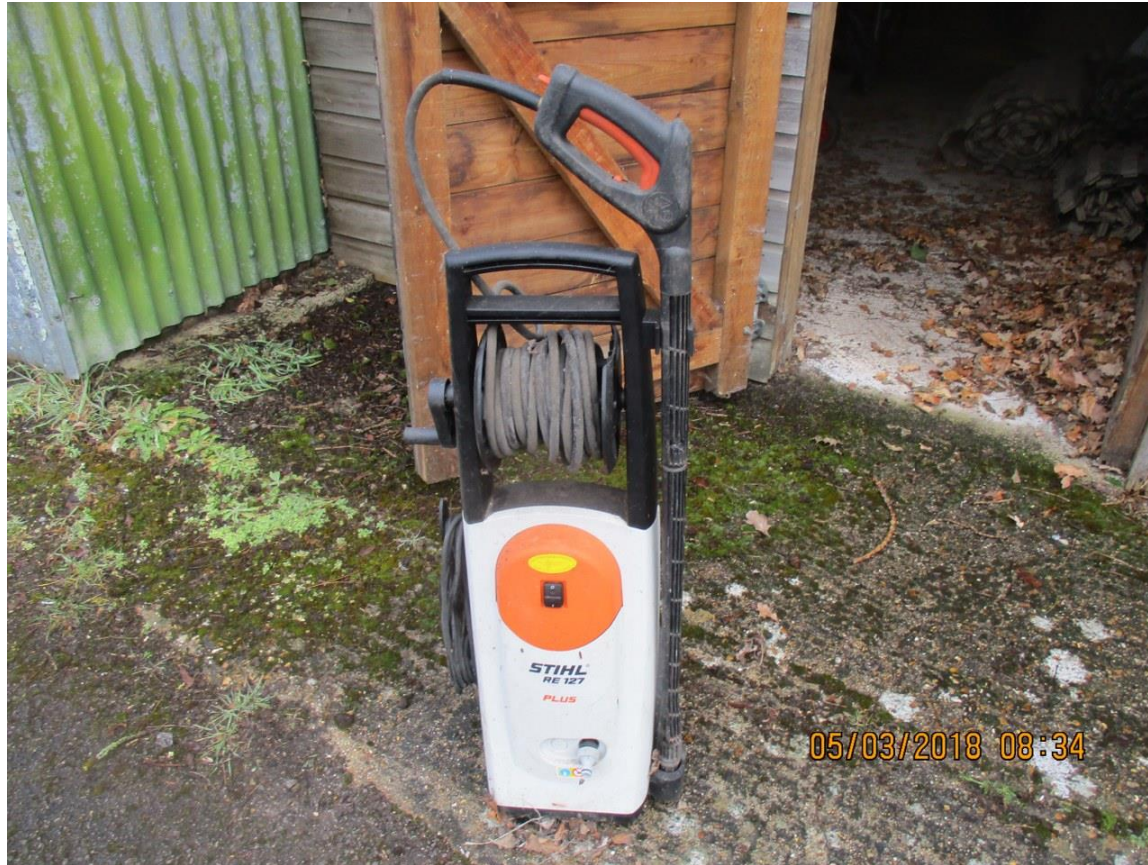
Pressure Washer

Ensure all hoses are drained of water when the pressure washer is not being used to prevent stagnant water forming; aerosols are created when in use mainly in the summer months so ensure minimal persons are within the vicinity when in operation.

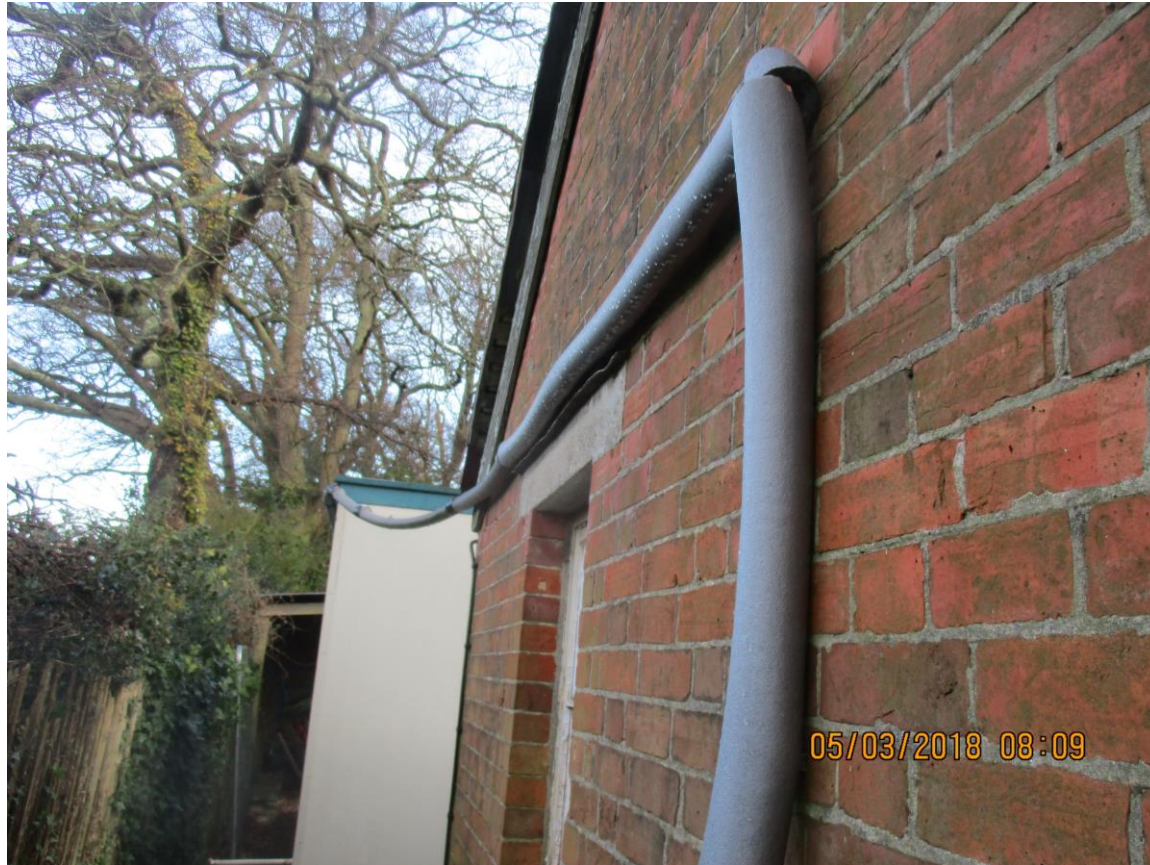
External Pipe Work

External mains water pipe work was seen to be insulated to help prevent heat gain and frozen pipe work.

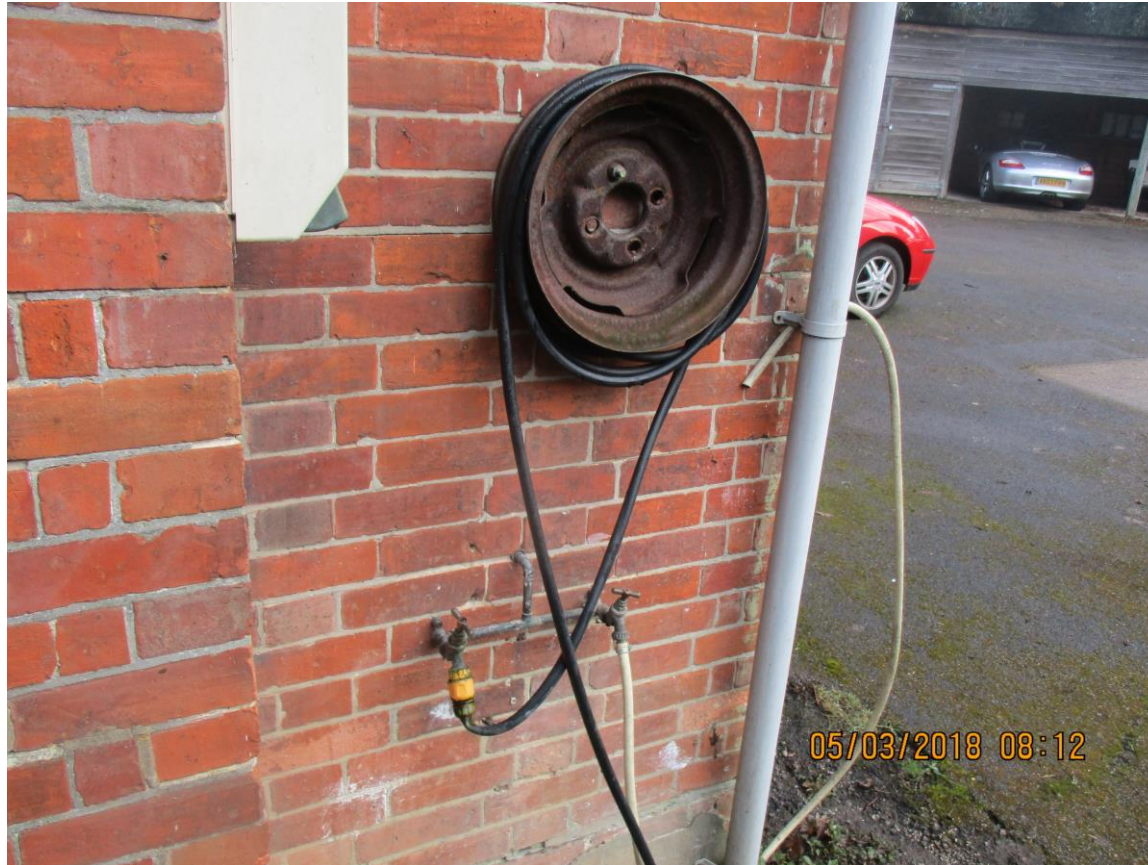
Outside Taps & Hose Reels

Ensure all outside tap outlets get regular usage or flush at least on a weekly basis; Disconnect and drain hoses to prevent stagnant water forming within the hoses when not being used.
