# **Paget Street Industrial Development**

## **Unit 1 Review Photographs**

**28<sup>th</sup> June 2018**

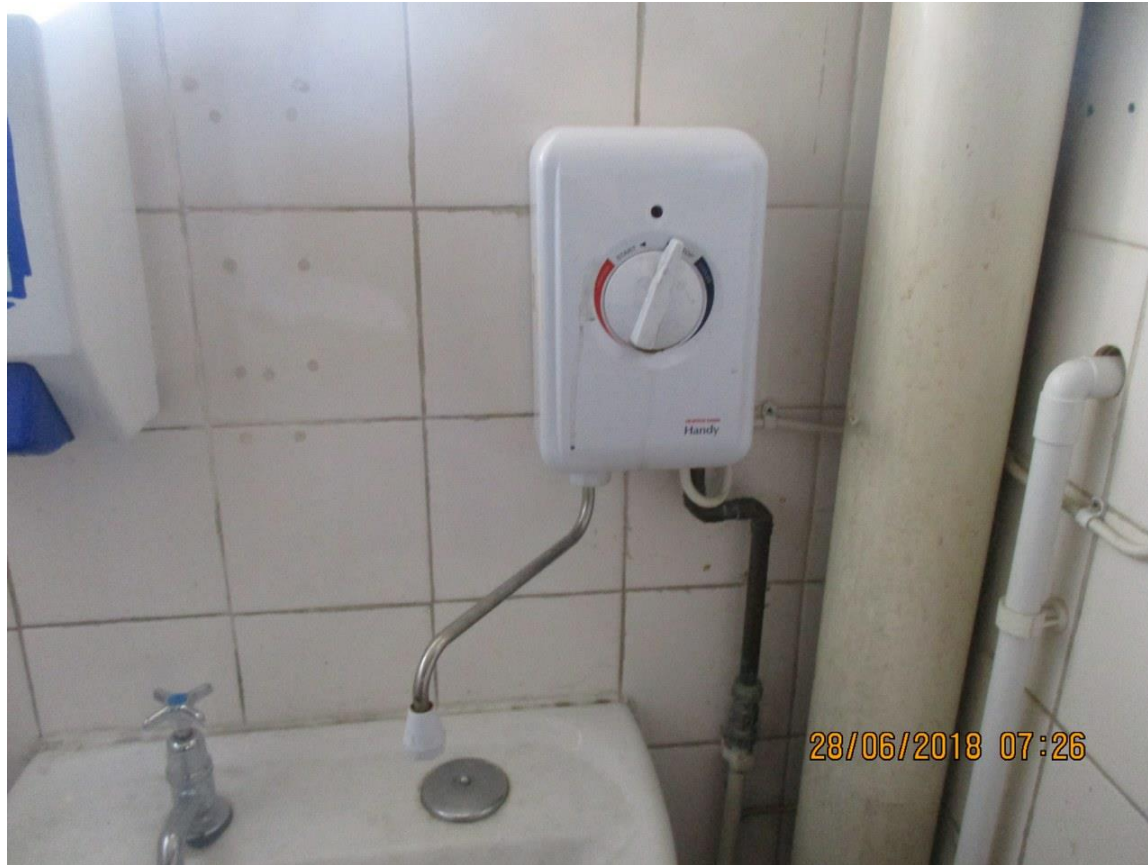
## **Instantaneous Water Heater Toilet Area**

Unit 1 toilet area instantaneous water heater had good temperature recorded at the time of this 2018 review; records seen indicate temperatures are normally satisfactory.

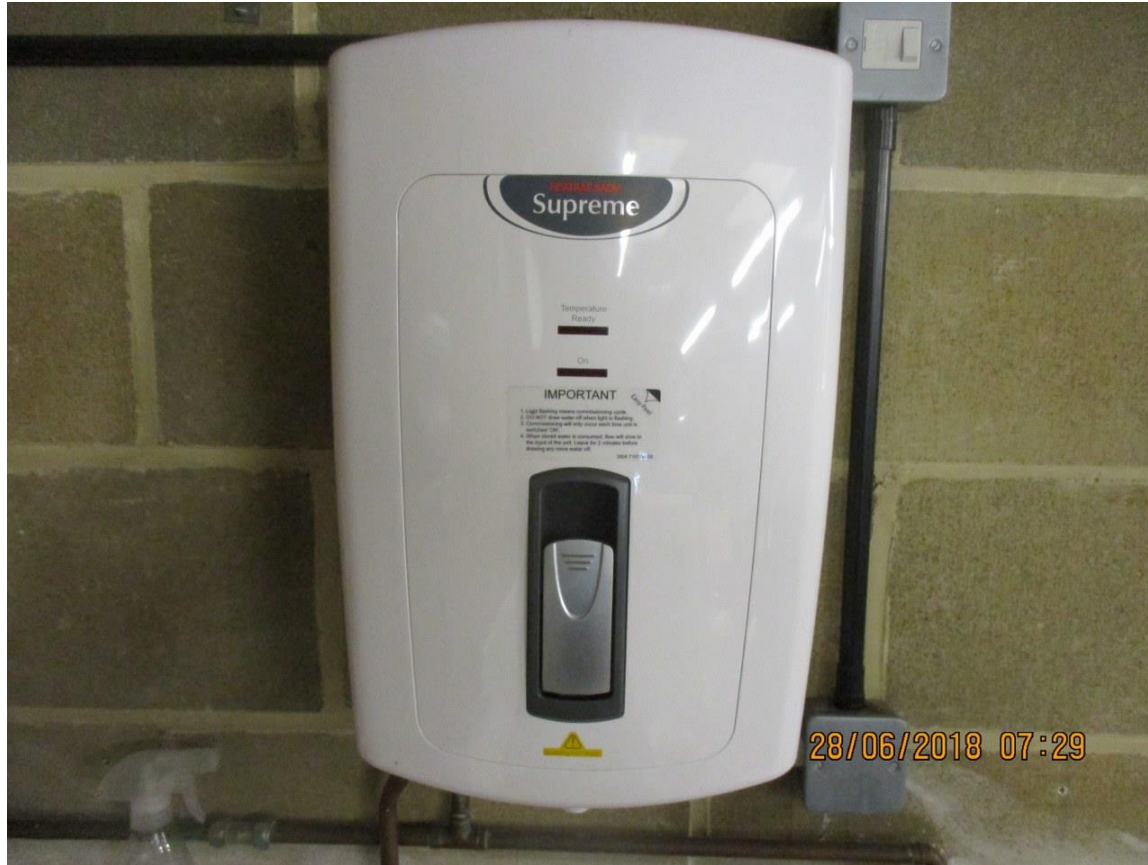
## Water Boiler Mezzanine Floor Kitchen

Unit 1 mezzanine floor kitchen boiler is not being used thus creating deadleg pipe work; remove if not required along with all associated pipe work.

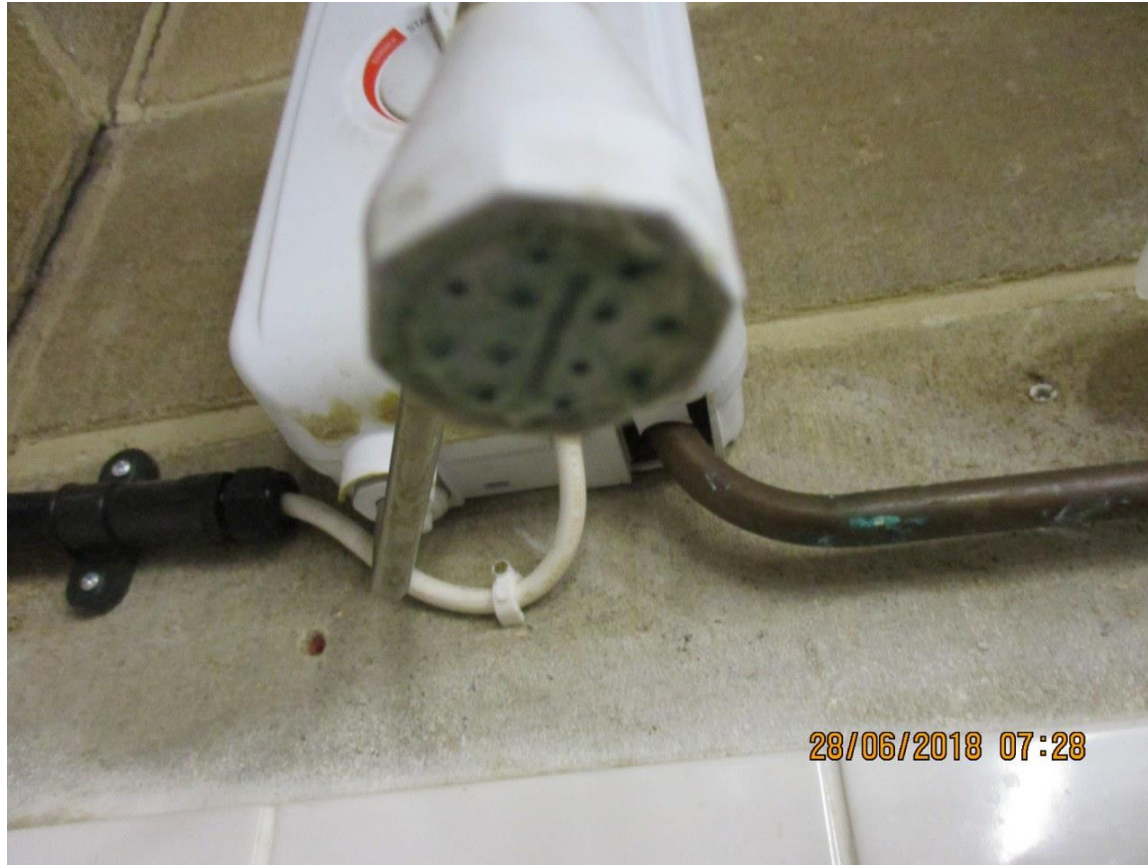
## **Water Heater Spray Nozzles**

Ensure the water heater outlet nozzles remain clean and free from scale build up.

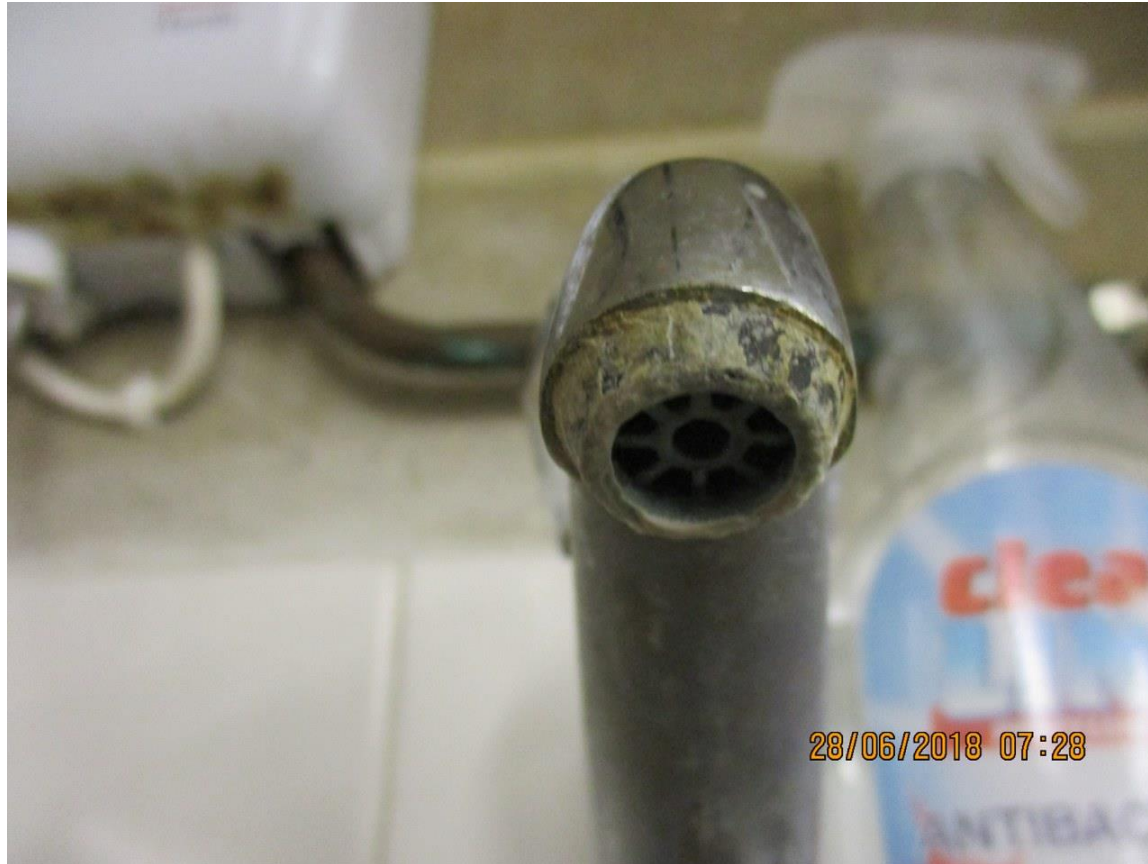
## Tap Outlets Scale

Ensure all tap outlets remain clean and free from scale build up as this can act as a nutrient for the proliferation of bacteria.

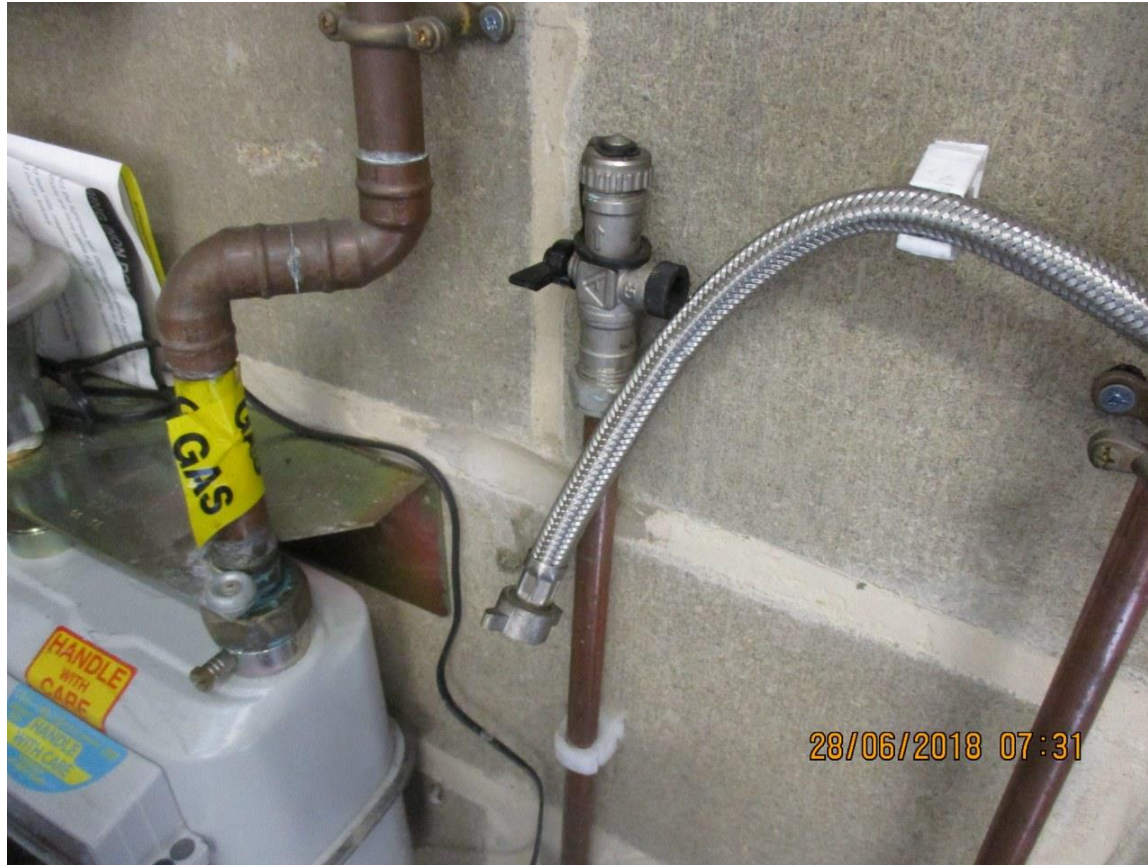
## Unit 1 Heating Quick Fill Deadleg

The cold main to the heating quick fill acts as deadleg pipe work; recommend this is flushed through on a regular basis; no records were seen at the time of this 2018 review to indicate this is being carried out..

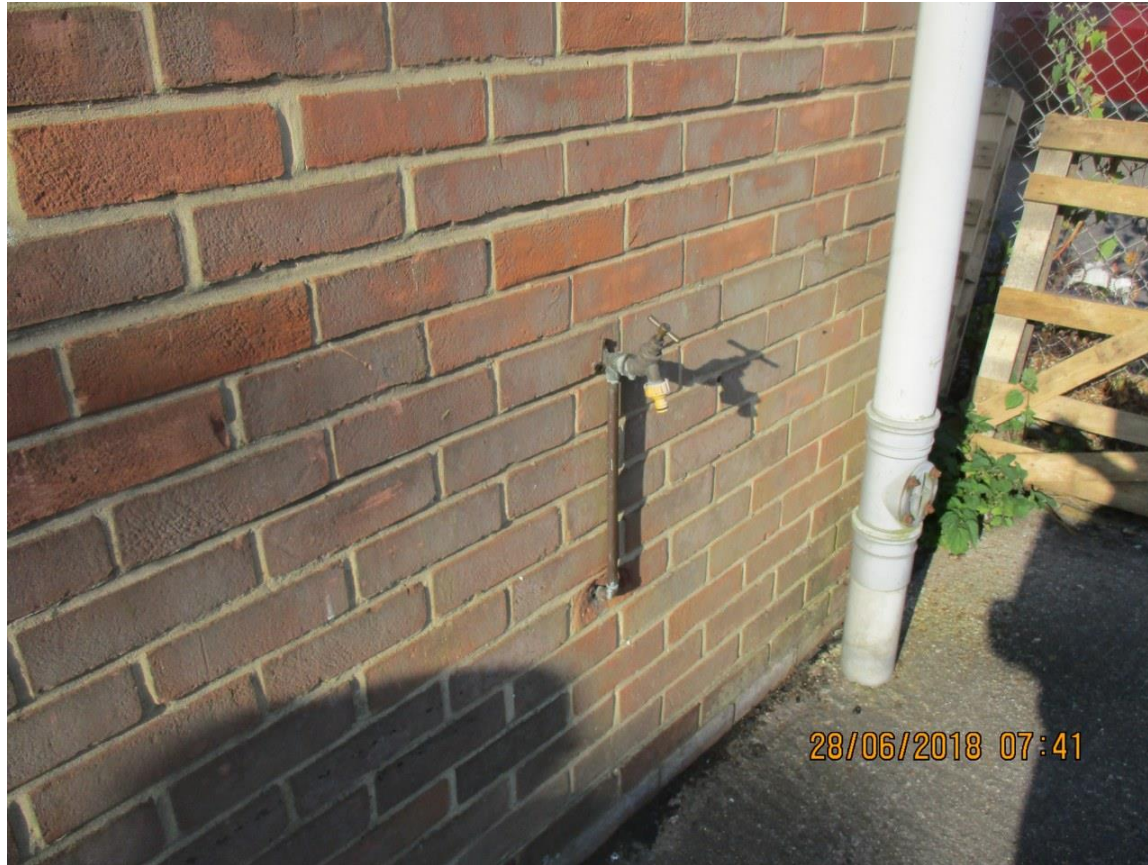
## **Unit 1 Infrequently Used Outlet**

Outside tap can be infrequently used; ensure this is opened and flushed through at least on a weekly basis; no records were seen at the time of this 2018 review to indicate this is being carried out..
