Schools Library Service Building

Review Photographs

7th March 2018

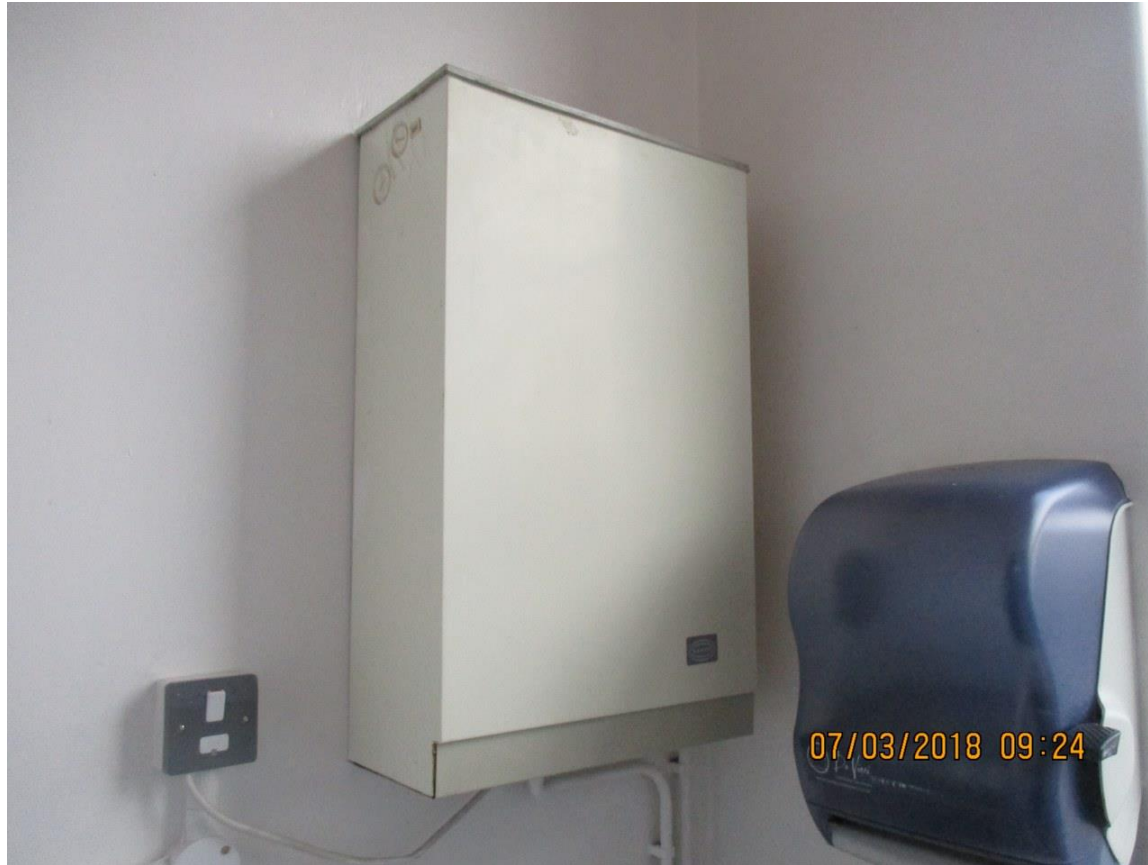
Kitchen Local Water Heater

With a capacity more than 15 litres the water heater should store hot water at 60.0C; slightly low at the time of this 2018 review.

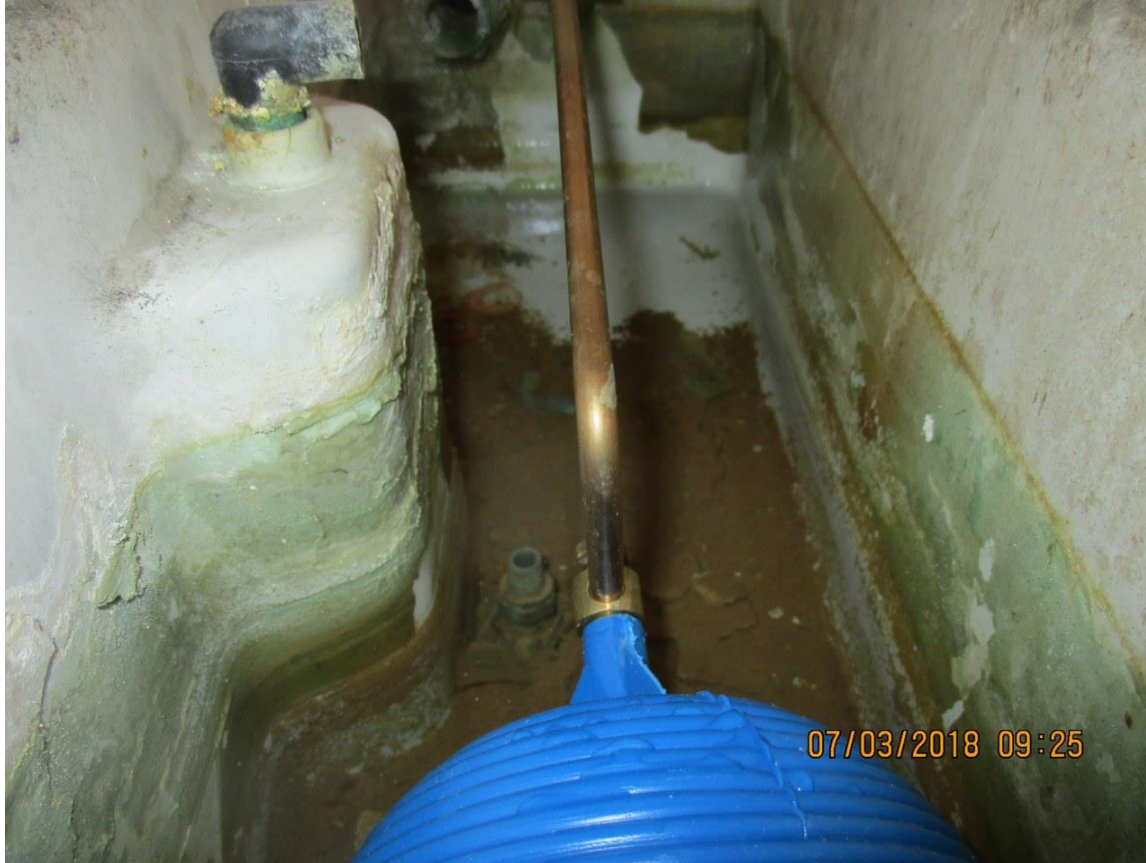
Kitchen Local Water Heater

Internal view of the kitchen local water heater proves a build up of sediment; recommend the header tank is cleaned and disinfected and continued annually if required.

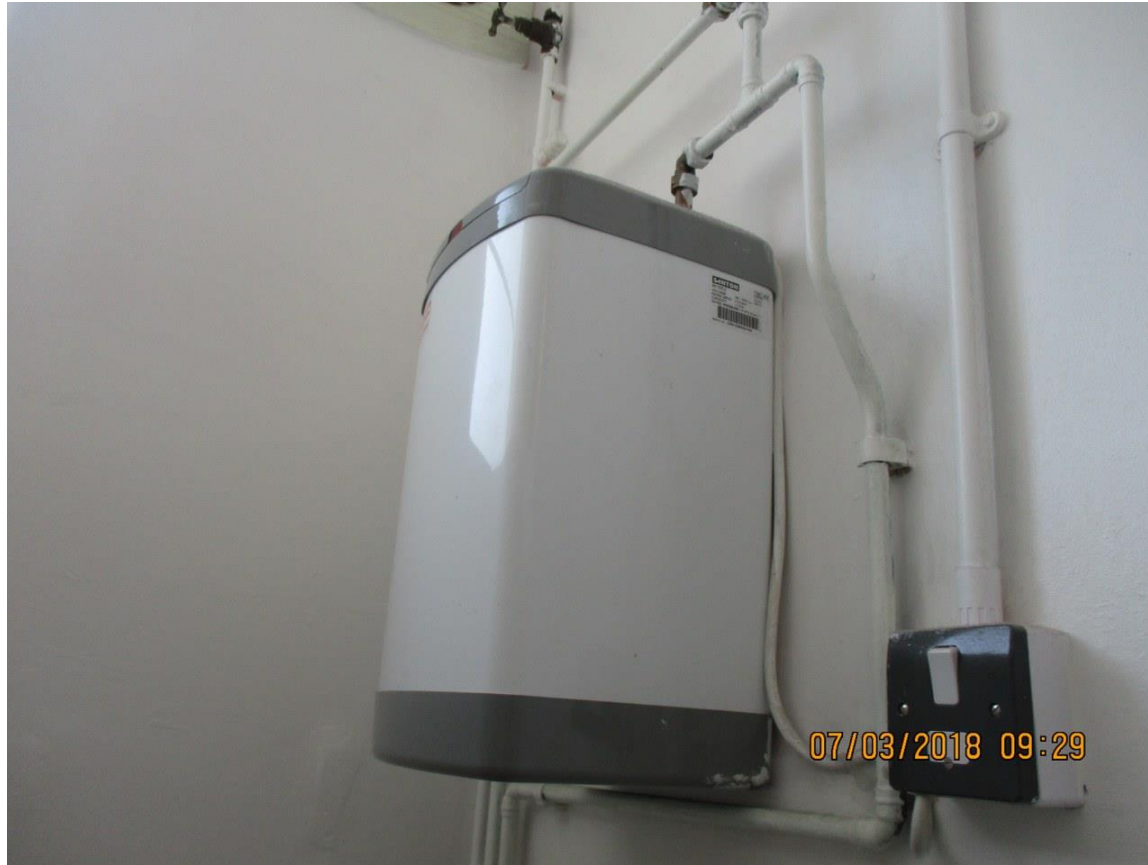
Local Water Heater

The local water heater serving the first floor toilet outlets had a good storage temperature at the time of this 2018 review.

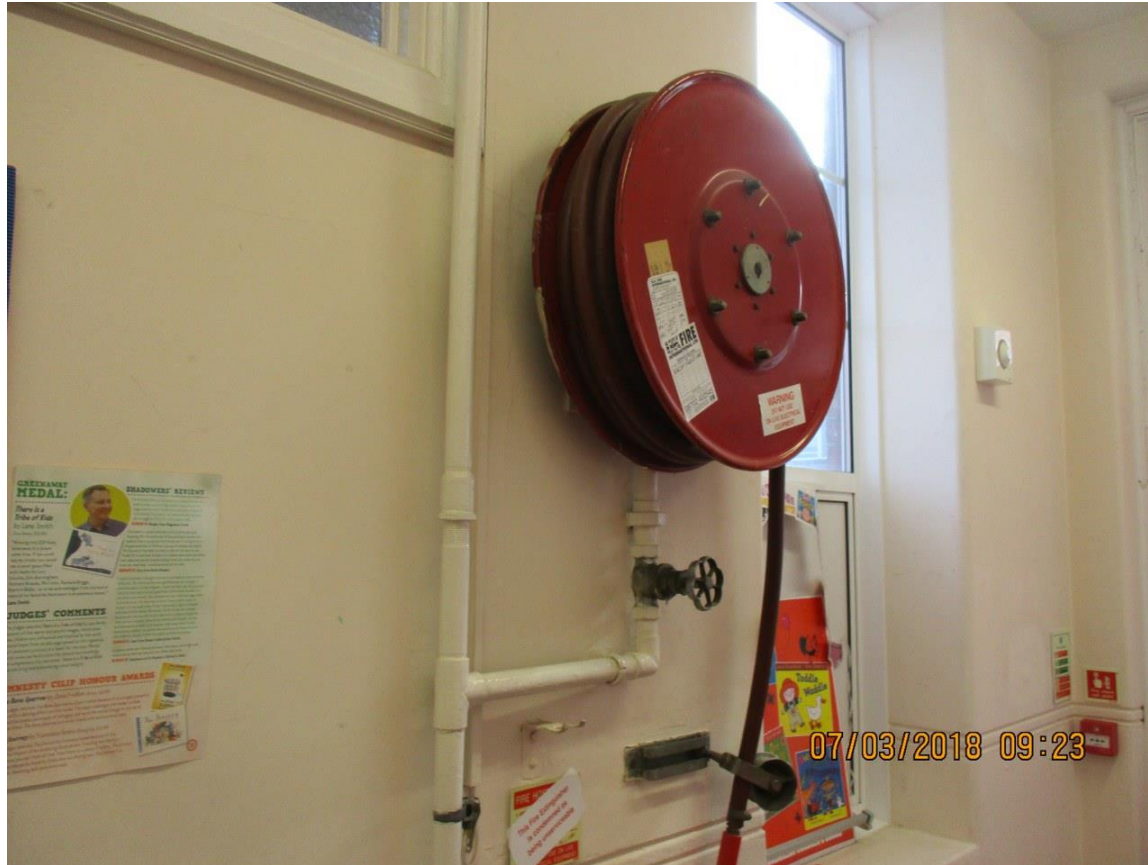
Deadleg Pipe Work Fire Hose Reels

The fire hose reels are supplied by the mains water service; it has been recommended that these fire hose reels be removed to prevent deadleg pipe work; these are still in place on the ground and first floors.
