Townhill Park Local Housing Office

Review Photographs

3rd January 2018

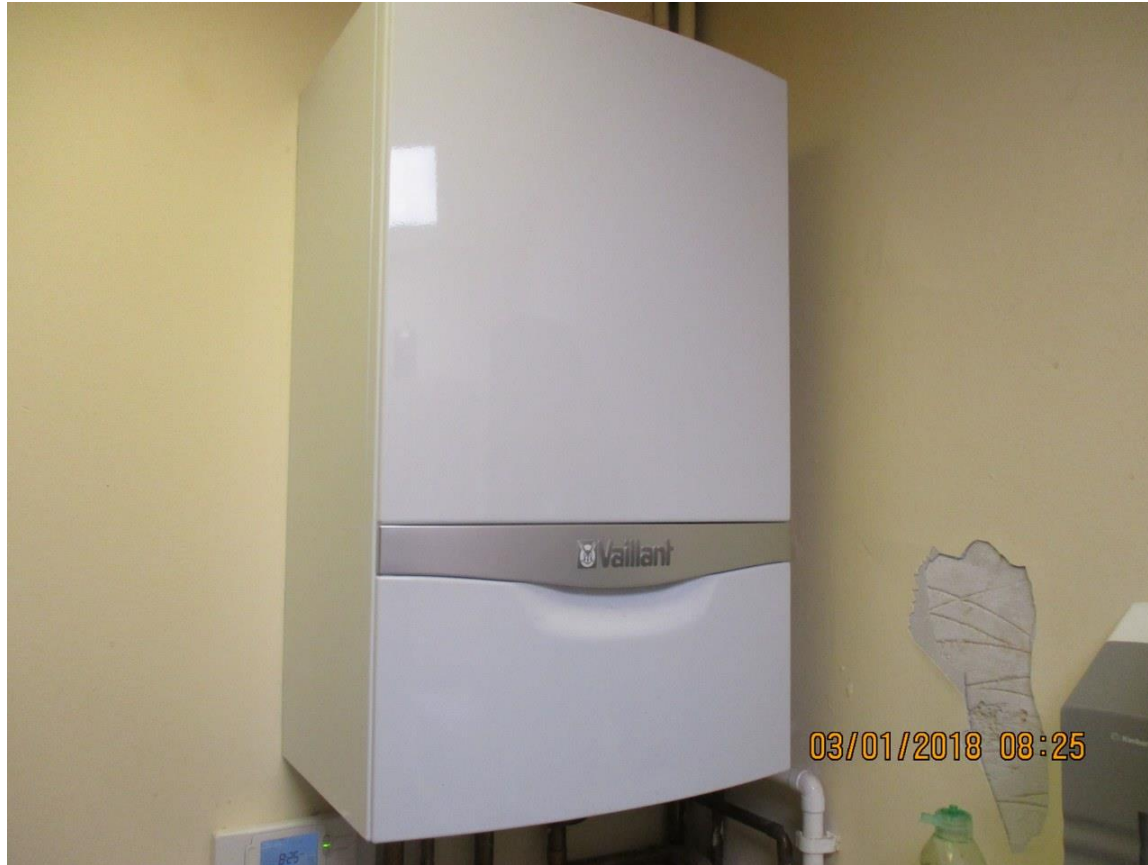
Combination Boiler

The combination boiler serving all hot water outlets; good outlet temperatures recorded above 50.0C at outlets at the time of this 2018 review.
