Wyndham Court Parking Services

Review Photographs

10th October 2018

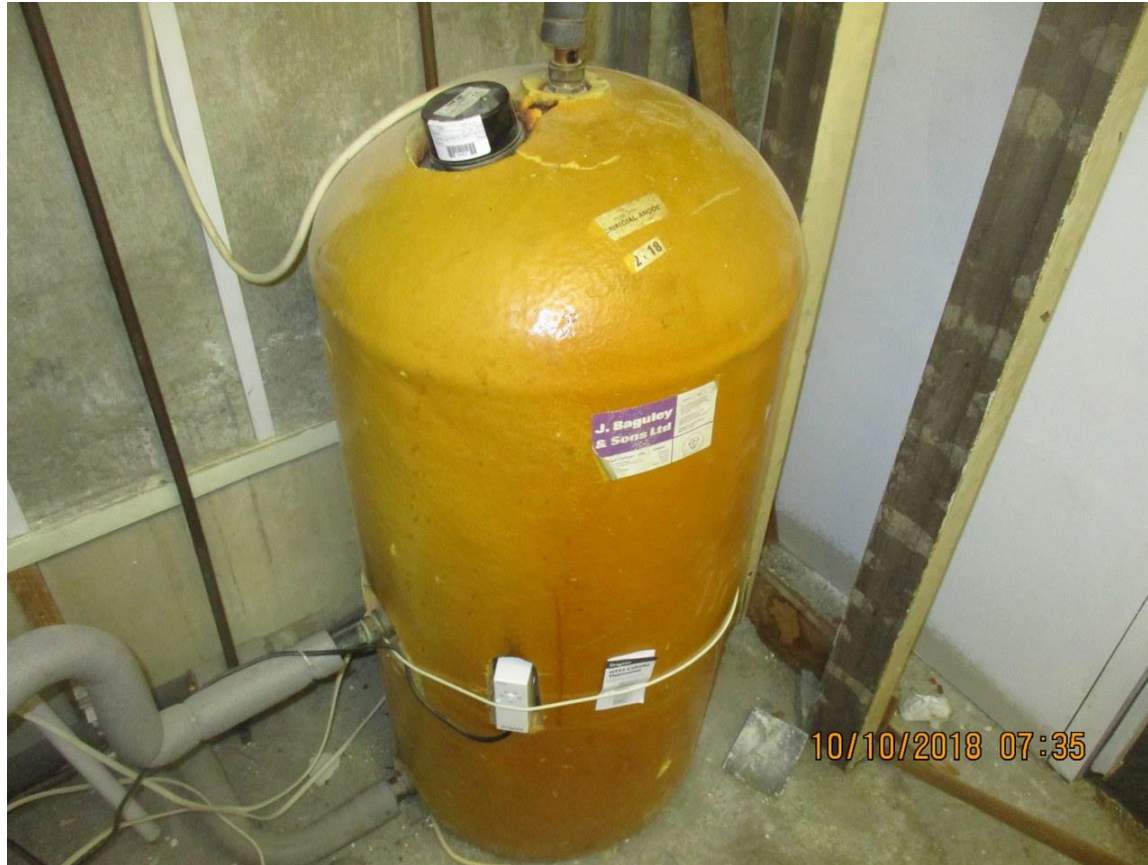
Hot Water Calorifier

The hot water calorifier had a good storage temperature at the time of this 2018 review; records seen indicate the storage temperature is has been satisfactory since August 18.

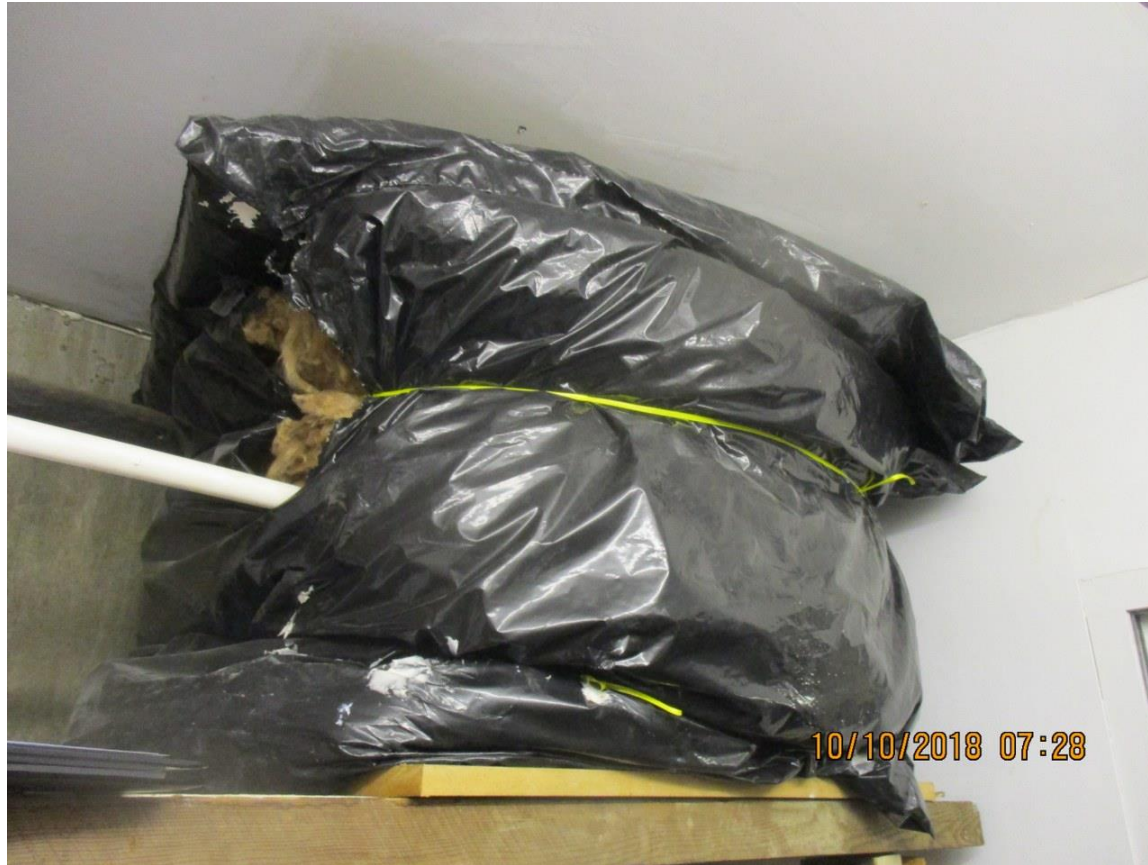
Cold Water Storage Tank

The water storage tank serving the calorifier is still located within the first floor plant room above the calorifier; the plant room can have very warm ambient temperature which can create elevated water temperatures; the storage temperature was satisfactory at the time of this 2018 review at 19.2C.

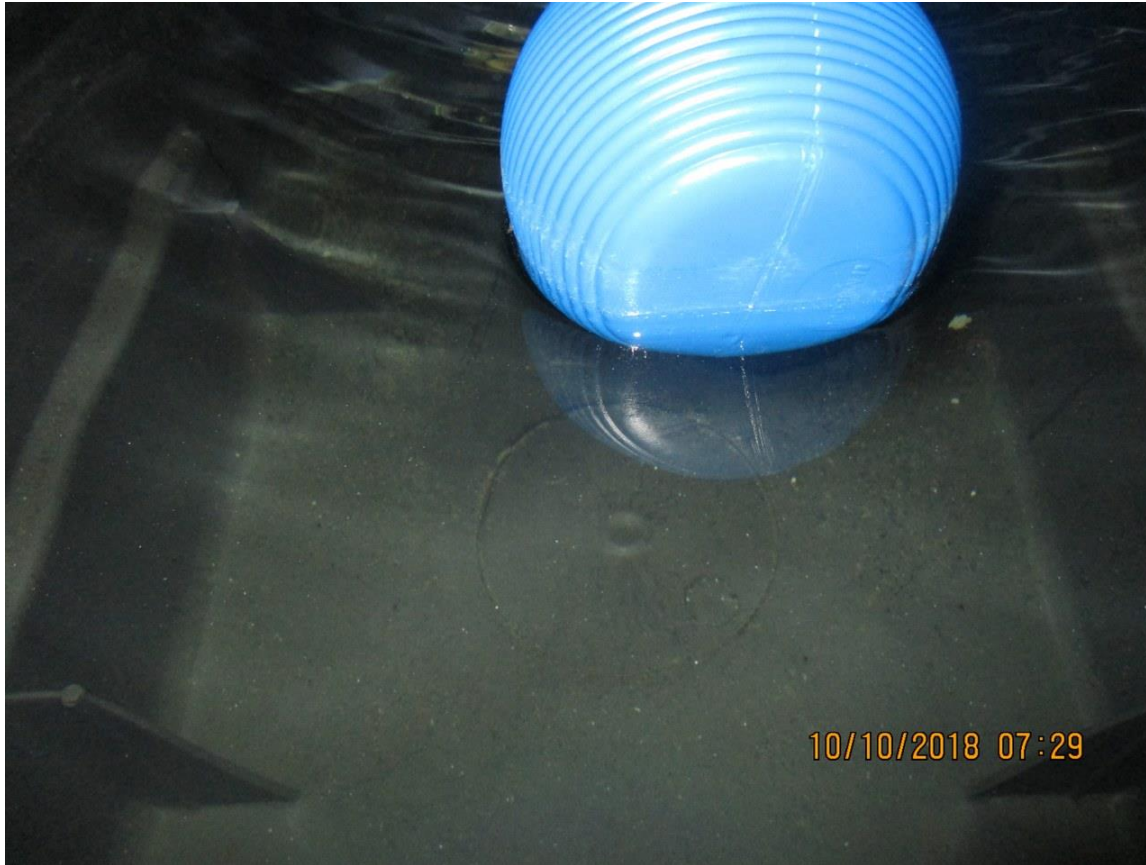
Cold Water Storage Tank

Internal view of the cold water storage tank proved it to be in a clean condition; it is not known when this tank was last cleaned and disinfected as no records were seen for this.

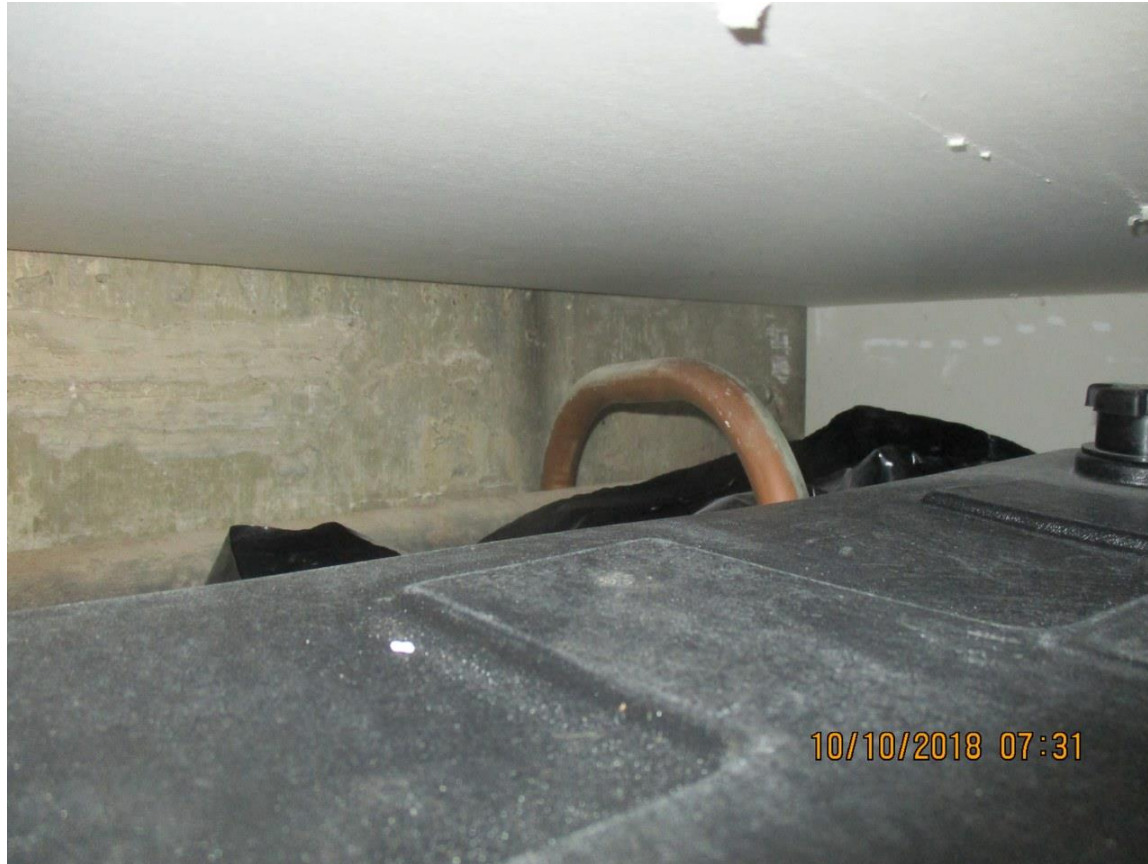
Returning Open Vent Pipe Work

The open vent pipe work from the calorifier is still returning to the cold water storage tank; I would again recommend this be re-routed to a drain via a tundish.

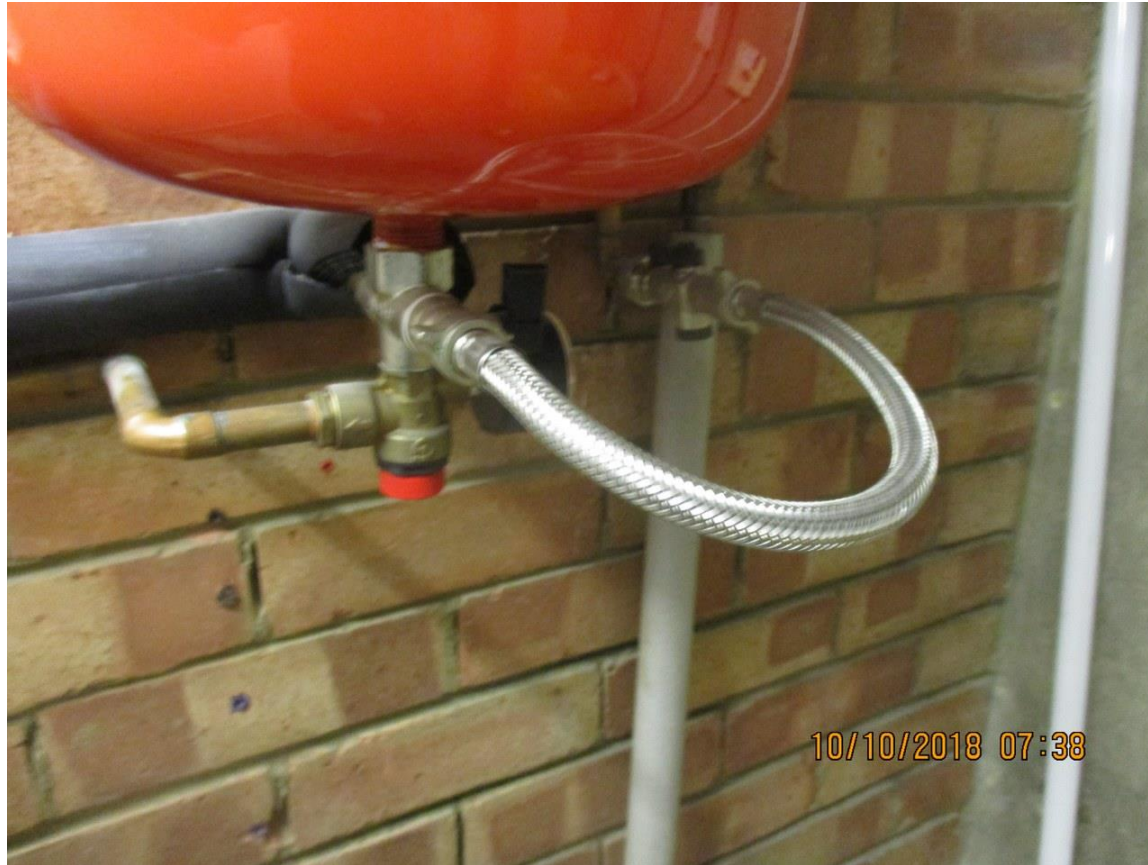
Heating Quick Fill

The heating quick fill pipe work acts as deadleg pipe work; I would recommend this be flushed through on a regular basis.

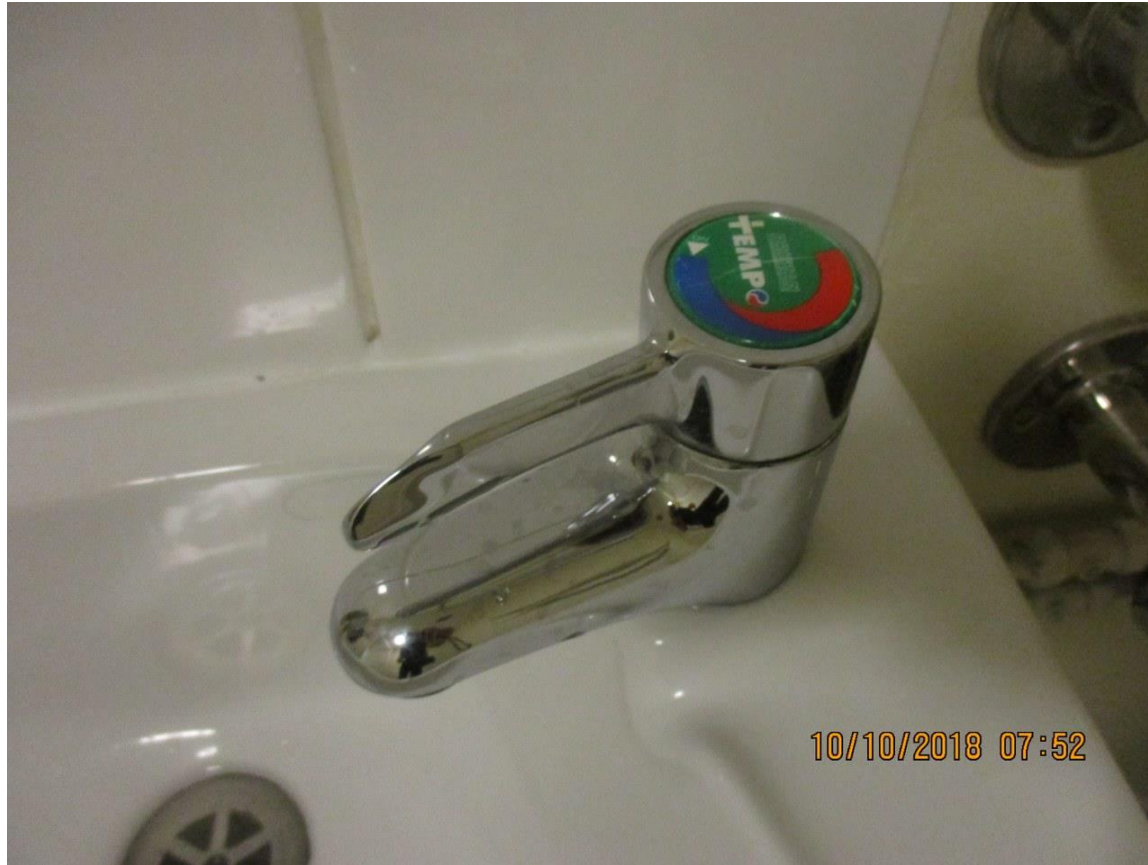
TMV Tap

No records were seen to indicate the TMV tap in the accessible toilet is being serviced and maintained as recommended by the manufacturers.

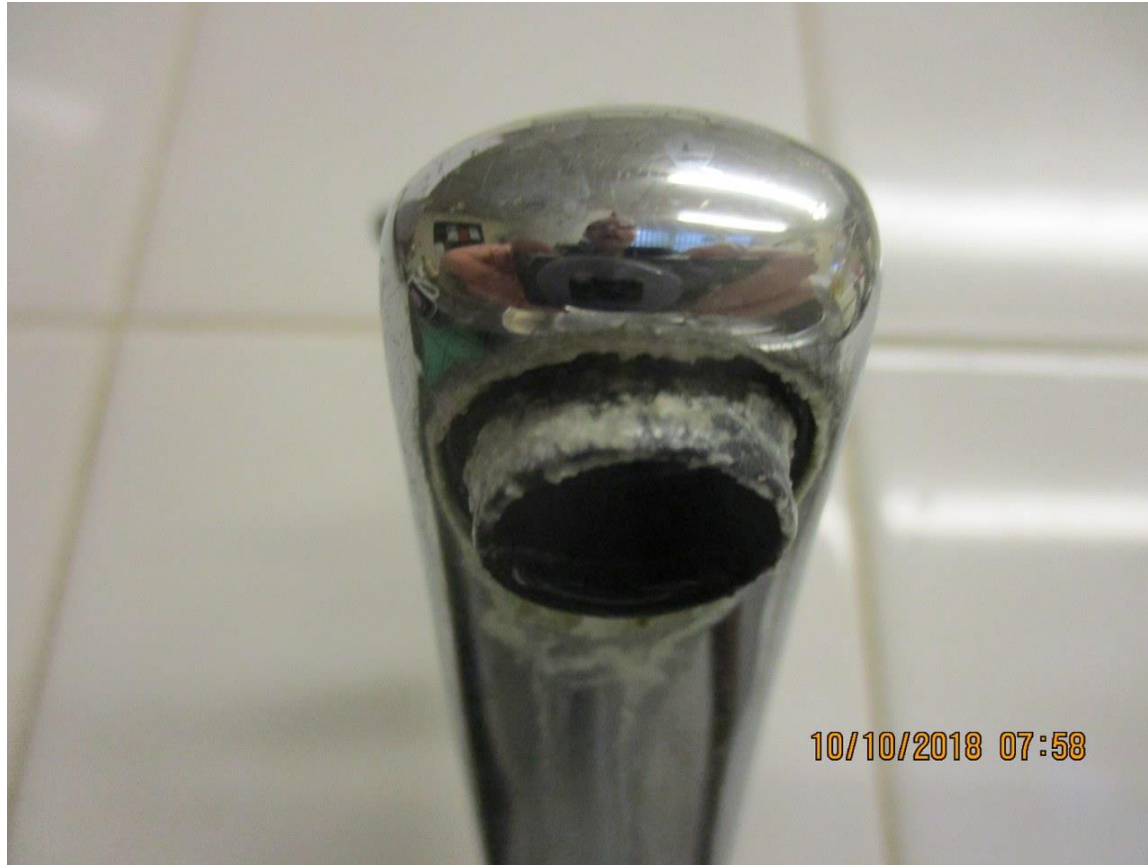
Scale Build Up

Ensure all tap outlets are cleaned and descaled on a regular basis as scale can act as a nutrient for the proliferation of bacteria.

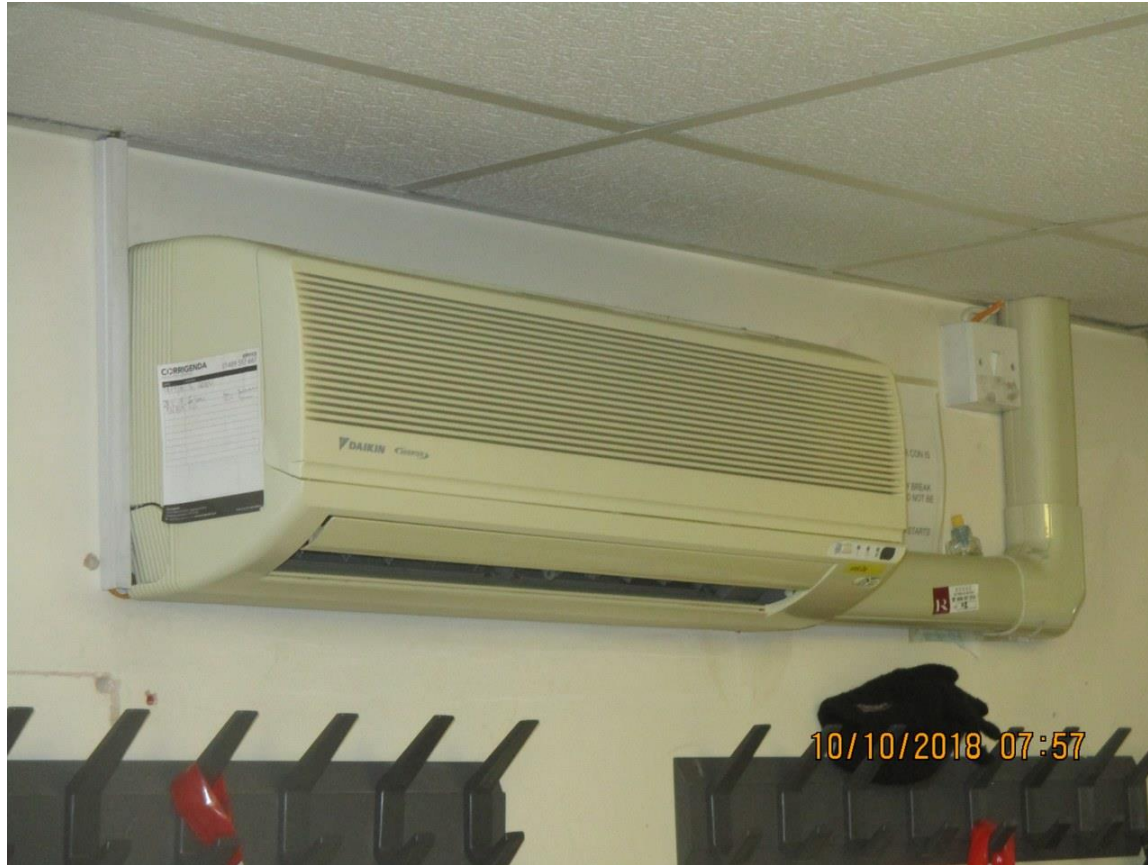
Air Conditioning Units

Ensure all air conditioning units are serviced and maintained as recommended by the manufacturers or as part of a regular maintenance schedule.
