Site: Merrydale Respite Care Centre
Church Lane
Kings Worthy
Winchester
Hampshire SO23 7QS

Date of Assessment: 17th March 2011

This report relates to a water source Risk Assessment carried out by Mr Chris Wilson of Freeston Water Treatment Ltd on the 31st March 2011 on behalf of Hampshire County Council. The Survey was carried out at Merrydale Respite Care Centre, Church Lane, Kings Worthy, Winchester, Hampshire SO23 7QS. During the course of the Survey water systems within the properties were risk assessed. These sources were chosen as being fully representative of the overall domestic water systems and outlets within the buildings.

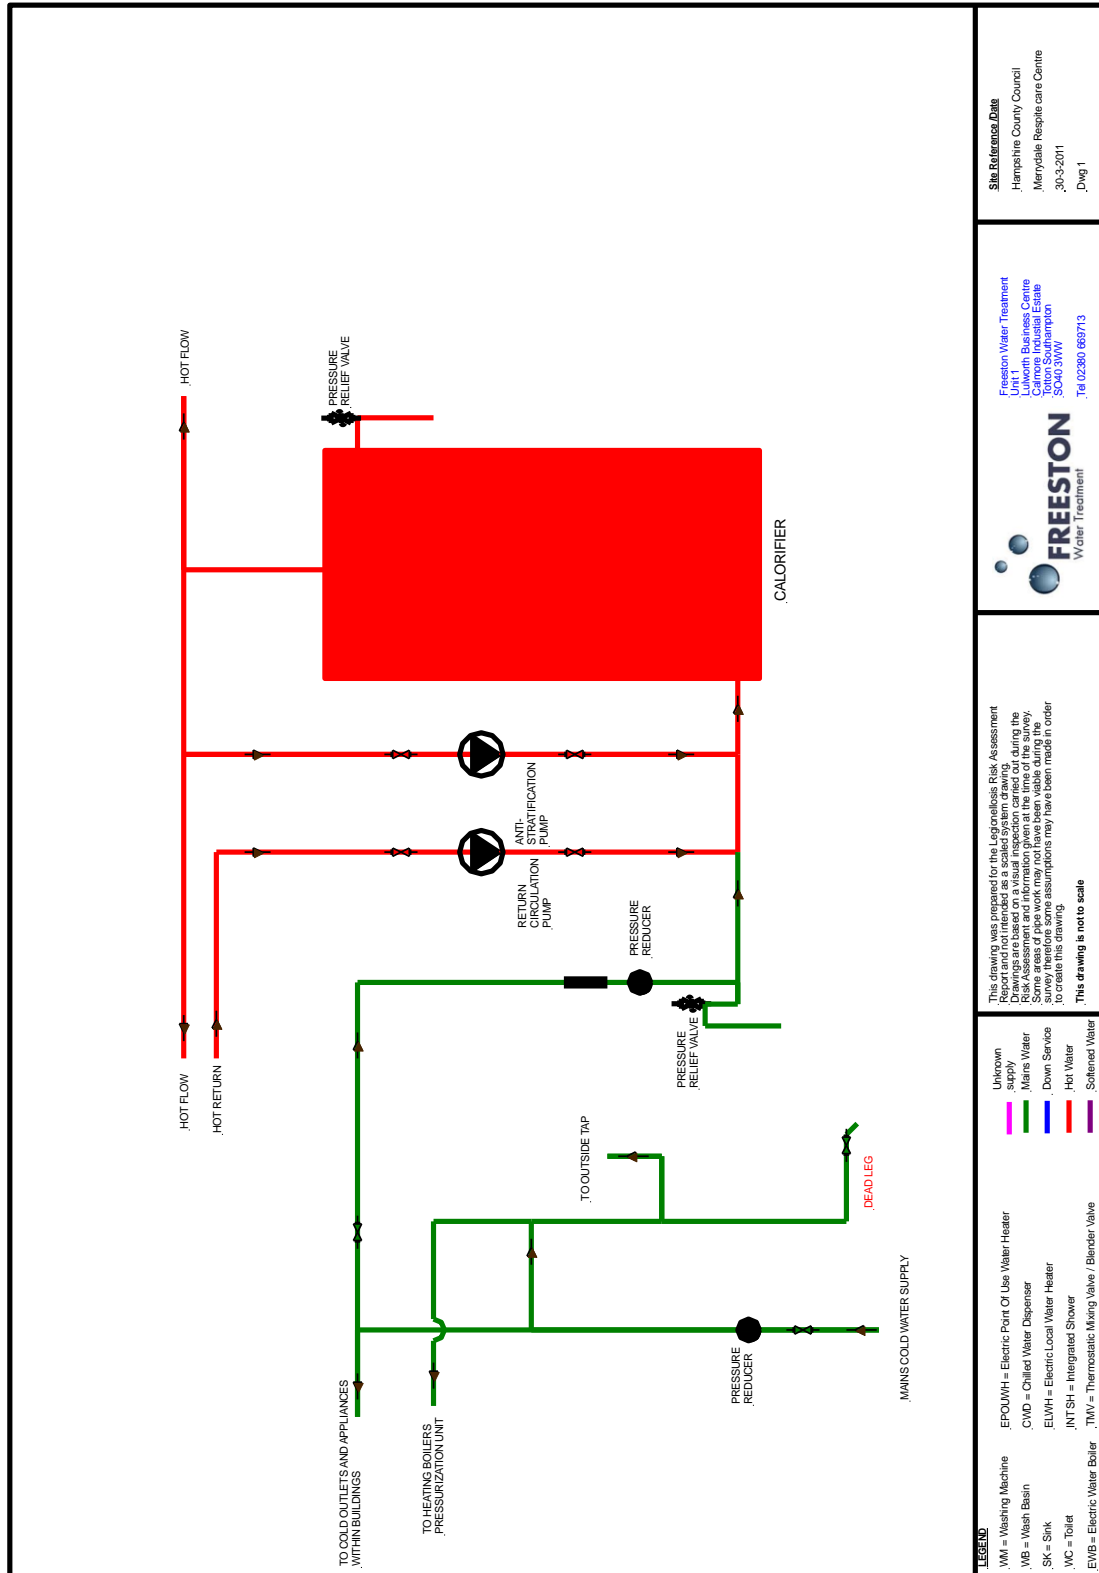
Site Reference/Date
Hampshire County Council
Merrydale Respite care Centre
30-3-2011
_Dwg 1

- Dead leg pipework are ideal areas for the proliferation of bacteria and should be removed or put on a weekly flushing regime (without creating an aerosol) and recorded. Dead legs were found in the following areas:-
 - Boiler Room - There is a drain on the mains cold water pipe that is too long and should be shortened.
 - House 4 Roof Space - There is a capped mains cold water pipe that used to feed the heating boilers feed and expansion tank that should be removed.
 - House 4 Laundry – There is a short pipe protruding through the ceiling which could be a dead leg on the domestic water system.

Site Reference/ Address	Remedial/Recommendations	Priority	Date Actioned	Signature
<u>Distribution</u> HCC Merrydale Respite Care Centre	Investigate possible dead leg in the Laundry. If found to be a dead leg on the domestic water system then remove and record in the logbook when carried out.	5		
	I would recommend Bacteriological and Legionella water samples be taken if the temperatures fall out of the recommended limits.	5		
	Commence weekly flushing of all low use outlets, toilets, showers, outside taps etc and record when carried out.	5		
	Clean and descale showerheads quarterly, or as necessary. Record when carried out.	2		
	Ensure that the inline anti-scale device is cleaned / maintained in line with the manufacturers recommendations.	4		
	Clean, maintain and dose the bubble tube with a safe biocide inline with the manufacturers recommendations.	4
