Customer: Hampshire County Council

Site: Lakeside School
Winchester Road
Chandlers Ford
Hampshire SO53 2DW

Date of Assessment: 7th June 2010

INTRODUCTION

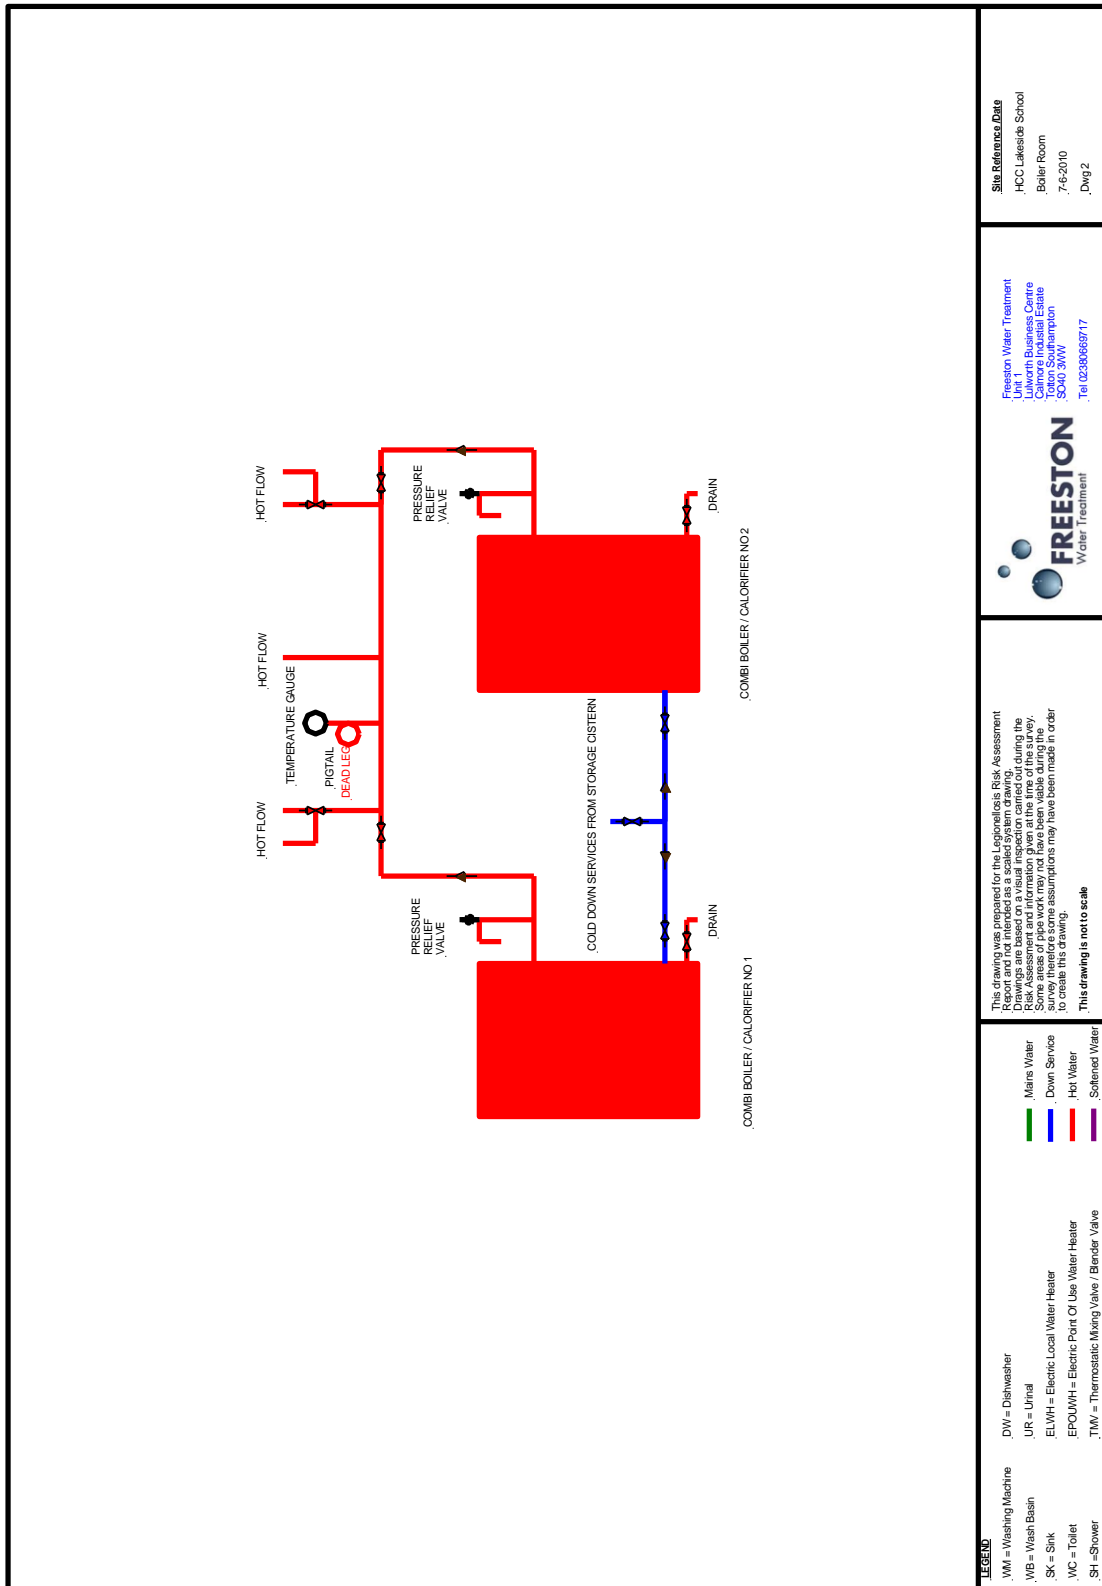
Site Reference/Date
 .HCC Lakeside School
 .Boiler Room
 .7-6-2010
 .Dwg 2

- Main Kitchen on the right side of the dishwasher on the cold pipe
 - Main Boiler Room a pigtail dead leg is on the hot flow pipe.
 - The Headmasters House the water in this building has been isolated but it should be ensured that no dead legs remain from the valve where it has been isolated to the mains cold water underground stop cock.
- The shower heads and hoses must be cleaned and disinfected quarterly and recorded when carried out as recommended in L8. No records could be found and it is unknown if this is being carried out.

- There is a mains cold water fed bib tap in the Boiler Room on the far wall which has a hose pipe attached to it. The hose pipe feeds a hose pipe reel that is fixed to the wall. The hose is un-insulated and in a warm environment this will create ideal conditions for the proliferation of bacteria including Legionella. I would recommend that the hose pipe is fixed as close to the bib tap as possible and is drained after every use before rolling back onto the reel. The hose must be flushed and drained every week when not used.

Site Reference/ Address	Remedial/Recommendations	Priority	Date Actioned	Signature
<u>Distribution</u> HCC Lakeside School	Remove dead leg pipe work or put on a weekly flushing regime and record in the logbook when carried out	5		
	I would recommend Bacteriological and Legionella water samples be taken if the temperatures fall out of the recommended limits.	5		
	Continue weekly flushing of any low use outlets etc and record when carried out.	3		
	Clean and descale showerheads at least quarterly. Record when carried out.	3		
	Ensure all domestic hot and cold pipe work is insulated within the building.	4		
	Re-site the hose reel in the Boiler Room next to the bib tap.	5		
	Ensure that the water softener is serviced and maintained in-line with the manufacturer's recommendations.	3		
	Ensure that the filter on the water cooler is cleaned / replaced in-line with the manufacturer's recommendations.	3
