**Site:** Osborne School  
Athelstan Road  
Winchester  
Hampshire SO23 7GA

**Risk Assessment Consultant:** Mr Chris Wilson MWM Society

**Date of Assessment:** 9<sup>th</sup> June 2010

## INTRODUCTION

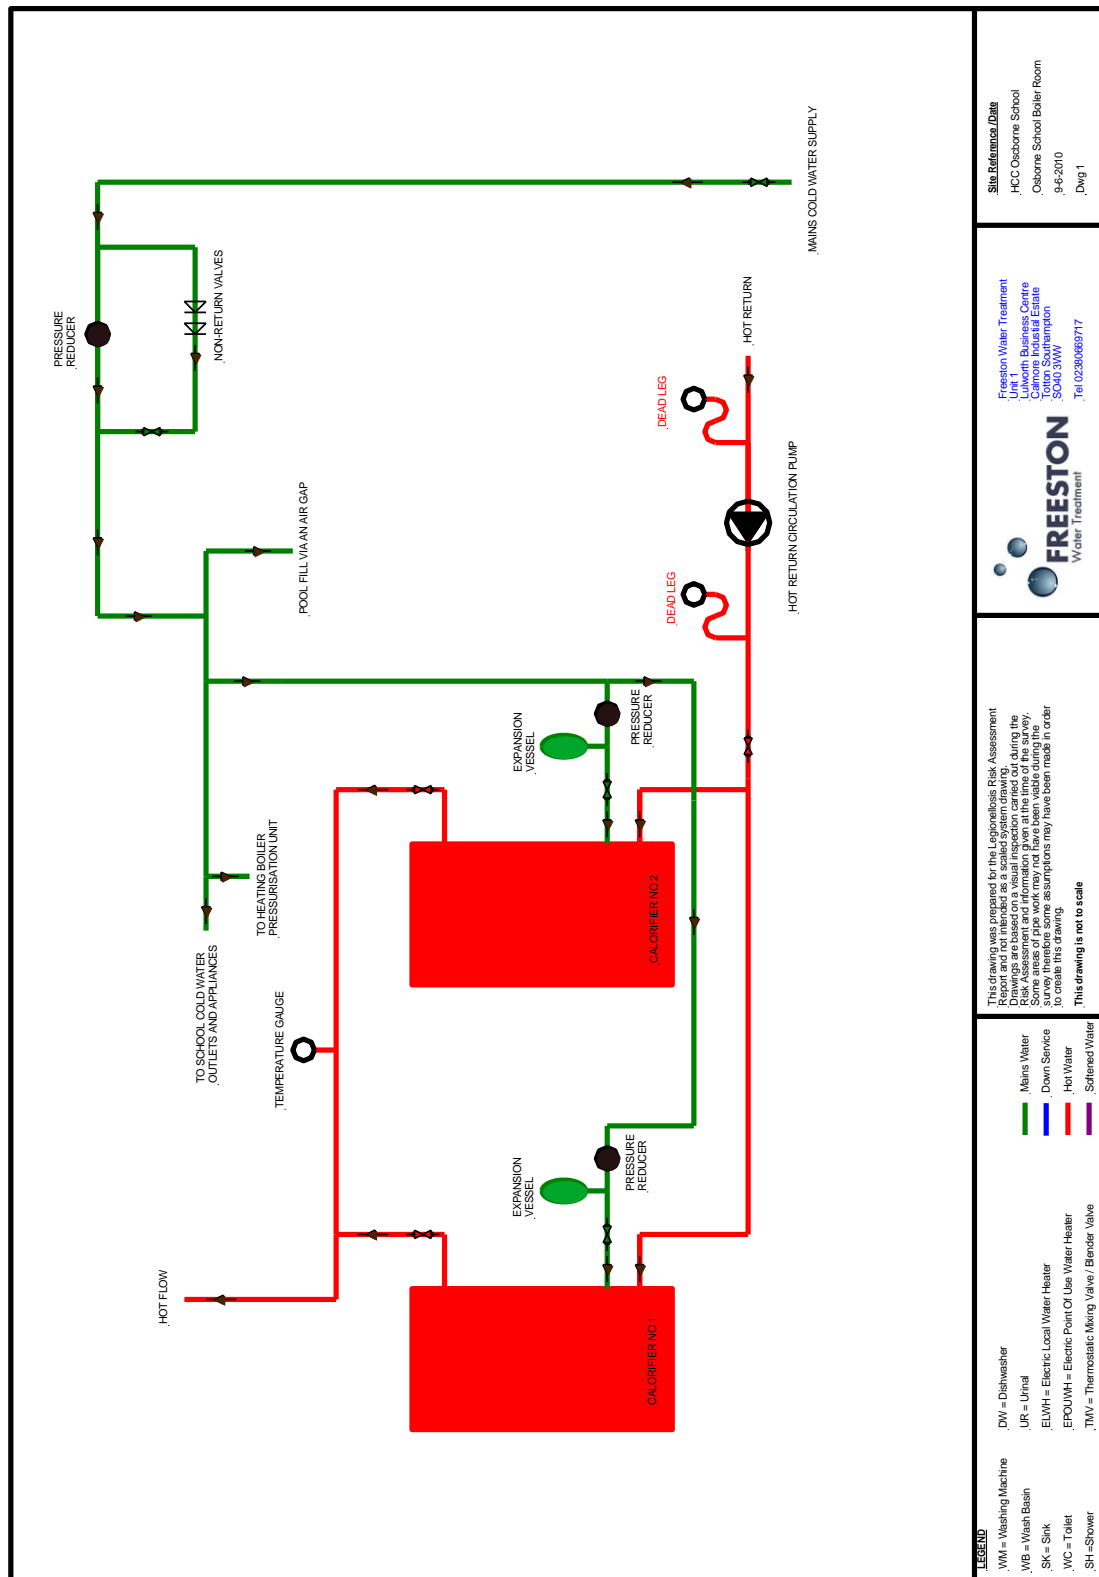
**Site Reference/Date**  
HCC Osborne School  
Osborne School Boiler Room  
9-6-2010  
Dwg 1

- Boiler Room two swan neck type dead leg pipes are on the hot water return pipe.
- Science Prep Room two dead legs were found under the worktop.
- Room 16GY Hygiene Area the WC Sluice has been removed and the pipe work to the taps is still in place albeit with open ends. This should be investigated behind the panels to ensure that no dead legs have been left.
- Hygiene Room adjacent to Room 8WF the shower has no hose, rendering it a dead leg.
- Outside tap near ASD Class this outlet is never used.
- Ground Floor Hygiene Room next to room 7JS there was no water from the sink possibly rendering it a dead leg. This should be investigated further.

Site Reference/ Address	Remedial/Recommendations	Priority	Date Actioned	Signature
<u>Distribution</u> HCC Osborne School	Remove dead leg pipe work or put on a weekly flushing regime and record in the logbook when carried out	5		
	I would recommend Bacteriological and Legionella water samples be taken if the temperatures fall out of the recommended limits.	5		
	Commence <b>weekly</b> flushing of any low use outlets etc and record when carried out.	5		
	Clean and descale showerheads at least quarterly. Record when carried out.	3		
	Ensure all domestic hot and cold pipe work is insulated within the building.	2		
	Commence monthly temperature monitoring of the domestic cold water systems; sentinel outlets. Record within a logbook.	5
