Homewood

INTRODUCTION

This report relates to a **Review** of the Legionella Risk Assessment that was carried out by Freeston Water Treatment in April 2009; this is the latest Risk Assessment for this building. The Review Survey was carried out at Homewood, Enham Lane, Charlton, Andover, Hampshire SP10 4AN. The Review of Recommendations highlighted in the previous Risk Assessment was undertaken in order to comply with the Health and Safety Executive requirements on the control and prevention of Legionellosis. This Review has been carried out as asked for by Hampshire County Council in accordance with ACoP L8 'The control of Legionella bacteria in water systems' (APPROVED CODE OF PRACTICE & GUIDANCE) only:

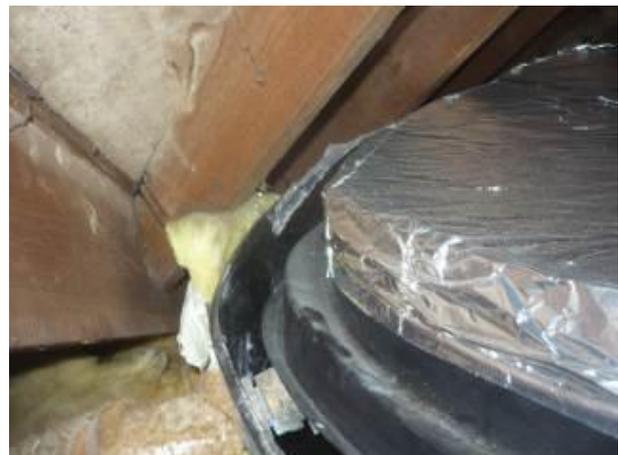
Some water storage tank lids do not fit properly due to the roof beams; recommend this is addressed to prevent any ingress of contaminants.

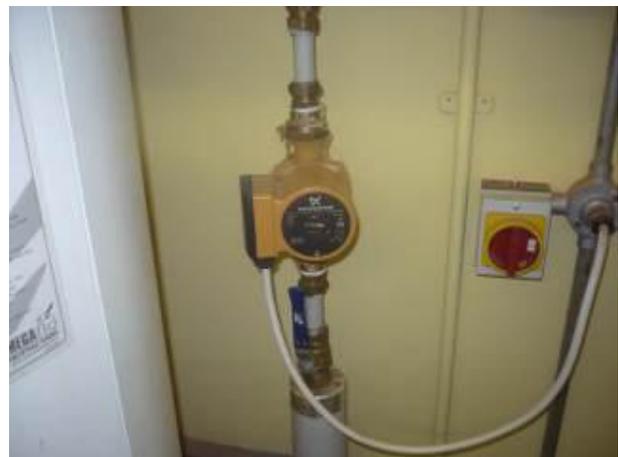
Calorifier hot water circulating / return pump. Good return temperatures recorded at the time of this Review.
