CONTENTS

Client Address	Hampshire County Council PBRS Three Minsters House 76 High Street Winchester Hampshire SO23 8UL
Site Name	Solent Mead OPH & Day Centre
Site Address	Church Lane Lymington Hampshire SO41 3RA
Site contact	Tina Britton
Site telephone number	01590 674687
Last risk assessment carried out by	Freeston Water Treatment Limited
Date of risk assessment	April 2011
Date of previous review	N/A
Date of new review	26th March 2012
Review carried out by	Mr Chris Wilson

This Review has been carried out in accordance with ACoP L8 'The control of Legionella bacteria in water systems' (APPROVED CODE OF PRACTICE & GUIDANCE) and BS 8580 (RISK ASSESSMENTS FOR LEGIONELLA CONTROL-CODE OF PRACTICE).

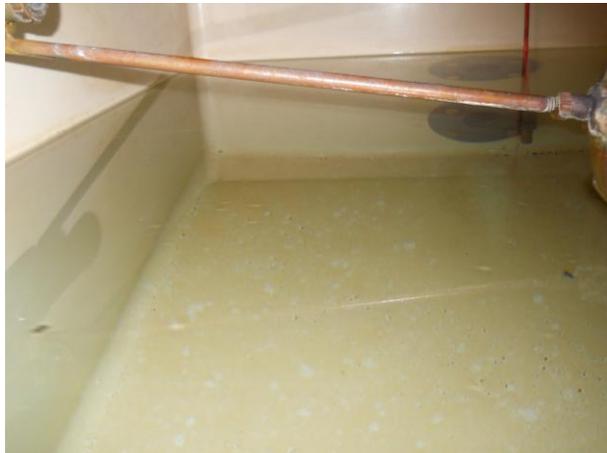
The inside of the tank showed a light deposit of sediment on the base and a slight amount of biofilm on the sides.

Sediment, corrosion and biofilm act as nutrients and an ideal environment for the proliferation of bacteria including legionella.

Internal view of cold water storage tank no. 1.

ACoP L8 recommends that domestic cold water storage tanks are inspected annually and cleaned and disinfected if required. I would recommend that this vessel is cleaned and disinfected within the near future.

- Commence six monthly temperature monitoring of the cold water storage tanks and record the results within the logbook.
- Clean and disinfect the domestic cold water storage tanks within the near future. Inspect the tanks annually and repeat if required.

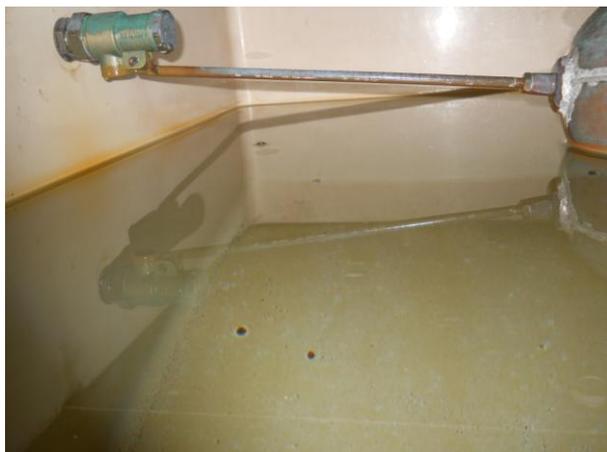
The inside of the tank showed a light deposit of sediment on the base and a slight amount of biofilm on the sides.

Sediment, corrosion and biofilm act as nutrients and an ideal environment for the proliferation of bacteria including legionella.

Internal view of cold water storage tank no. 2.

ACoP L8 recommends that domestic cold water storage tanks are inspected annually and cleaned and disinfected if required. I would recommend that this vessel is cleaned and disinfected within the near future.

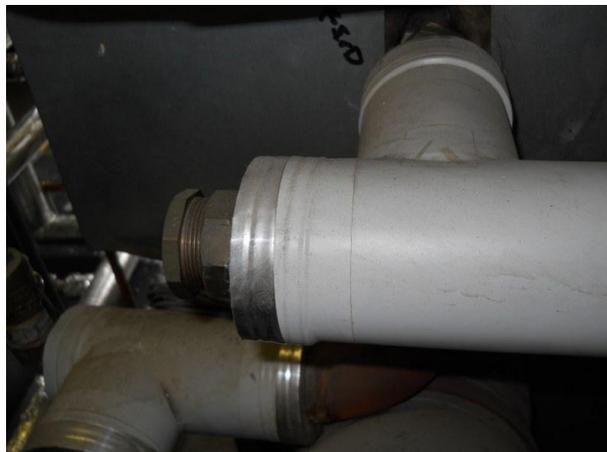
Dead leg on the cold fill pipe to calorifier no. 1.

- Dead leg pipework are ideal areas for the proliferation of bacteria and should be removed or put on a weekly flushing regime (without creating an aerosol) and recorded. Dead legs were found in the following areas:-

- Boiler Room - There is a dead leg on the cold feed pipe as it enters calorifier no. 1.
 - Boiler Room - The drain on the pipe to the cold water expansion vessel is too long and creating a dead leg.

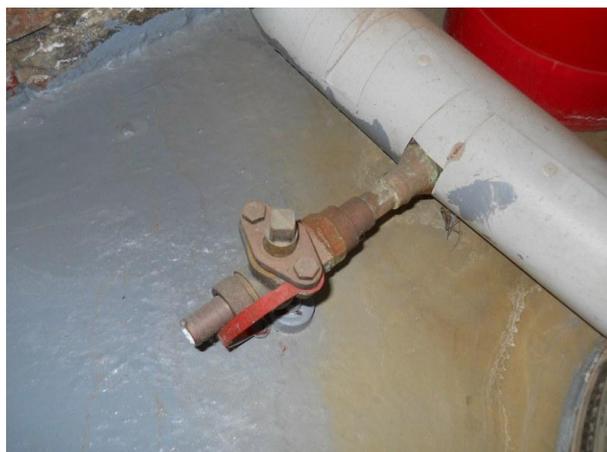
Boiler Room

Dead leg on the drain pipe to the cold water expansion vessel.
