**Site: Brixham Marina
Berry Head Road
Brixham
Devon TQ5 9BW**

Date of Review: 30th January 2013

This report relates to the Second Legionella Risk Assessment Review carried out by Mr Chris Wilson of Freeston Water Treatment Ltd on the 30th January 2013 on behalf of Marina Developments Ltd.

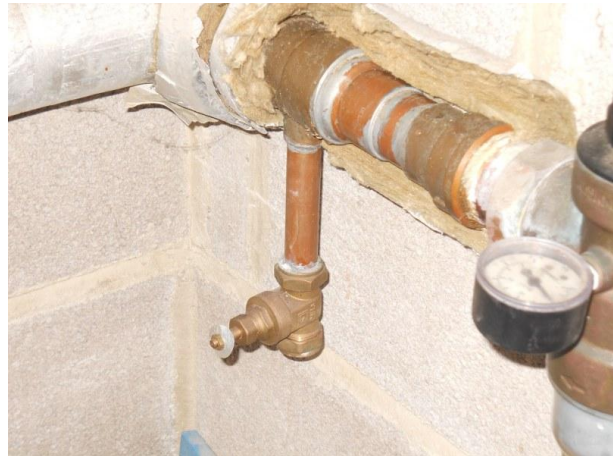
- There is insulation missing on pipe work and I would recommend that the pipes are adequately insulated to prevent heat loss / gain.
- Dead leg pipe work is an ideal area for the proliferation of bacteria including legionella and should be either removed as soon as is practicable or put on a weekly flushing regime (without creating an aerosol) and recorded in the logbook. Dead legs were found in the following areas:-

- Plant Room - On the mains cold water pipe to the right of the right side calorifier.
 - Plant Room - On the Chemical WC mains cold water supply pipe.

Dead leg on the mains cold water pipe.

Remove all dead legs or put on a weekly flushing regime and record in the logbook.

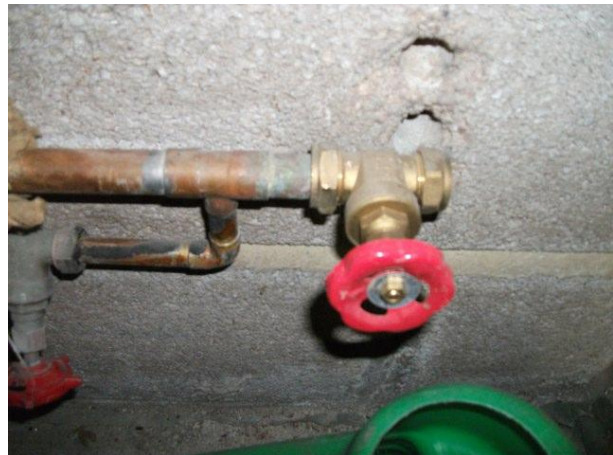
- Plant Room - On the end of the hot water return pipe to the right of the right side calorifier.

Dead leg on the hot return pipe.

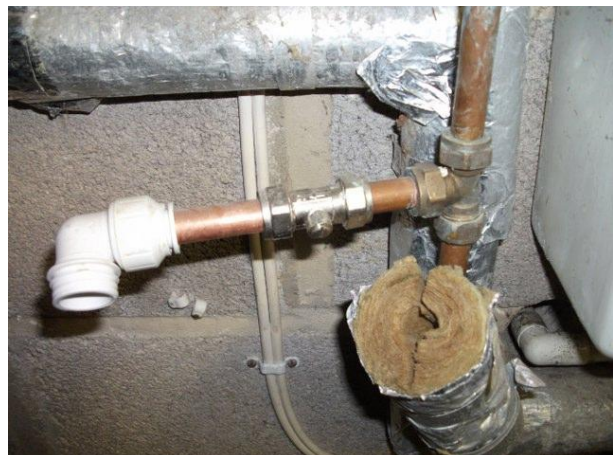
Plant Room

Dead leg on the chemical toilet WC mains supply pipe.

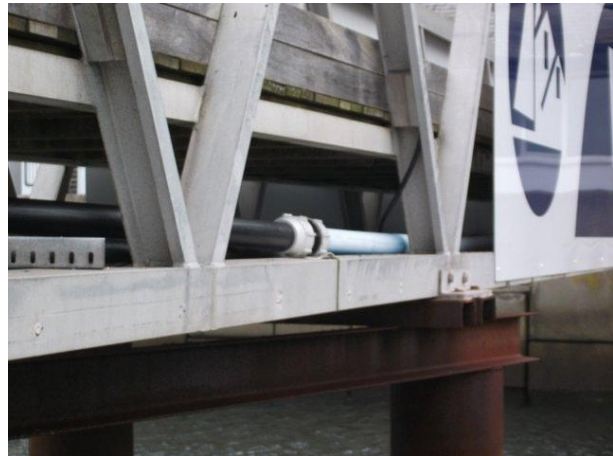
- The Pontoon hose reels are supplied by blue UPVC type plastic water hoses that run along the side of the pontoons. These are un-insulated and I would expect the water temperature in the summer to exceed the recommend maximum of 20.0°C, as outlined in L8. I would recommend that temperature monitoring and flushing of the hoses are carried out as regularly as needed to keep the water temperature to below 20.0°C or the pipework be adequately insulated.

Uninsulated mains cold water pipe.

Flush pontoon hoses as often as necessary to keep the cold water temperature to below the maximum temperature of 20°C as outlined in ACoP L8 or adequately insulate the pipework.	5
