**Redbridge Primary School**

**Review Photographs**

**10<sup>th</sup> February 2017**

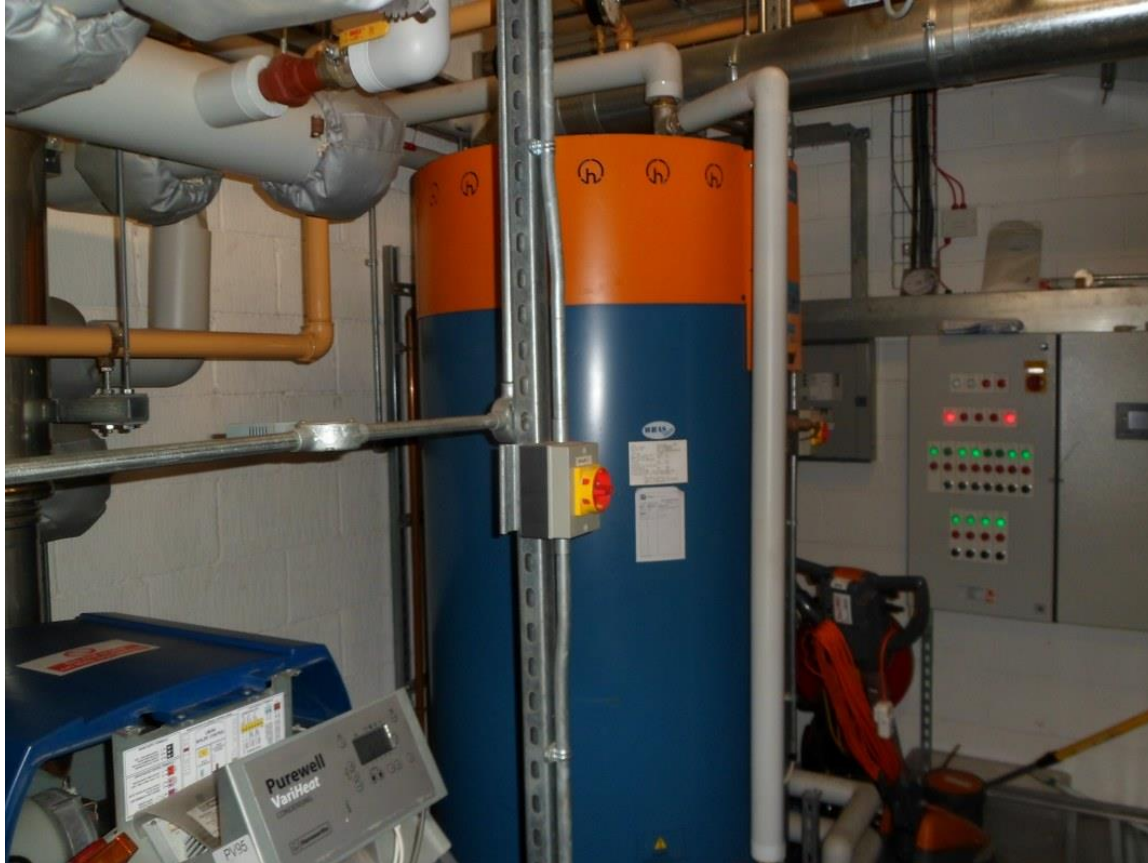
## Hot Water Calorifier

The hot water calorifier serving all hot water outlets in the school was found to have good storage and return temperatures; records seen indicate these are normally good.

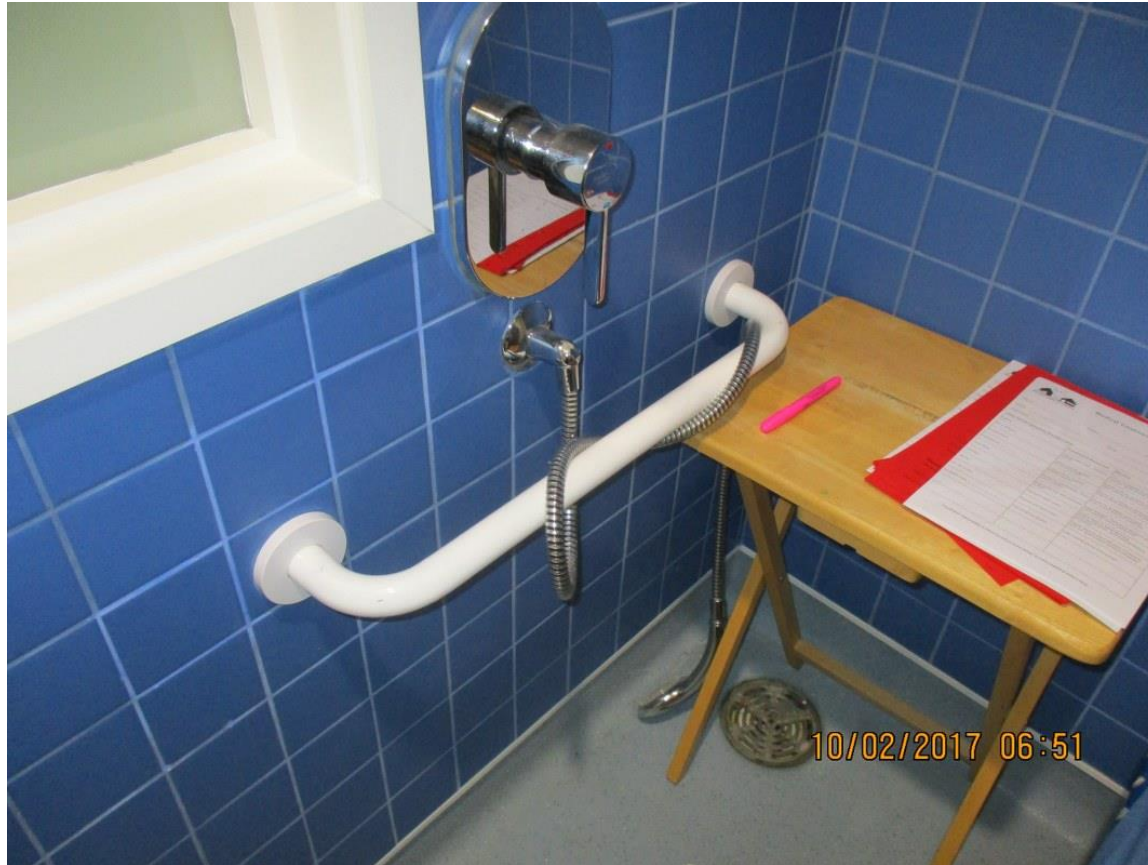
## **Accessible Toilet Shower**

The accessible toilet shower is being flushed on a weekly basis and this is being recorded in the site managers folder located in the site managers office.

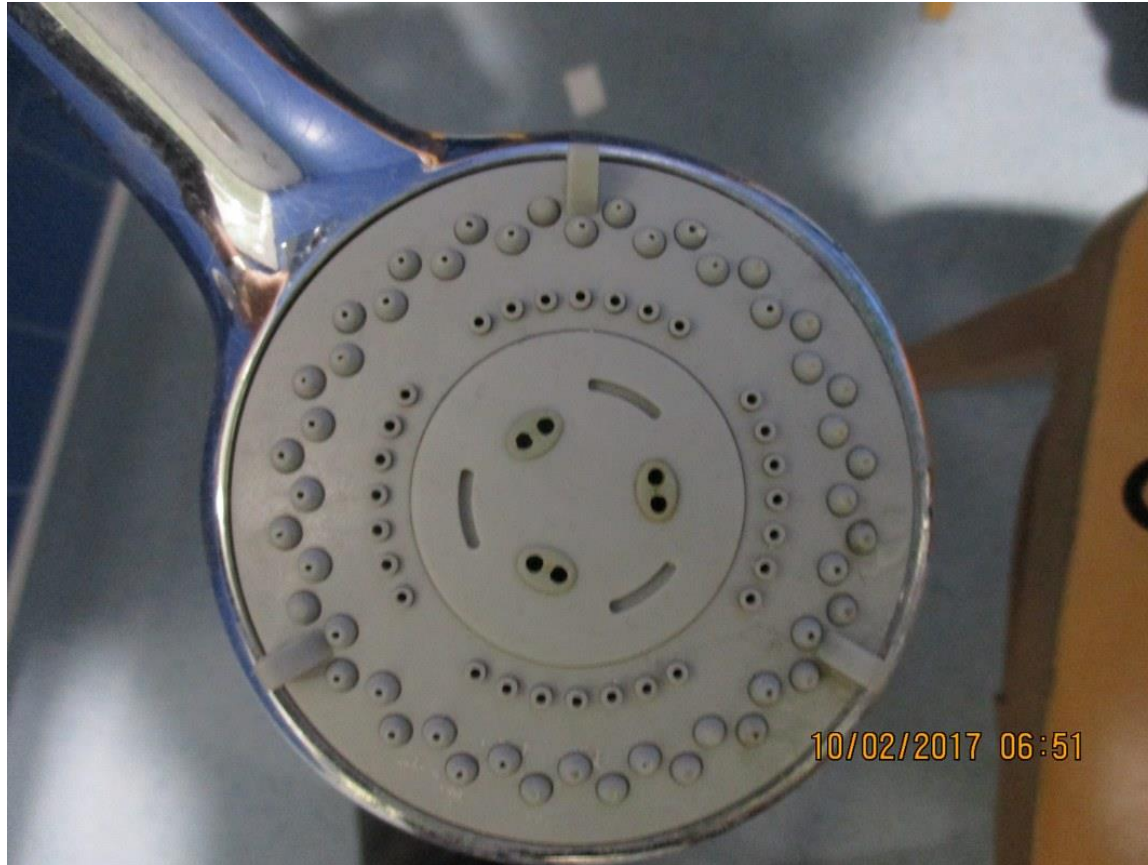
## Showerhead

The accessible toilet showerhead is being cleaned on a quarterly basis by the site manager; this is being recorded in the site managers folder located in the site managers office when carried out.

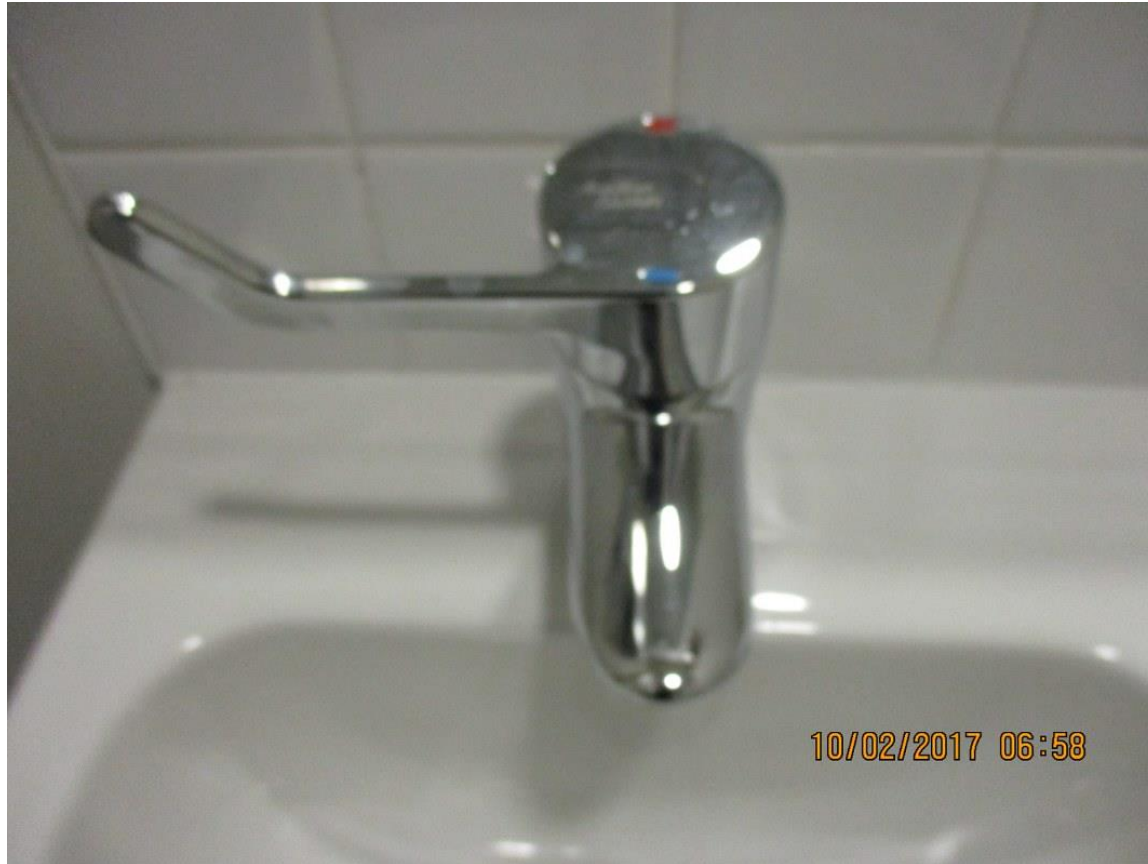
## **TMV Tap Outlets**

TMVs within the school are being serviced and maintained on a six monthly basis; this is recorded in the water systems logbook when carried out. Records seen at the time of this 2017 review indicate this was last carried out in August 2016.

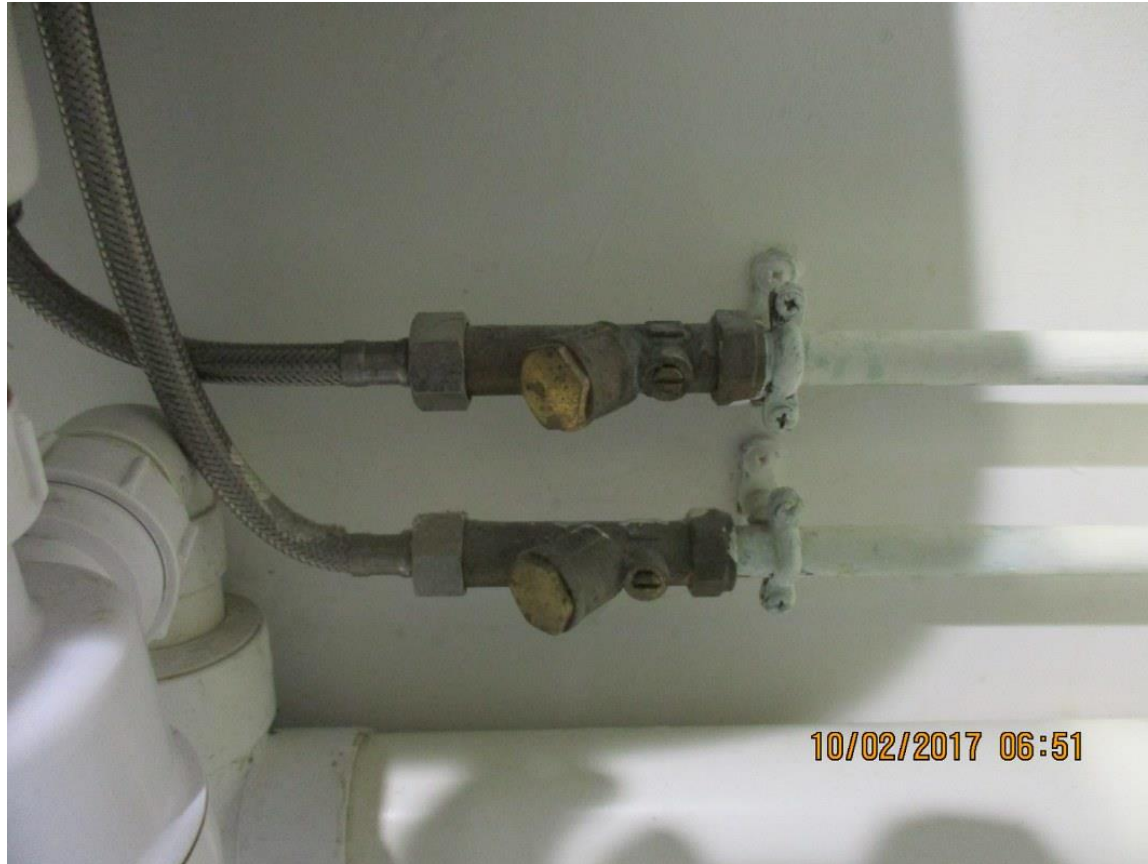
## **Inline Strainers**

Inline strainers are fitted on supplies to the TMV taps; these should be cleaned as part of the service and maintenance schedule as these are ideal areas for bacteria proliferation; no records were seen at the time of this 2017 review to indicate this is being carried out.

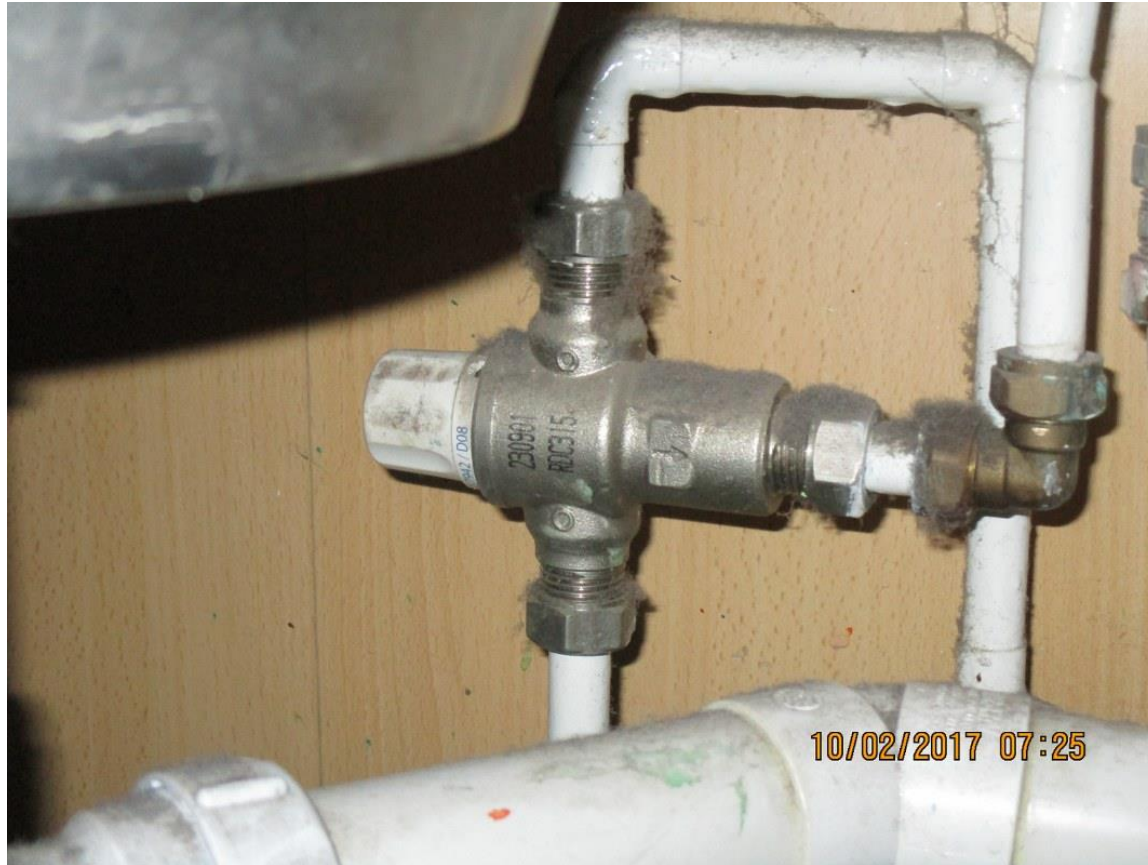
## TMVs

TMVs within the school are being serviced and maintained on a six monthly basis; this is recorded in the water systems logbook when carried out. Records seen at the time of this 2017 review indicate this was last carried out in August 2016.

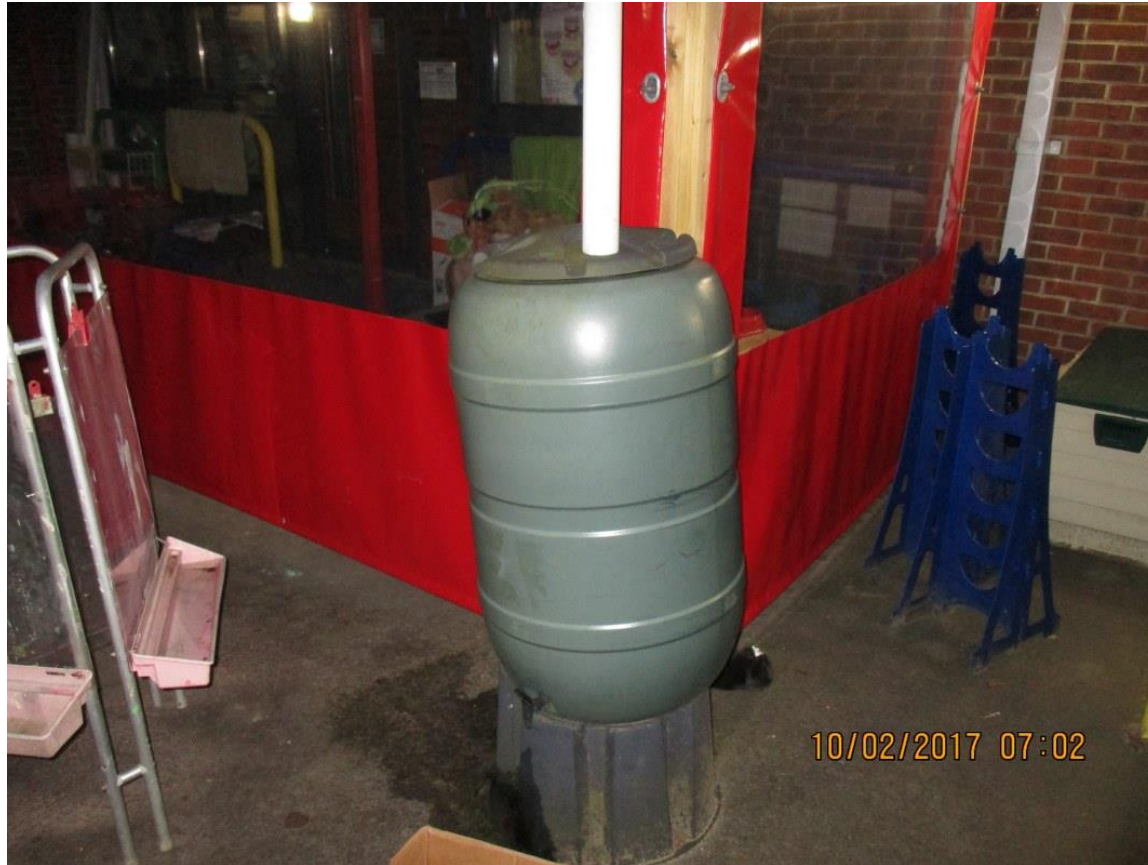
## **Water Butts**

Water butts are being used to store water for watering flowers etc; ensure the water barrels are cleaned out on a regular basis as ideal areas for bacteria proliferation.

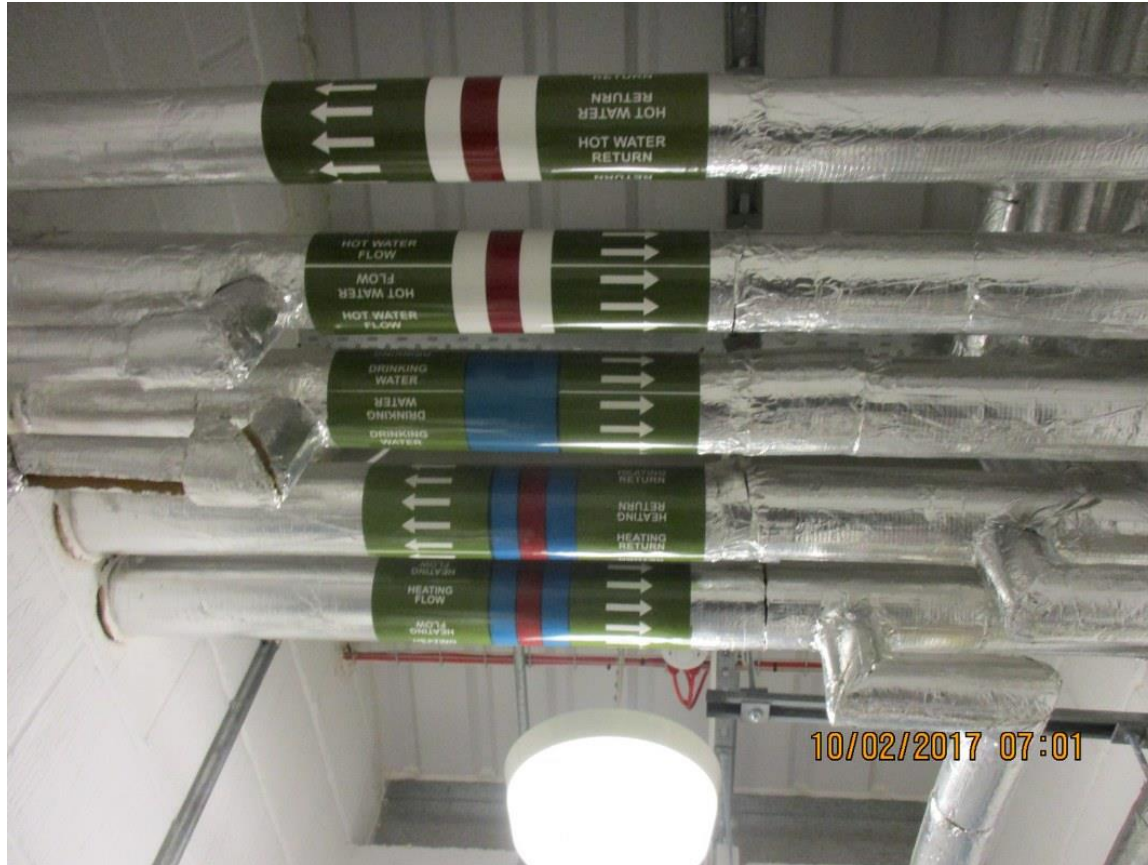
## Insulation

Domestic water pipe runs within the school were seen to be well insulated to protect from heat gain / loss.
