Bassett Green Primary School

Water System Drawings

12th November 2018

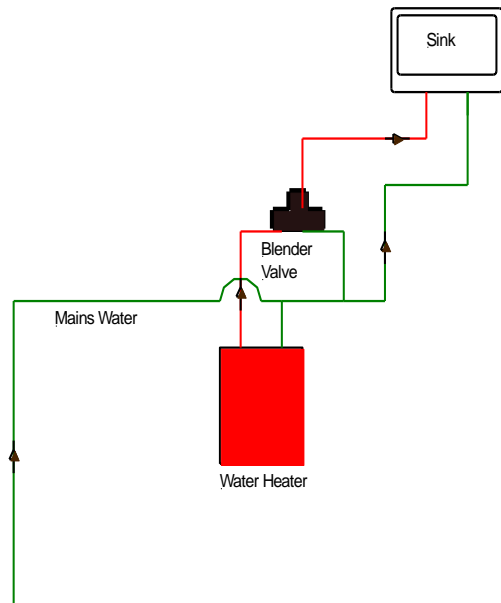
Drawing No.8A

No Hot Water was available at the time of this 2018 Review the water heater was switched on and should therefore be investigated; very poor flow of water from outlets

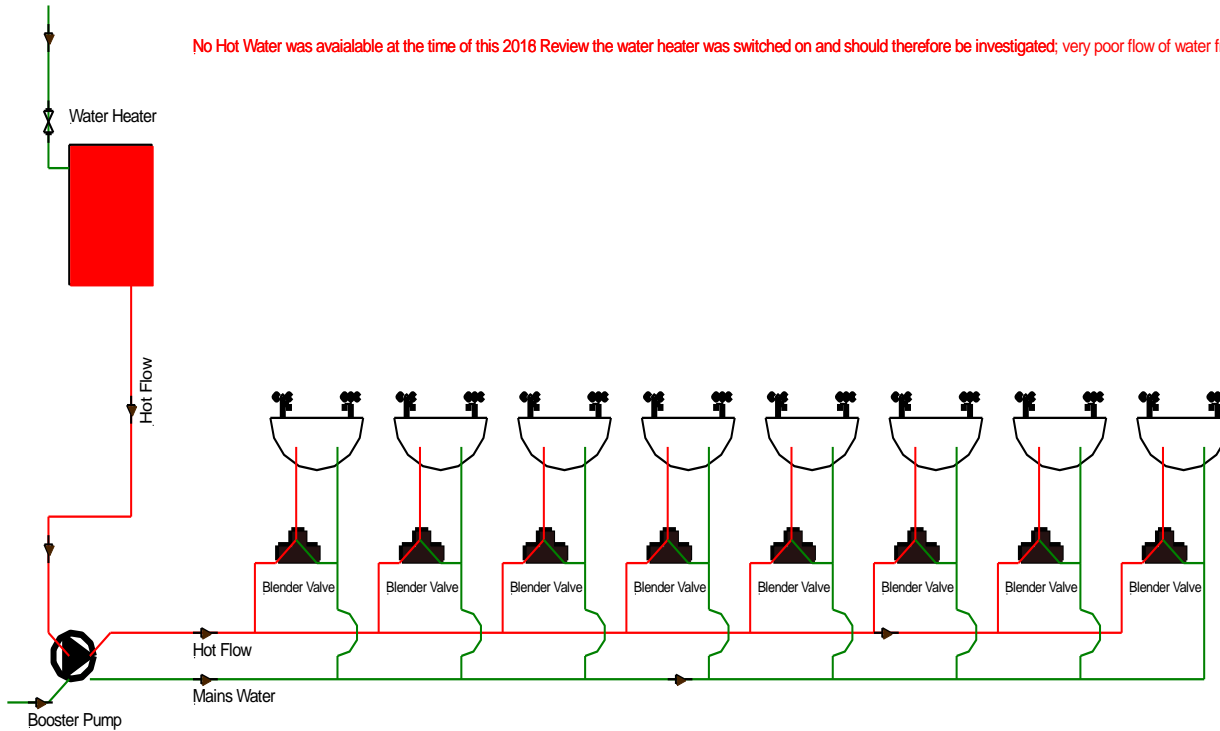
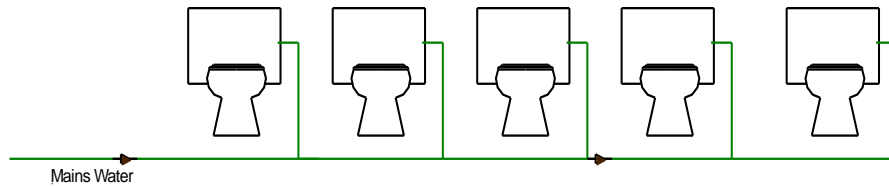
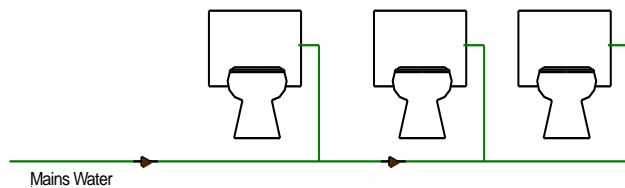
Drawing No.9

No hot water at the time of this 2018 review; water heater switched off; very poor flow of water at the outlets and should be investigated.

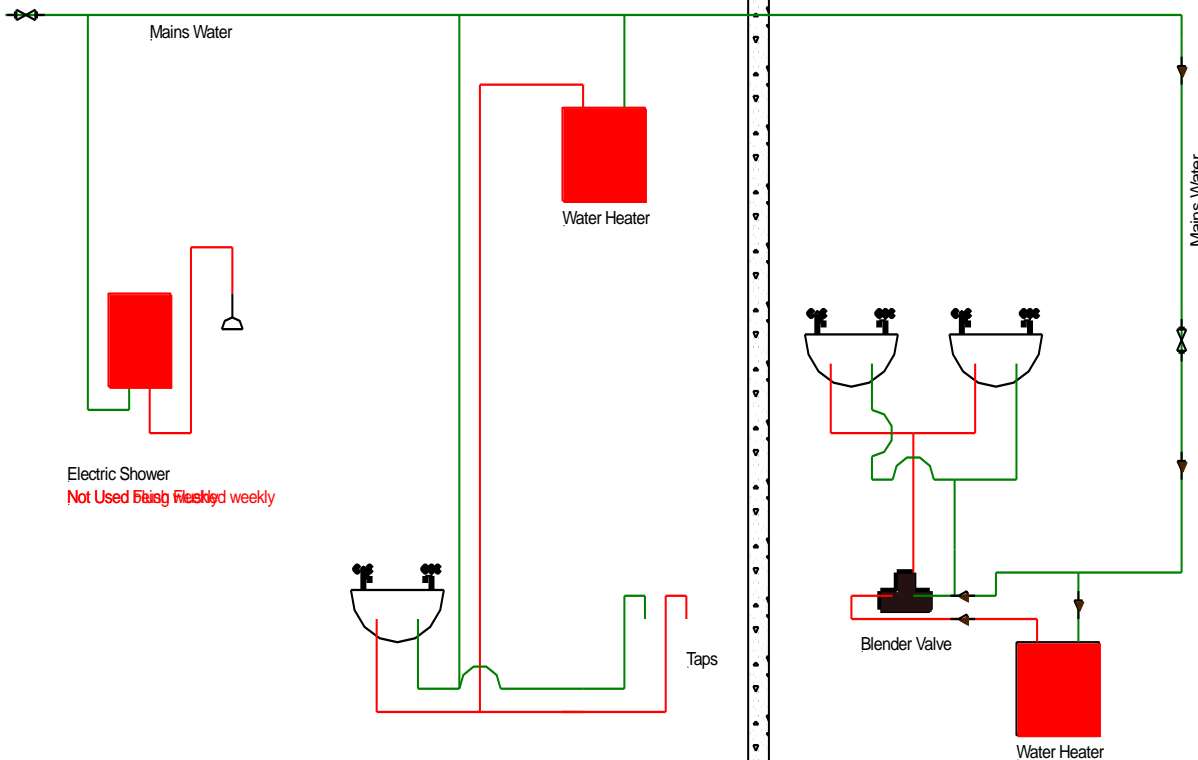
Drawing No.12A

Electric Shower
 Not Used Being Flushed weekly

Toilet
 Toilet area being used for storage; outlets are not being used and should be flushed weekly
