**Harefield Pre-School (Hoppers)  
& Sure Start  
Review Photographs  
4<sup>th</sup> September 2018**

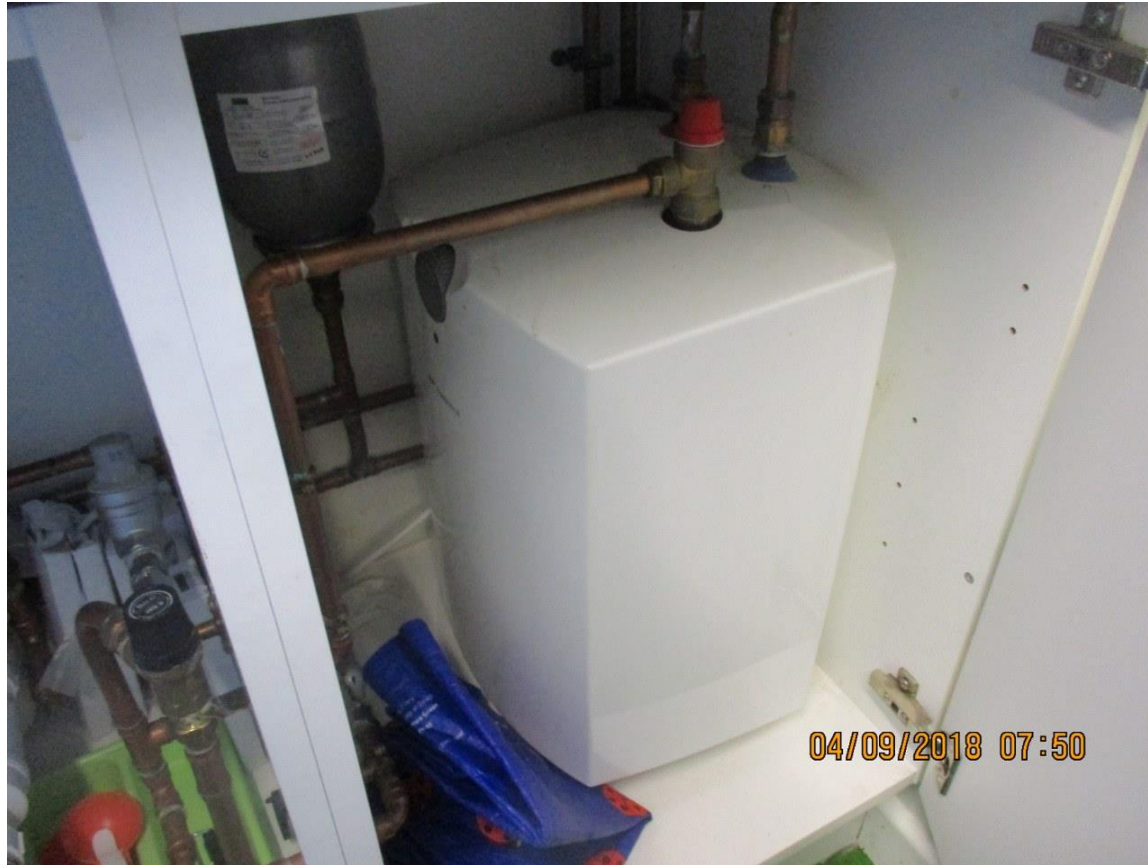
## Local Water Heaters

A typical local water heater serving hot water outlets within the Pre-School and Springwell Sure Start areas; these water heaters have no greater than 15 litre capacity and should therefore operate at 50.0C-60.0C.

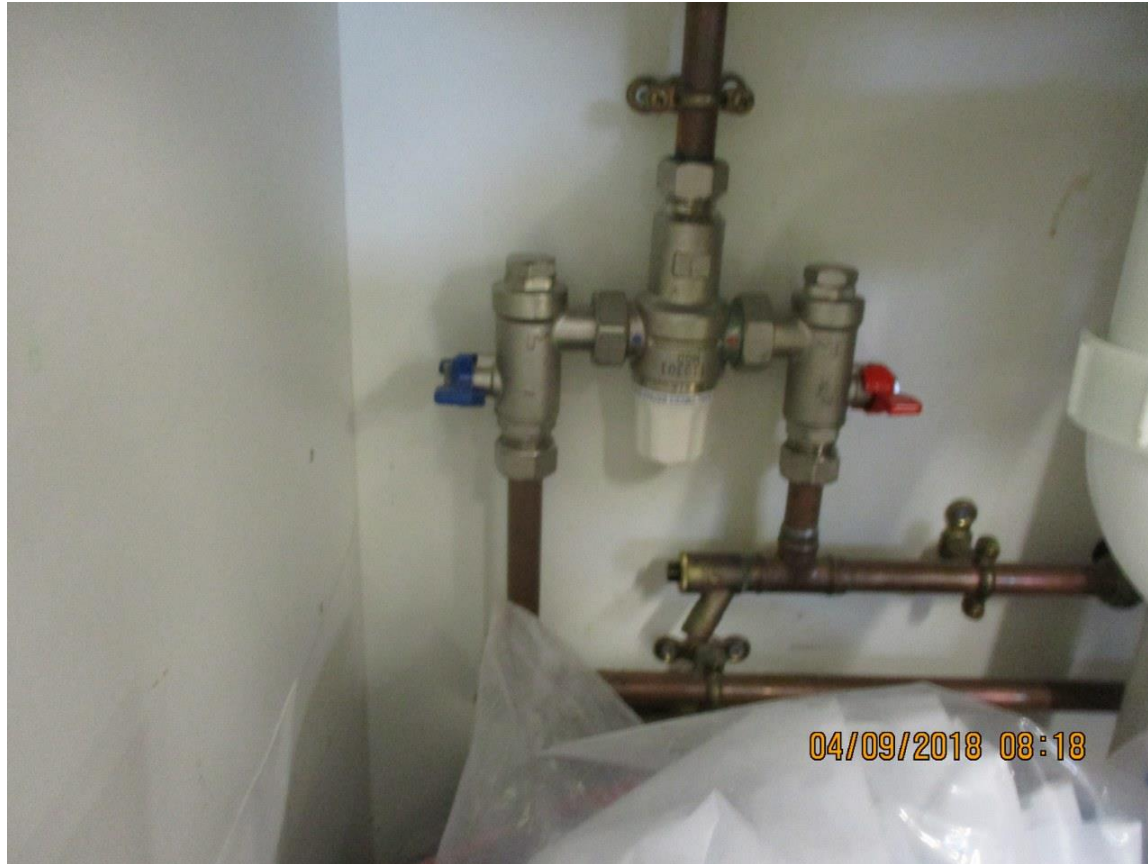
## **Deadleg Area / Pipe Work**

The two sinks in the Springwell hall area have been isolated creating deadleg pipe work on the hot and cold water systems; it is unknown why these have been isolated and should be investigated at the earliest opportunity.

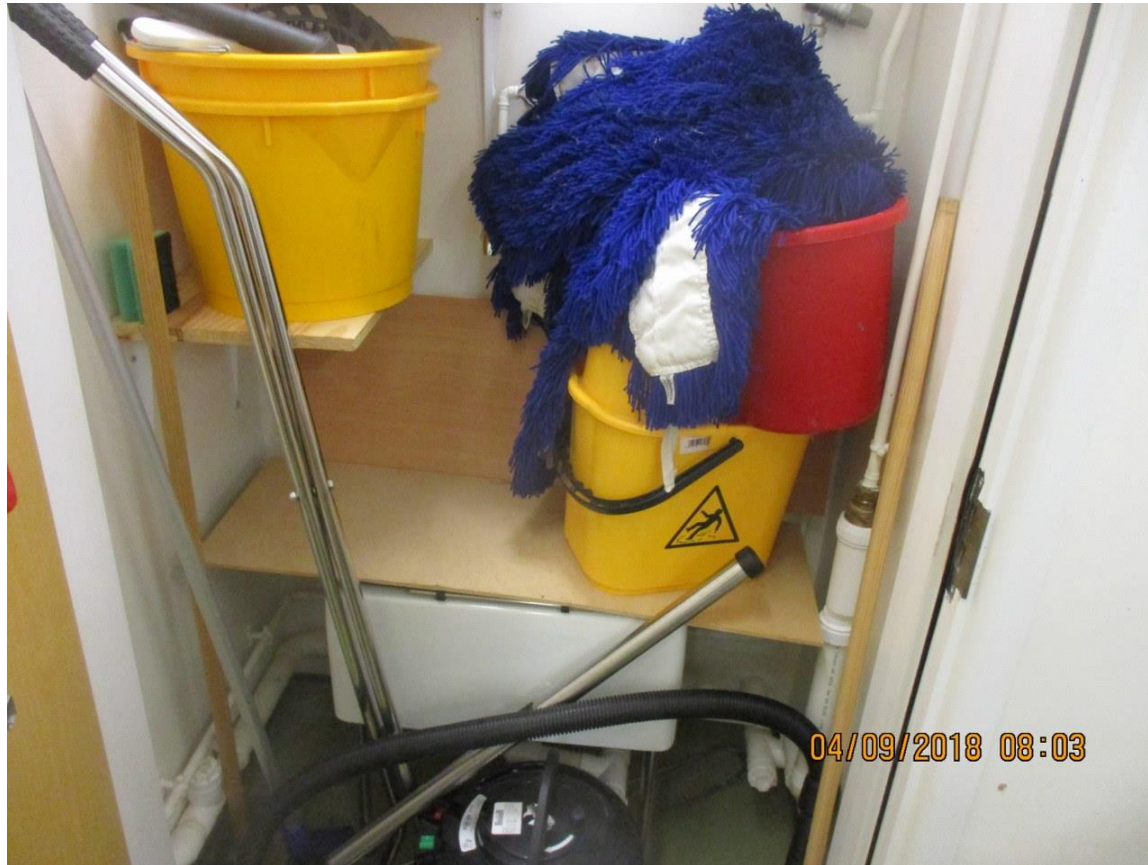
## **Cleaners Sink Infrequently Used Outlet**

I was informed the cleaners sink is not used but is being flushed although no records were seen for this; it should be ensured that weekly flushing infrequently used outlets is recorded in the logbook documentation when carried out.

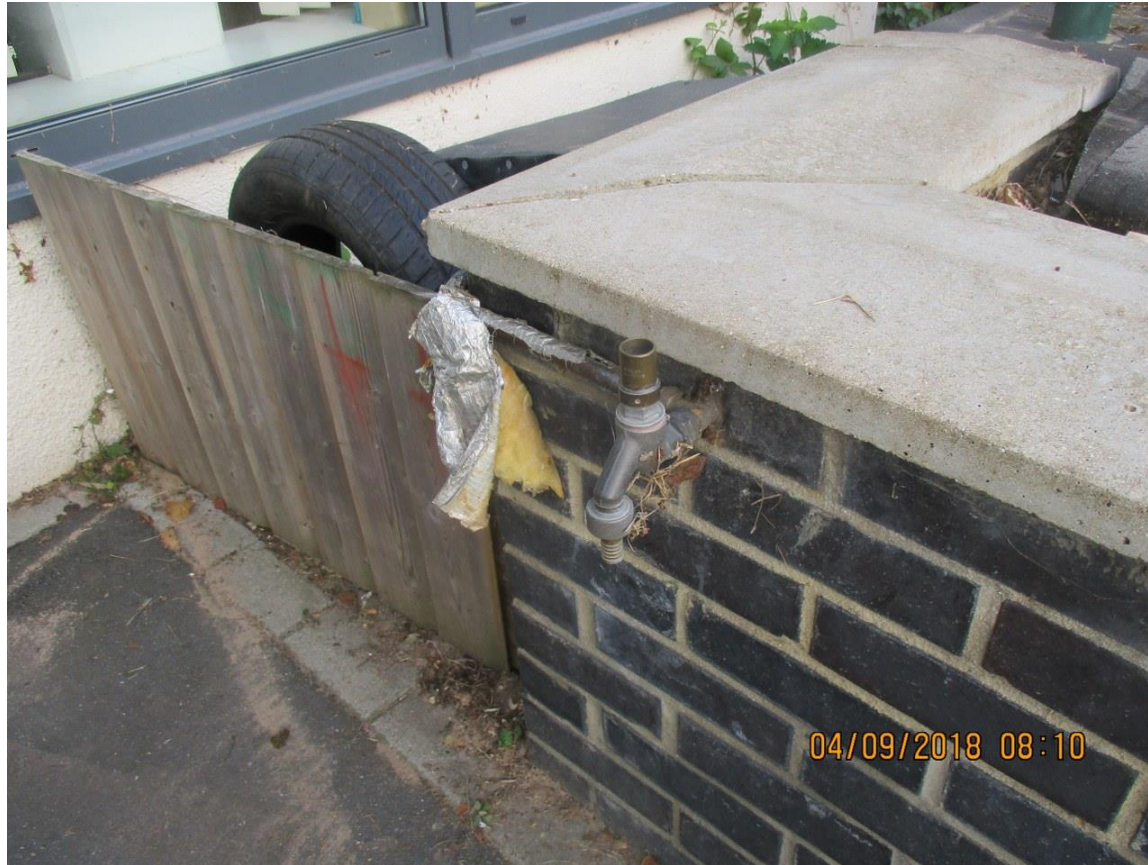
## **Outside Tap Infrequently Used Outlet**

Although the outside tap is being flushed monthly by the monitoring contractors it should be flushed and recorded in the logbook on a weekly basis.

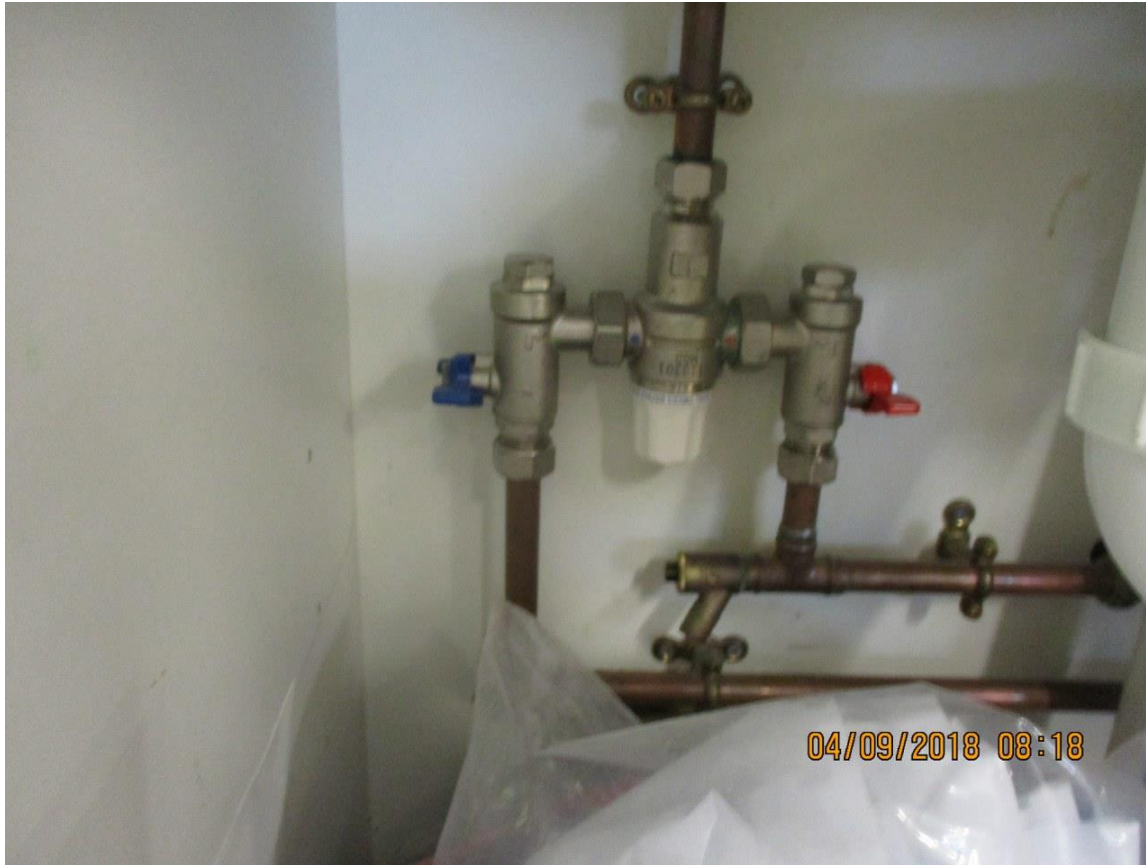
## **TMVs**

TMVs are fitted at most outlets within the building; records seen in the logbook documentation at the time of this 2018 review indicate these were last serviced and adjusted in March 2018; this is being carried out on a six monthly basis and is therefore due again this month.
