Maybush Local Housing Office

Water System Drawing

9th August 2018

Site Ref
Maybush Local Housing Office
Water Systems Layout

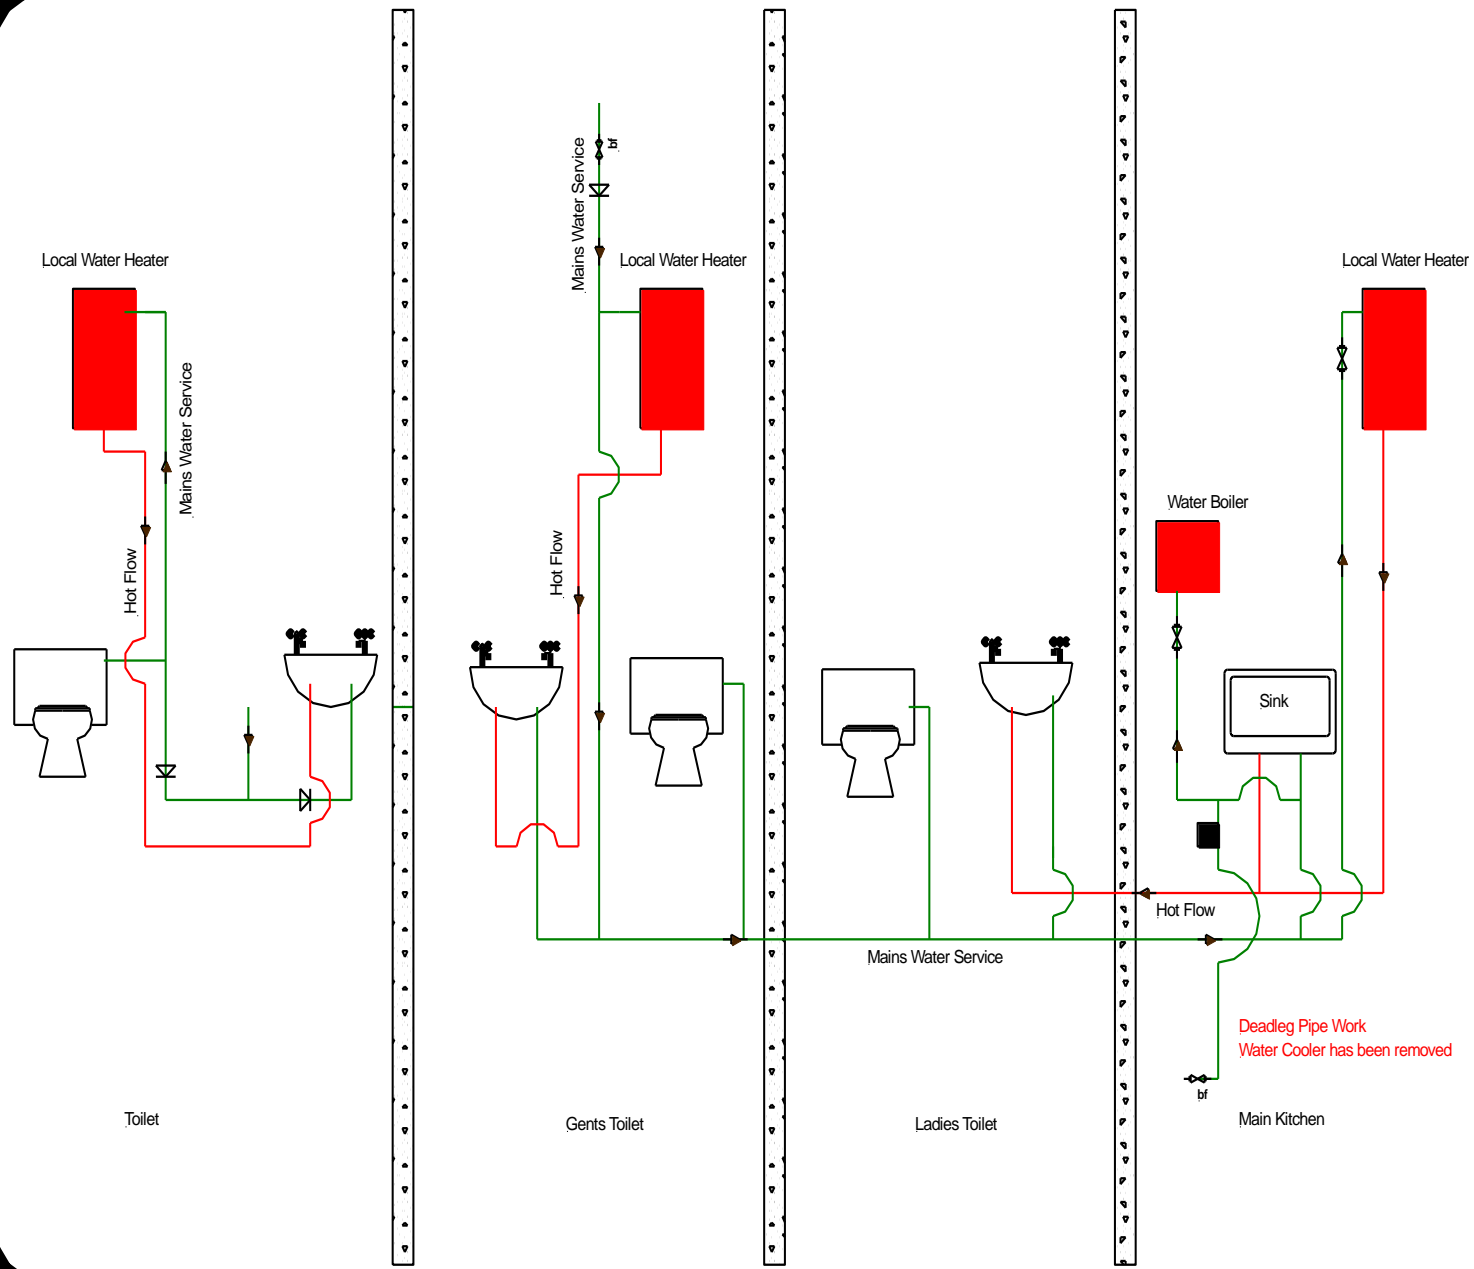
Drawing No.1

This drawing was prepared for the Legionellosis Risk Assessment Report and not intended as a scaled system drawing. Drawings are based on a visual inspection carried out during the Risk Assessment and information given at the time of the survey. Some areas of pipe work may not have been visible during the survey therefore some assumptions may have been made in order to create this drawing. This drawing is not to scale.
