Shirley Library & Housing Office

Review Photographs

19th March 2018

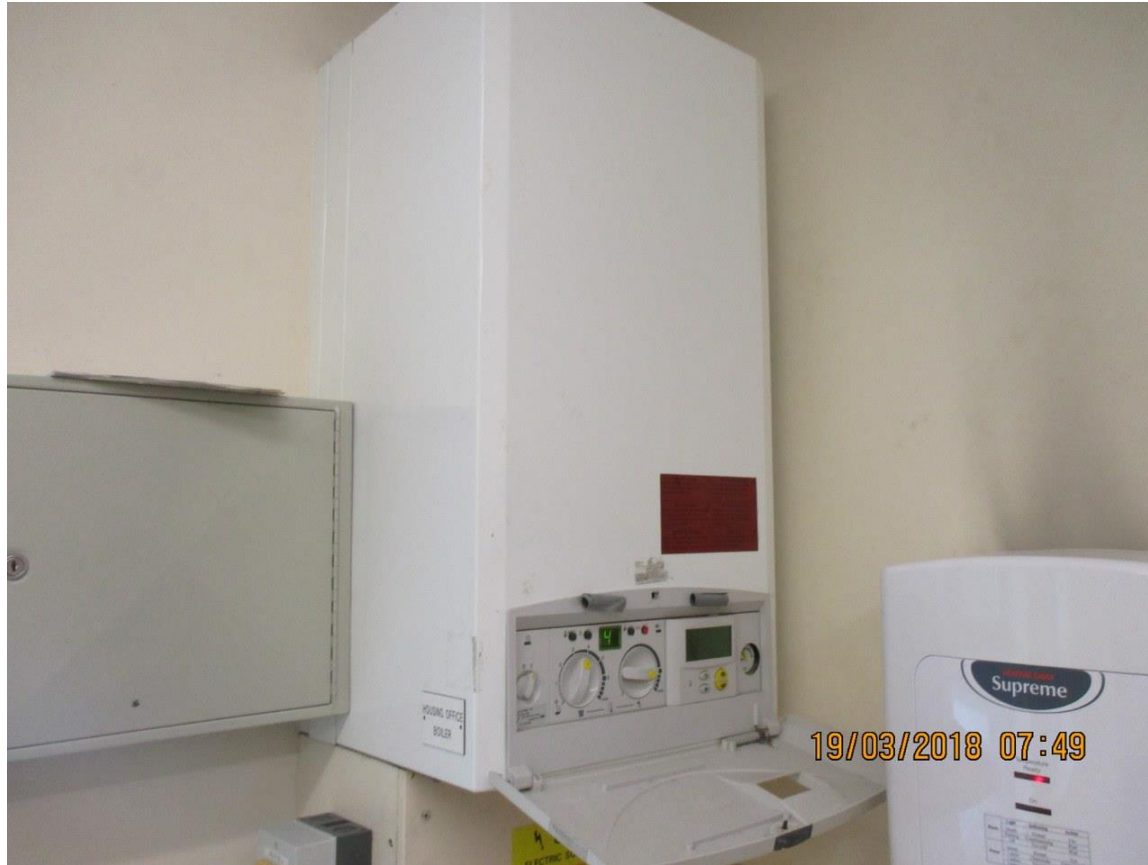
Mess Room Combination Boiler

The combination boiler serving the staff room and toilet areas; the boiler does not maintain 50.0C or more at the furthest outlets in the ladies and accessible toilets after running for over three minutes; investigation required.

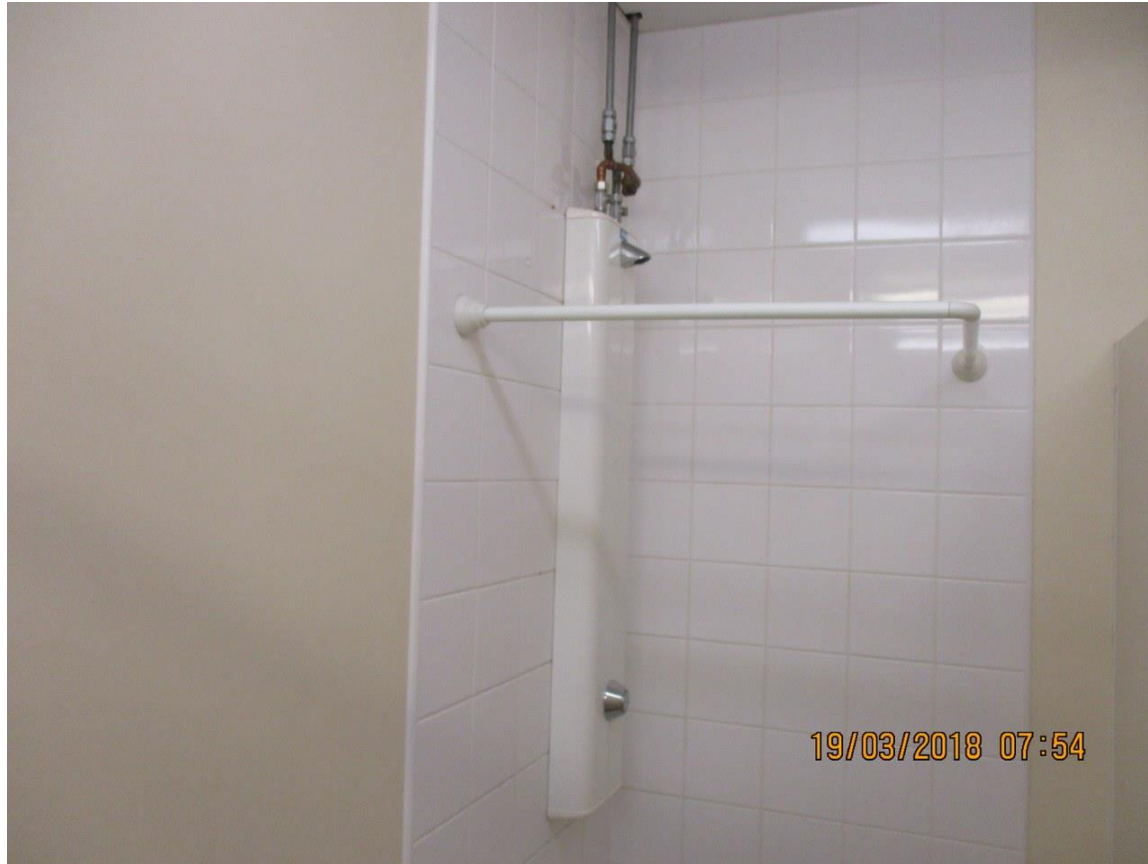
Showers

The showers within the ladies and gents toilet areas are infrequently used therefore should be flushed weekly; records seen indicate these are being flushed monthly by the contractors; consider removal along with all associated pipe work.

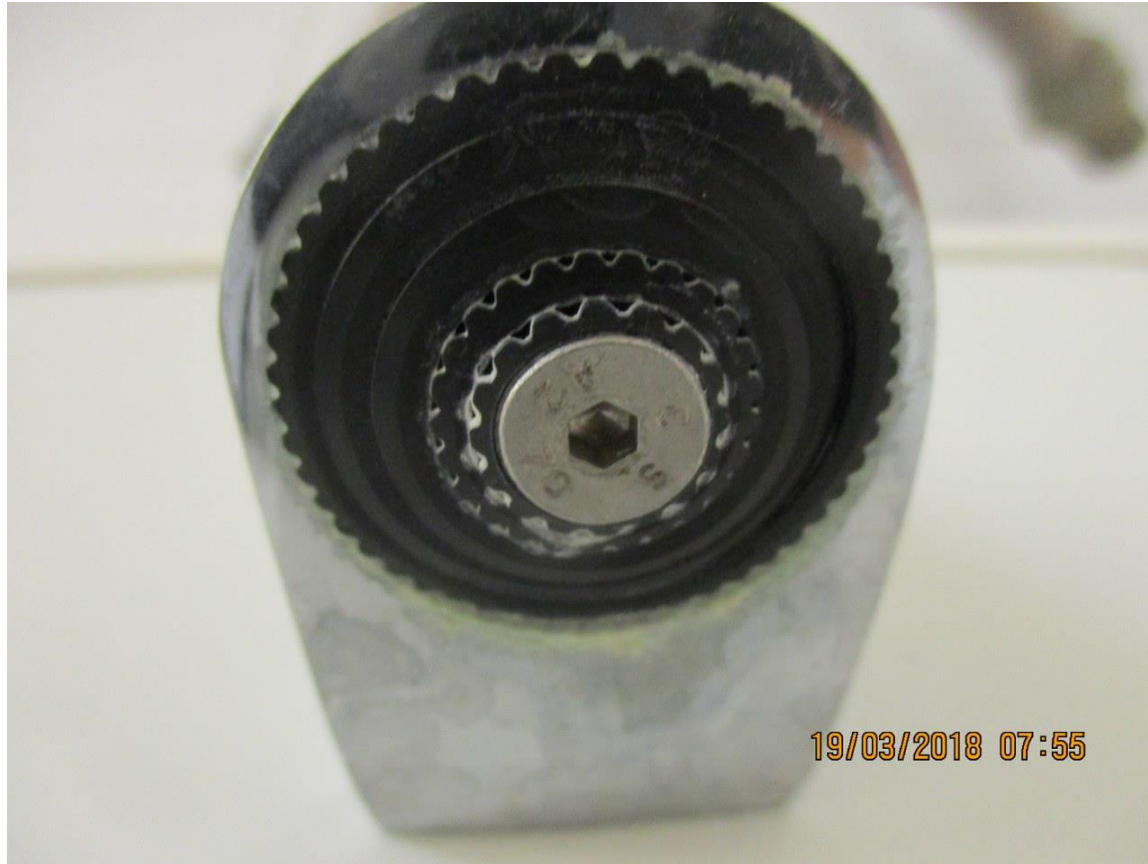
Showerheads

The showerheads are being cleaned and descaled on a quarterly basis; this was last carried out in January 2018.

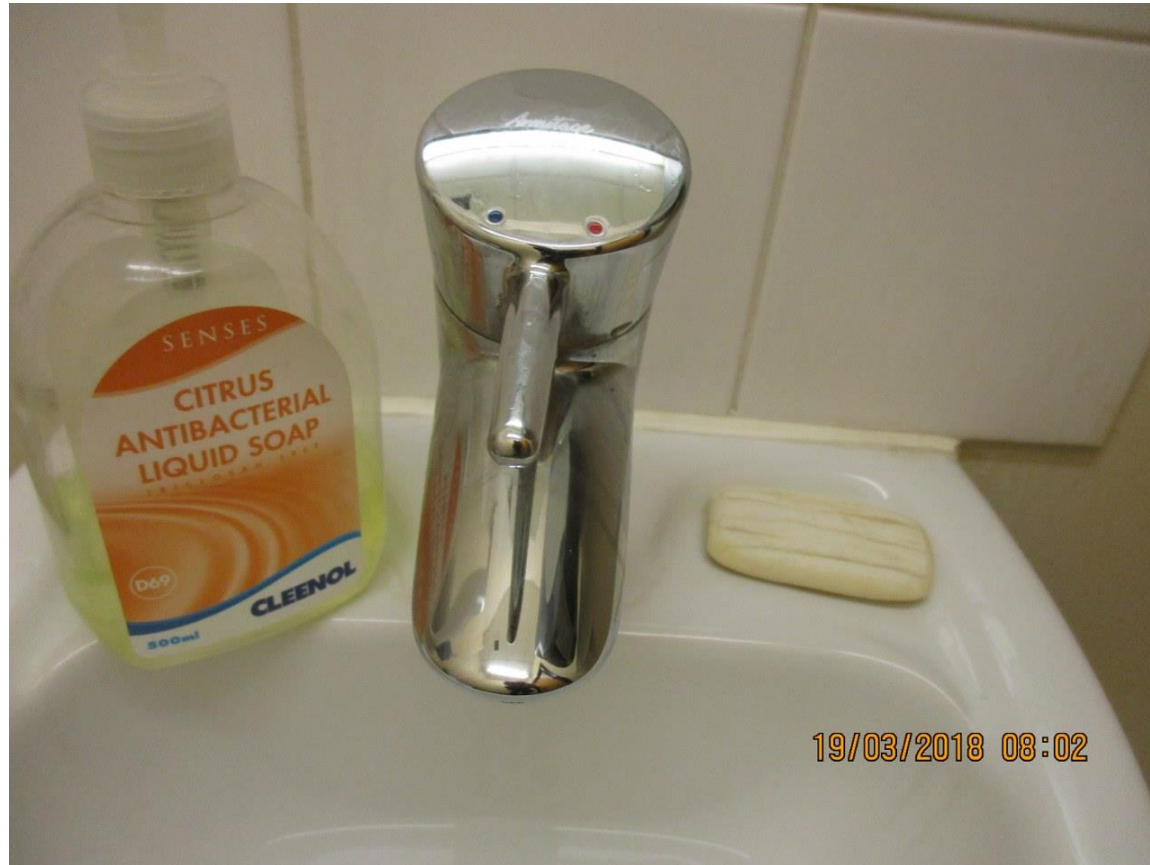
TMV Tap

Unable to check TMV tap as the hot water to this outlet did not achieve 50.0C to the tap; the TMV should be serviced and maintained as recommended by the manufacturers; no records were seen for this being carried out.

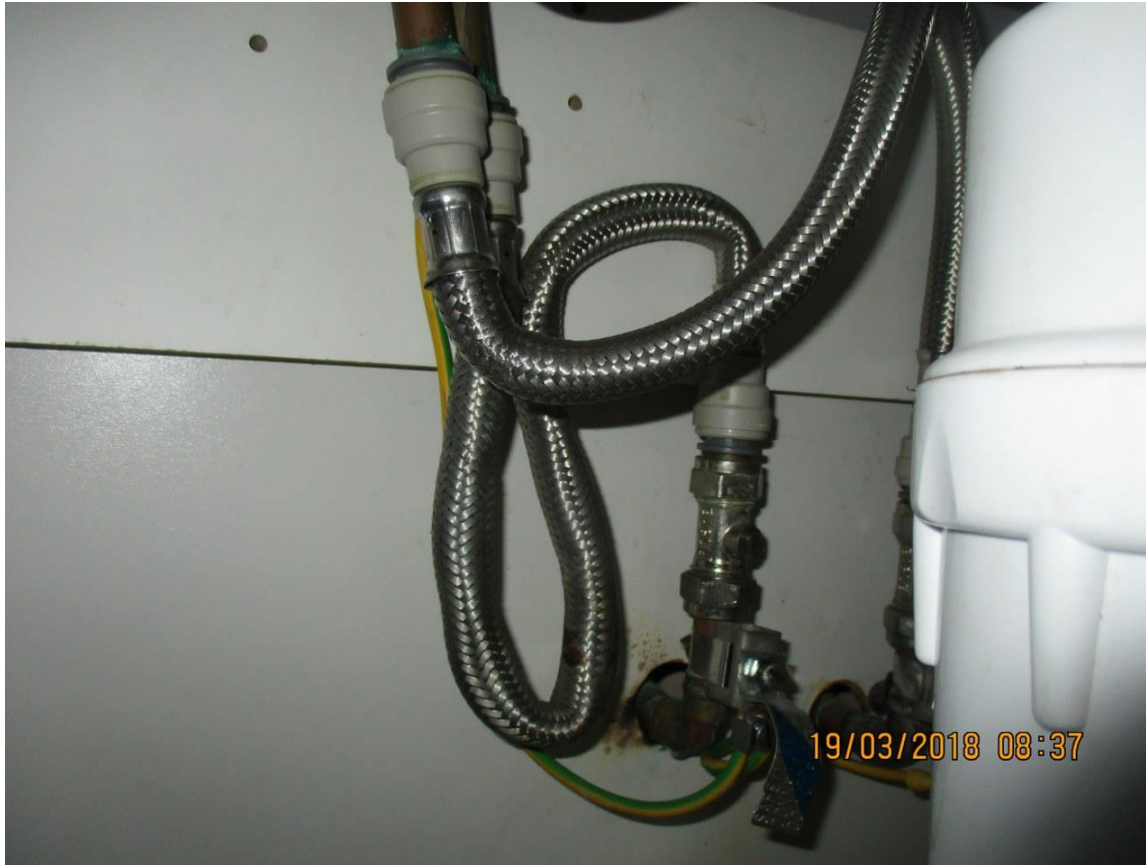
Flexible Hoses

Flexible hoses should not have kinks in them as reduces flow of water and breaks down the hose internally creating ideal areas for bacteria proliferation.
