# **LEGIONELLA RISK ASSESSMENT**

## **Hot and Cold Domestic Water System**

**32A Kentish Road  
Shirley  
Southampton  
Hampshire  
SO15 3GX**

15<sup>th</sup> September 2020

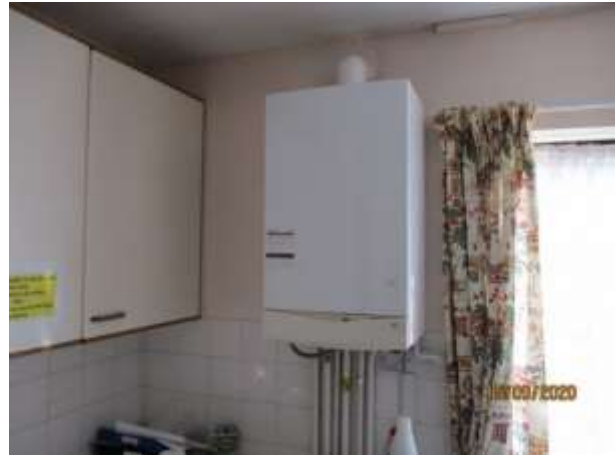
**P1**

**Kitchen**

Combination Boiler. Not working at the time of this assessment.

The combination boiler in 32A Kentish Road was not working at the time of this assessment. The boiler has been off for several years and the hot outlets are only supplying cold water. Combination boilers, when working, heat water on demand and do not store water, therefore the risk of bacterial proliferation is reduced.

| RECOMMENDATION | | | | | | |
|---|---|--|---|---|---|---|
| 13 | 1 | The combination boiler should be serviced and maintained as recommended by the manufacturers. This should be recorded in the log book when carried out. | | | | Low |

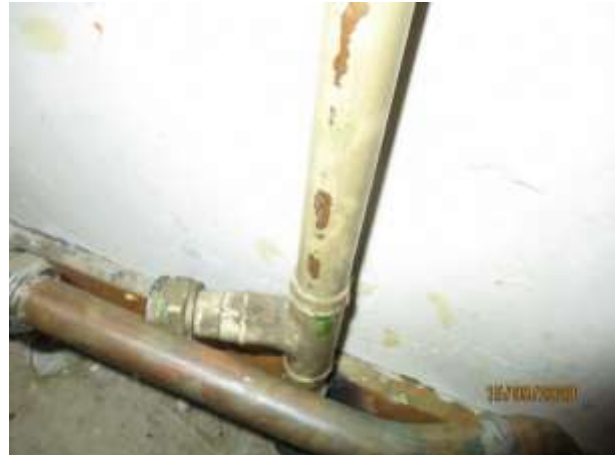
**ADDITIONAL PHOTOGRAPHS****P2****DL1****1<sup>st</sup> Floor Cupboard**

There is a small dead leg on the cold mains pipework.

- Dead leg pipework are ideal areas for the proliferation of bacteria and should be removed or put on a weekly flushing regime (without creating an aerosol) and recorded within the logbook. Dead legs were found in the following areas:-
  - DL1 – 1<sup>st</sup> Floor Cupboard – There is a small dead leg on the cold mains pipework.
  - DL2, 3 – 1<sup>st</sup> Floor Toilet – There are two small dead legs on the hot and cold pipework.

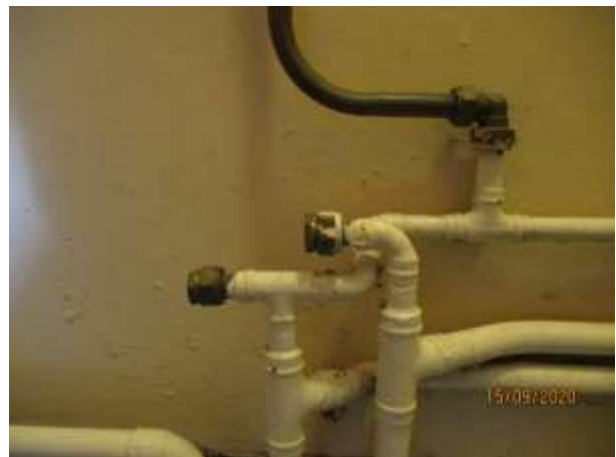
**P3****DL2, 3****1<sup>st</sup> Floor Toilet**

There are two small dead legs on the hot and cold pipework.

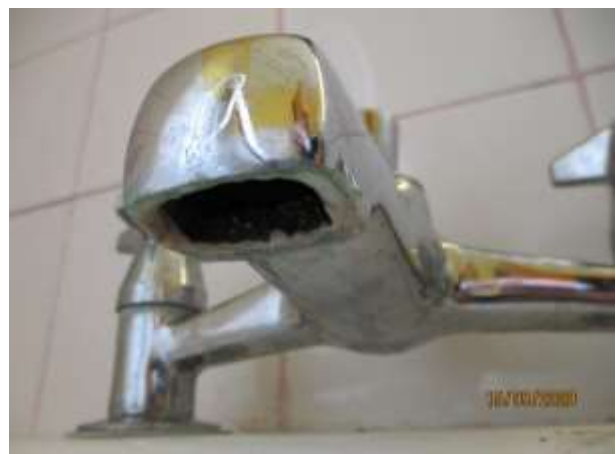
**P4****All Outlets**

Outlets should be descaled and disinfected on a regular basis. Scale is an ideal area for bacteria proliferation.

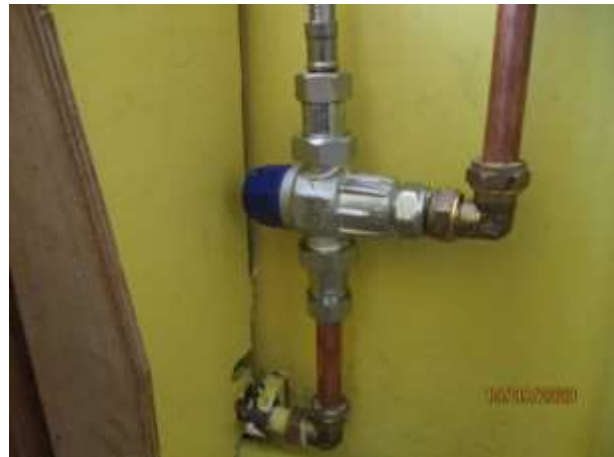
**P5**

**TMVs**

TMVs should be serviced and maintained as recommended by the manufacturers. This should be recorded in the logbook when carried out.

| RECOMMENDATION | | | | | | | |
|---|---|--|---|---|---|---|--|
| 11 | 5 | TMVs should be serviced and maintained as recommended by the manufacturers. This should be recorded in the logbook when carried out. | | | | Low | |

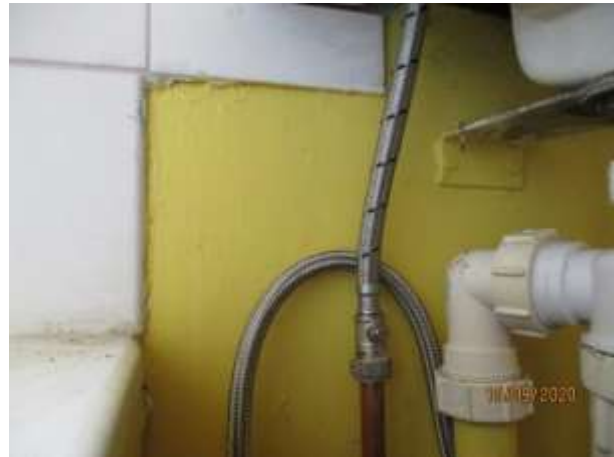
**P6**

**Flexible Hoses**

Flexible hoses should be WRAS approved, change as required or hard plumb pipework.

- TMVs should be serviced and maintained as recommended by the manufacturers. This should be recorded in the logbook when carried out.
- Flexible hoses were seen fitted within the building on wash basins, sinks etc. It should be ensured all flexible hoses are WRAS approved; change as required or hard plumb pipe work. This should be recorded within the logbook when carried out.
