LEGIONELLA RISK ASSESSMENT

Hot and Cold Domestic Water System

**Canute House
King Street
Southampton
Hampshire
SO14 3DG**

12th November 2020

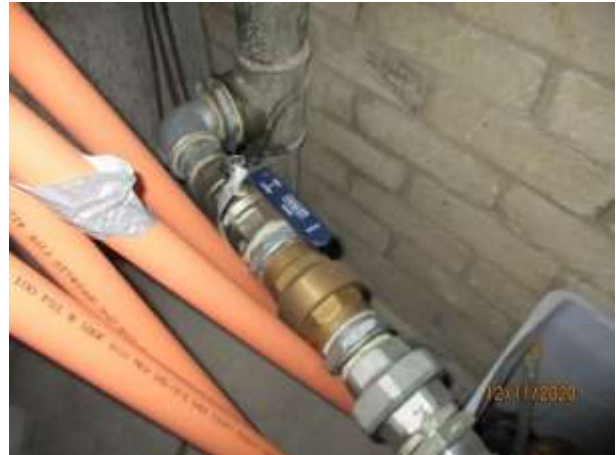
ADDITIONAL PHOTOGRAPHS**P1****DL1****Pump Room Cupboard**

The supply to the sprinkler system pressurisation unit is creating dead leg pipework.

RECOMMENDATION						
Risk		HIGH	System	DOMESTIC WATER SYSTEMS		
Ref No	Photo No	Works	Comments:	Work Assigned To:	Date Completed	Residual Risk After Completion
1	1	DL1 – Pump Room cupboard – The supply to the sprinkler system pressurisation unit is creating dead leg pipework. Dead leg pipework is an ideal area for the proliferation of bacteria (including Legionella) and should be removed or flushed (without creating an aerosol) for at least two minutes at least on a <u>weekly</u> basis and recorded within the logbook when carried out. It is difficult to flush fill lines on a weekly basis therefore I would recommend that backflow protection is added to the fire sprinkler supply line as close to the main cold live pipework as possible.				Low

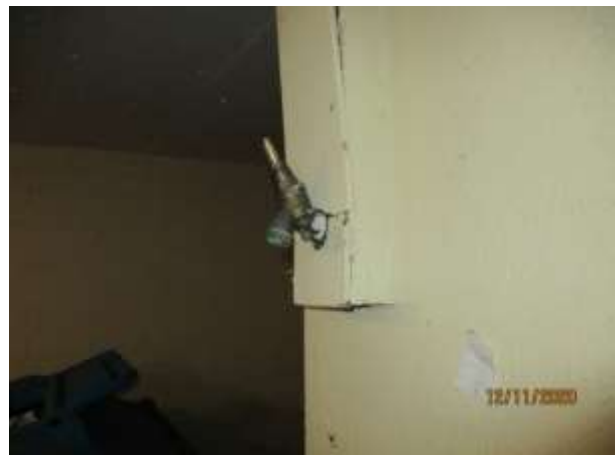
**P2****DL2****Bin Storage Area**

The bib Tap has no handle and is creating a dead leg.

- Dead leg pipework are ideal areas for the proliferation of bacteria and should be removed or put on a weekly flushing regime (without creating an aerosol) and recorded within the logbook. Dead legs were found in the following areas:-
 - DL1 – Pump Room cupboard – The supply to the sprinkler system pressurisation unit is creating dead leg pipework.
 - DL2, 3 – Bin Storage Area – The bib taps have no handles fitted to enable flushing.

- The cold mains pipework is galvanised and does not appear to be insulated as it rises. Pipework should be insulated to minimise heat losses/gains.
- The bib taps in the Bin Storage areas should have backflow protection fitted to the pipework. I would recommend these are fitted.

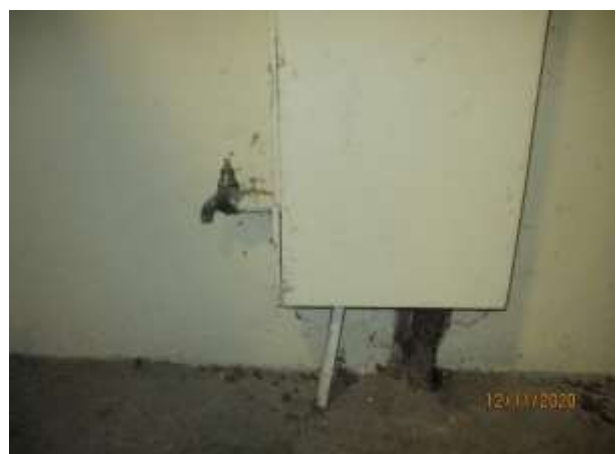
**P3****DL3****Bin Storage Area**

The bib Tap has no handle and is creating a dead leg.
