LEGIONELLA RISK ASSESSMENT

Hot and Cold Domestic Water System

**St James House
Orchard Lane
Southampton
Hampshire
SO14 3DH**

11th November 2020

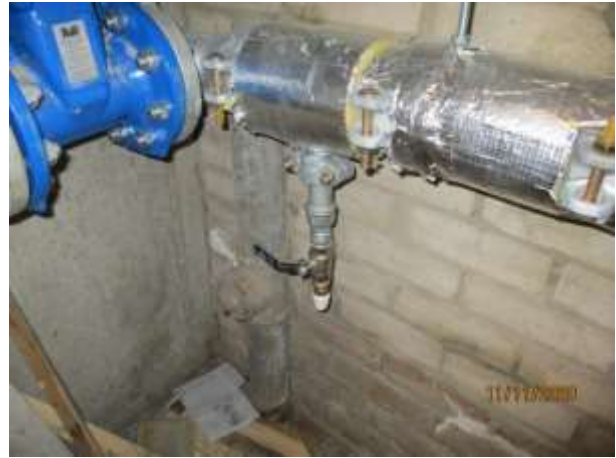
ADDITIONAL PHOTOGRAPHS**P1****DL1****Pump Room Cupboard**

Small dead leg on the cold mains pipework.

RECOMMENDATION						
Risk		HIGH	System	DOMESTIC WATER SYSTEMS		
Ref No	Photo No	Works	Comments:	Work Assigned To:	Date Completed	Residual Risk After Completion
1	1, 2	DL1, 2 – Pump Room Cupboard – There are two small dead legs on the cold mains pipework. Dead leg pipework is an ideal area for the proliferation of bacteria (including Legionella) and should be removed or flushed (without creating an aerosol) for at least two minutes at least on a <u>weekly</u> basis and recorded within the logbook when carried out.				Low

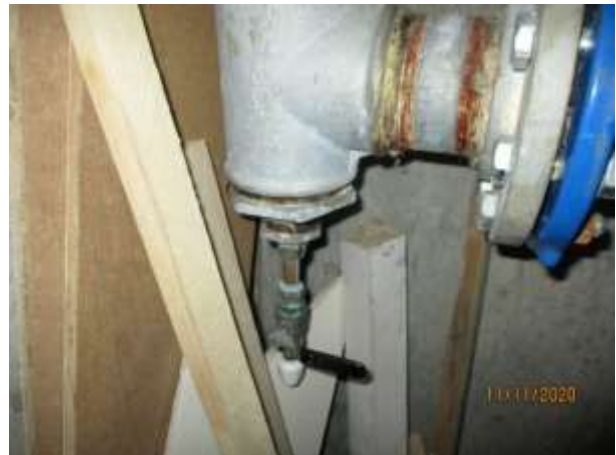
**P2****DL2****Pump Room Cupboard**

Small dead leg on the cold mains pipework.

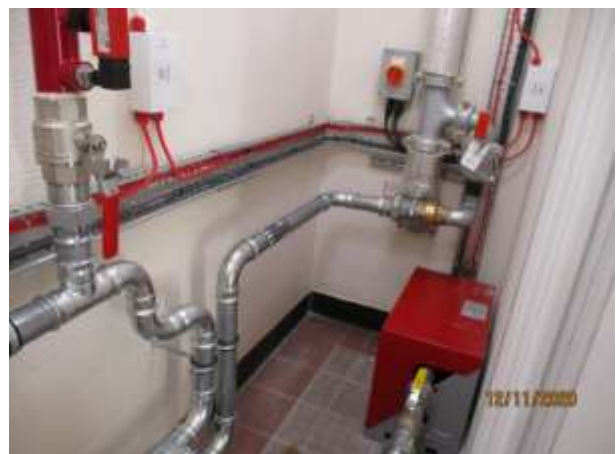
**P3****Fire Sprinkler Cupboard**

The supply to the sprinkler system pressurisation unit is creating dead leg pipework.

RECOMMENDATION							
Risk		HIGH	System	DOMESTIC WATER SYSTEMS			
Ref No	Photo No	Works	Comments:	Work Assigned To:	Date Completed	Residual Risk After Completion	
2	3	<p>DL3 – Fire Sprinkler cupboard – The supply to the sprinkler system pressurisation unit is creating dead leg pipework.</p> <p>Dead leg pipework is an ideal area for the proliferation of bacteria (including Legionella) and should be removed or flushed (without creating an aerosol) for at least two minutes at least on a <u>weekly</u> basis and recorded within the logbook when carried out. It is difficult to flush fill lines on a weekly basis therefore I would recommend that backflow protection is added to the fire sprinkler supply line as close to the main cold live pipework as possible.</p>				Low

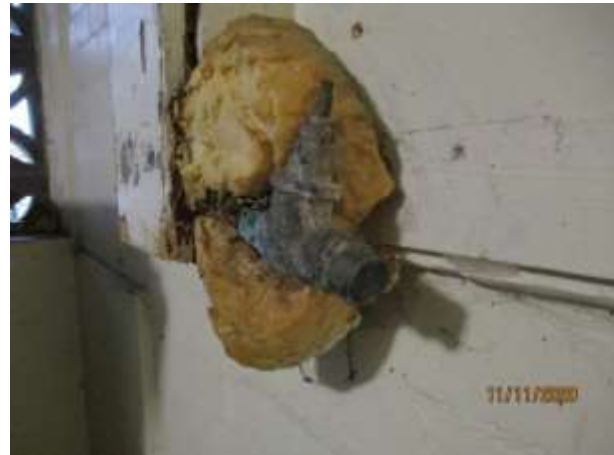
P4

Flat 1 – 7 Bin Storage Area

The bib tap has been capped off creating dead leg pipework.

RECOMMENDATION							
Risk		HIGH	System	DOMESTIC WATER SYSTEMS			
Ref No	Photo No	Works		Comments:	Work Assigned To:	Date Completed	Residual Risk After Completion
3	4	DL4 – Flats 1 – 7 Bin Storage Area – The bib tap has been capped off and is creating a dead leg. Dead leg pipework is an ideal area for the proliferation of bacteria (including Legionella) and should be removed or flushed (without creating an aerosol) for at least two minutes at least on a <u>weekly</u> basis and recorded within the logbook when carried out.					Low

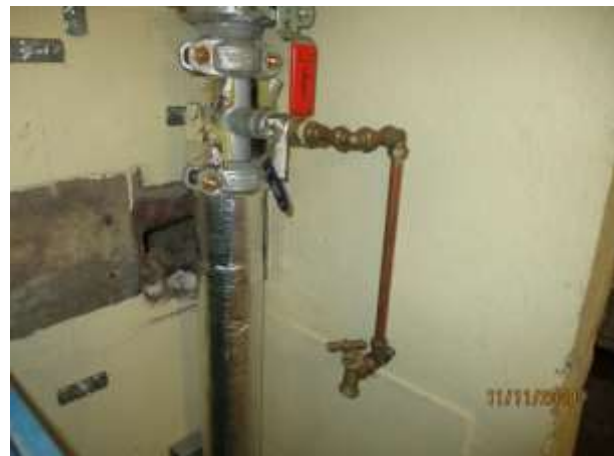
P5

Bib Taps

The bib taps should have backflow protection fitted.

- The bib taps in the Bin Storage areas should have backflow protection fitted to the pipework. I would recommend these are fitted.
- No schematic drawings of the domestic water systems were seen to be filed within the logbook. All schematic drawings should be kept updated when changes are made to the water systems. Schematic drawings are included within this assessment.
