## 10.Cold Water Storage Tank Temperatures & Condition Record

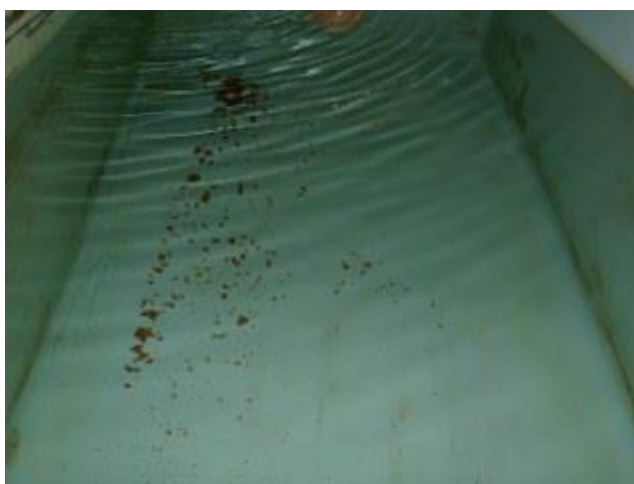
Old school building stairwell storage tank light sediment build up on the base of the tank; recommend tank is cleaned and disinfected in October 2014 when annual clean is due.

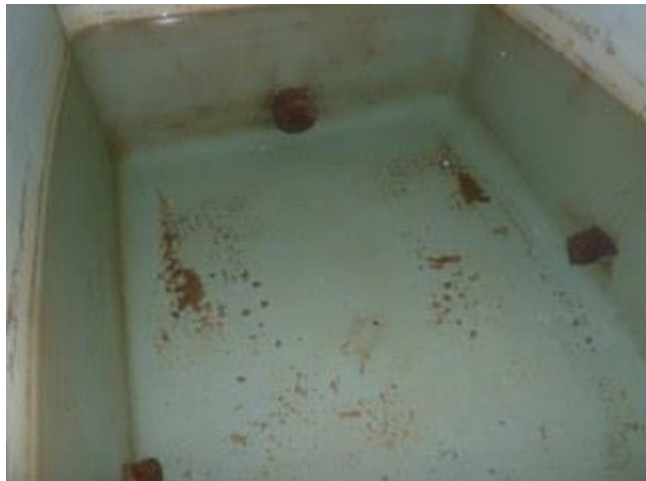
Old school building front tank in roof void; sediment build up on the base of the tank and staining on side walls; tank also had elevated water temperature probably due to no water turnover in holiday period.

Recommend tank is cleaned and disinfected in October 2014 when annual clean is due.

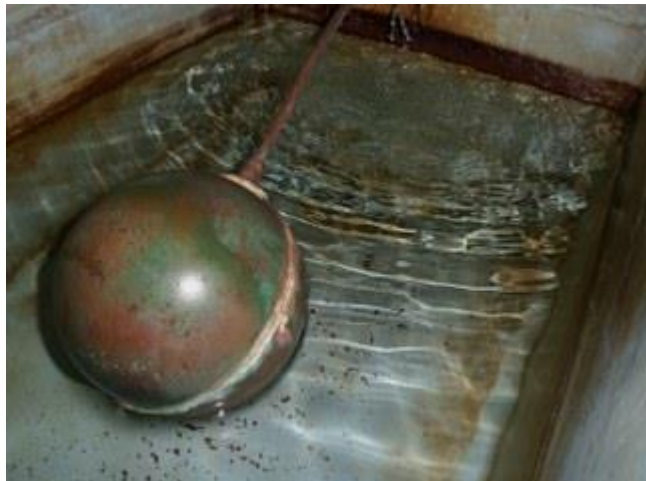
Old school building rear tank in roof void; sediment build up on the base of the tank and heavy staining on side walls.

Recommend tank is cleaned and disinfected in October 2014 when annual clean is due.

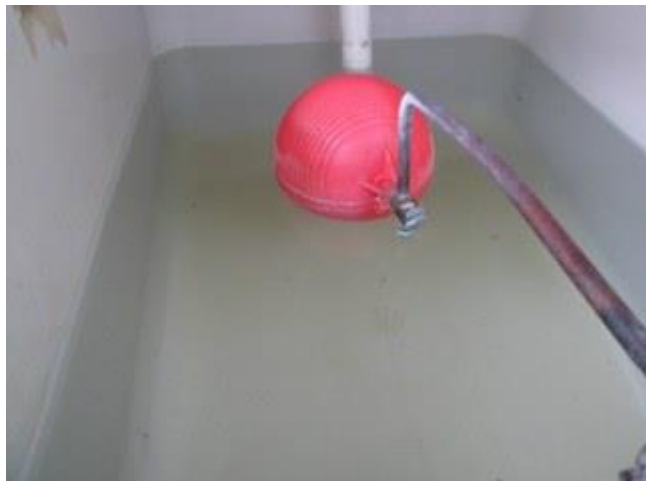
Science block water storage tank was seen to have slight surface stagnation due to no water turnover in the holiday period; this also had elevated cold water temperature and slight sediment on base of tank.

Recommend tank is cleaned and disinfected in October 2014 when annual clean is due.
